**FOURTH FIVE-YEAR REVIEW REPORT FOR
RAYMARK SUPERFUND SITE
MONTGOMERY COUNTY, PENNSYLVANIA**

September 2014

**Prepared by
U.S. Environmental Protection Agency
Region III
Philadelphia, Pennsylvania**

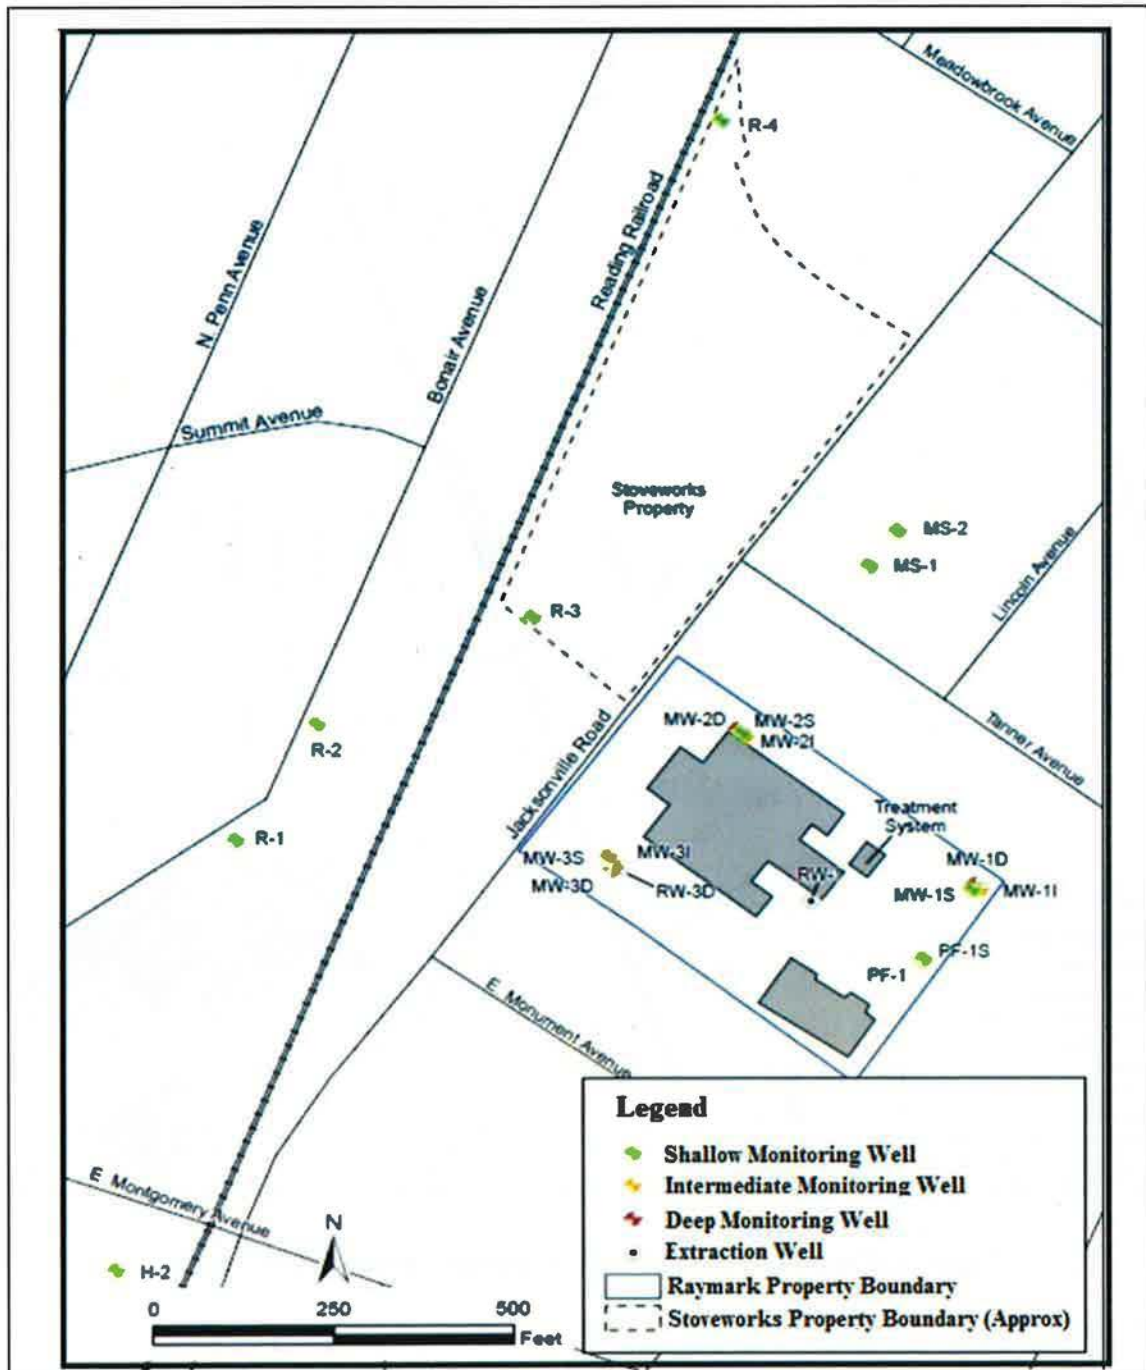
EPA (Plaintiff) and Hatboro Borough Authority (Plaintiff-Intervenor). In exchange for payment from the Settling Defendants, Hatboro agreed to design, install, operate and maintain two vapor phase carbon adsorption units on two off-site wells (H-14 and H-17). Pursuant to the Consent Decree, EPA agreed to design construct, operate and maintain an on-site groundwater extraction and treatment system including two extraction wells, RW-1 and MW-3D (MW-3D later collapsed and was replaced with extraction well R-3). Additionally, EPA agreed to design, install, operate and maintain a vapor phase carbon adsorption unit as part of the on-site treatment system. Figure 2 is a map of the Site which shows the location of on-site wells.

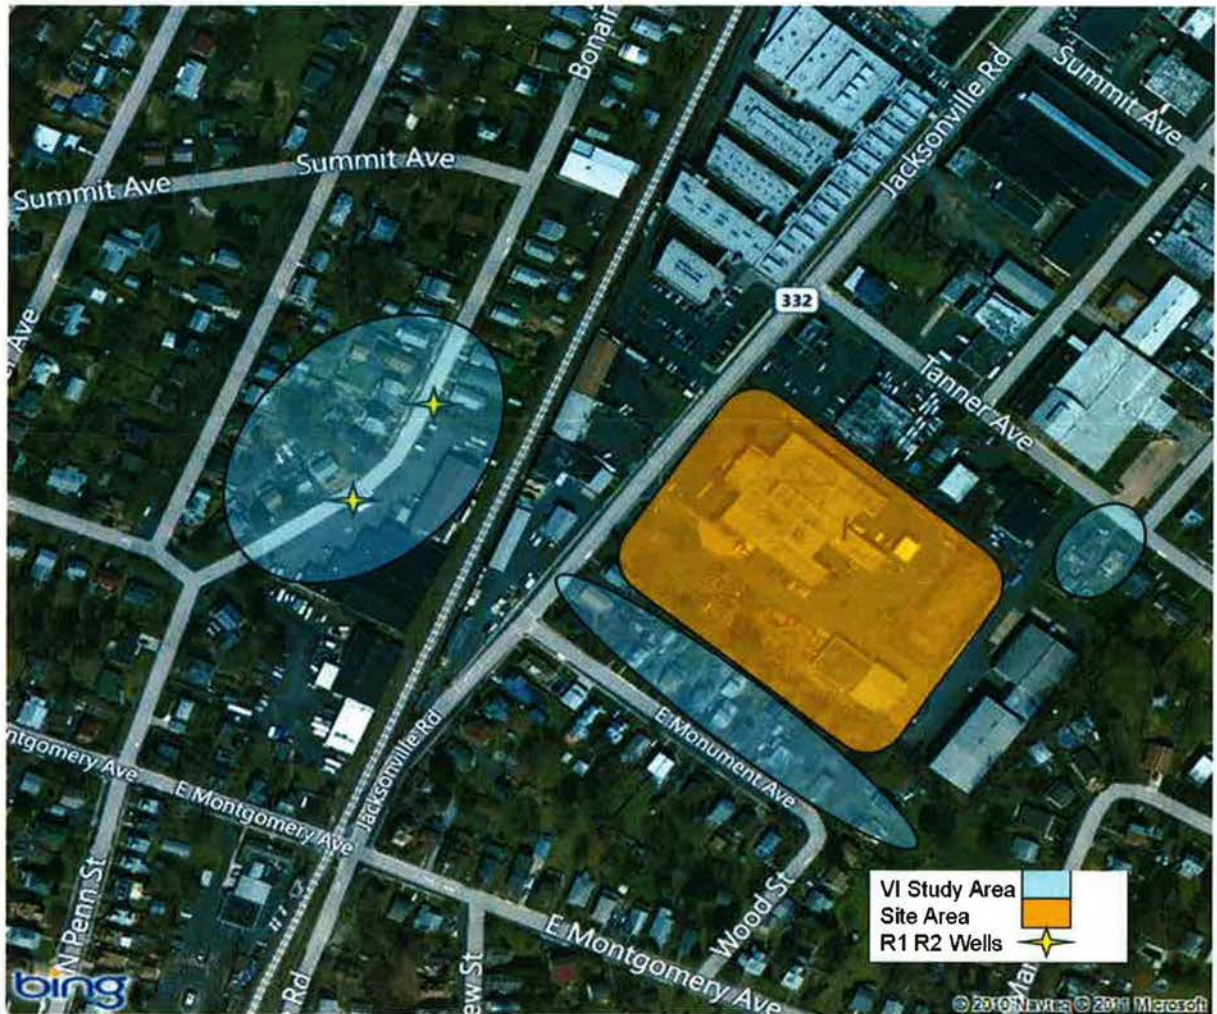
Figure 4. Vapor Intrusion Study Area and Former Area of Contamination

Several of the properties that were sampled showed evidence of actual or potential vapor intrusion of Site COCs. Analytical data revealed that the highest concentrations of COCs found in subslab vapor occurred at properties along Bonair Avenue. Regardless of this, VI it is not a current threat for human health due to the low concentrations found at those residences. It could potentially be in the future; therefore, further investigation efforts are warranted.

In order to address these issues, it is recommended that the VI study be expanded to evaluate other residences in the Bonair Avenue vicinity. Bonair Avenue was the location where the highest concentrations of COCs were found in the subslab during the VI study. Additional sampling is planned to be completed in late 2014 (October to December) and early 2015 (January to March).

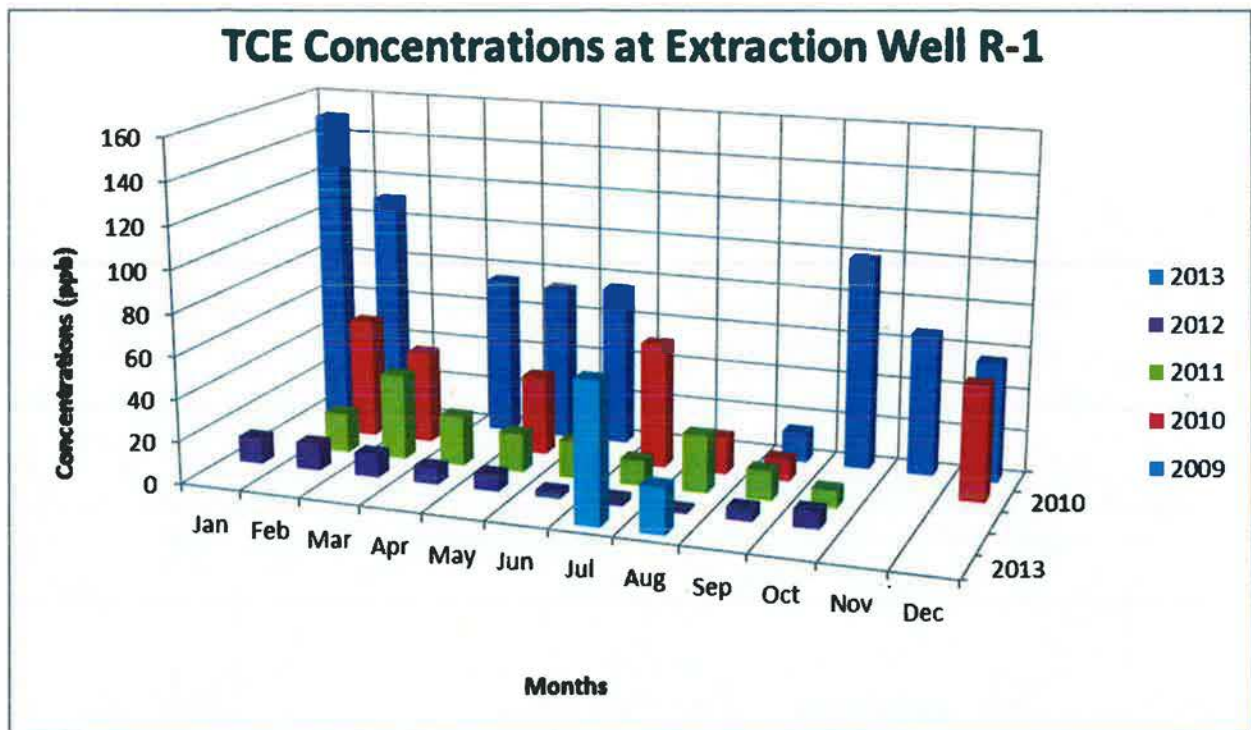
Figure 5. TCE Concentration at Extraction Well R-1

The groundwater was analyzed for volatile organic compounds. Well data from 2011 to 2013 indicates TCE continues to be present in groundwater throughout the Site. Two nested well sets (R1 and R2) were installed on Bonair Avenue in 2011 to delineate downgradient groundwater contamination and investigate the potential for vapor intrusion in nearby residences. TCE and its degradation product 1, 1-DCE were the only COCs that were detected in most wells (including the newly installed wells) above MCLs (1,1-DCE was found in MW-R1(D) above MCLs). TCE was the only COC detected in all wells at a concentration above the MCL. PCE was also detected in well in MW-2S, MW-3S and MW-3D above the MCL at some point since the last Five-Year Review.

EPA also plans to install a series of nested monitoring wells in 2014 to further delineate the shallow groundwater contamination. The shallow wells should help to determine the extent of the shallow groundwater contamination as well as the extent of the vapor intrusion study area. The deeper wells will provide the opportunity to gather data to determine the extent of the ground water contamination in the intermediate and deep interval of the aquifer. The last recommendation is to conduct a capture zone analysis, which will be used to evaluate the effectiveness of the groundwater extraction system. Once the capture zone analysis is complete, the groundwater treatment system will most likely need to be optimized.

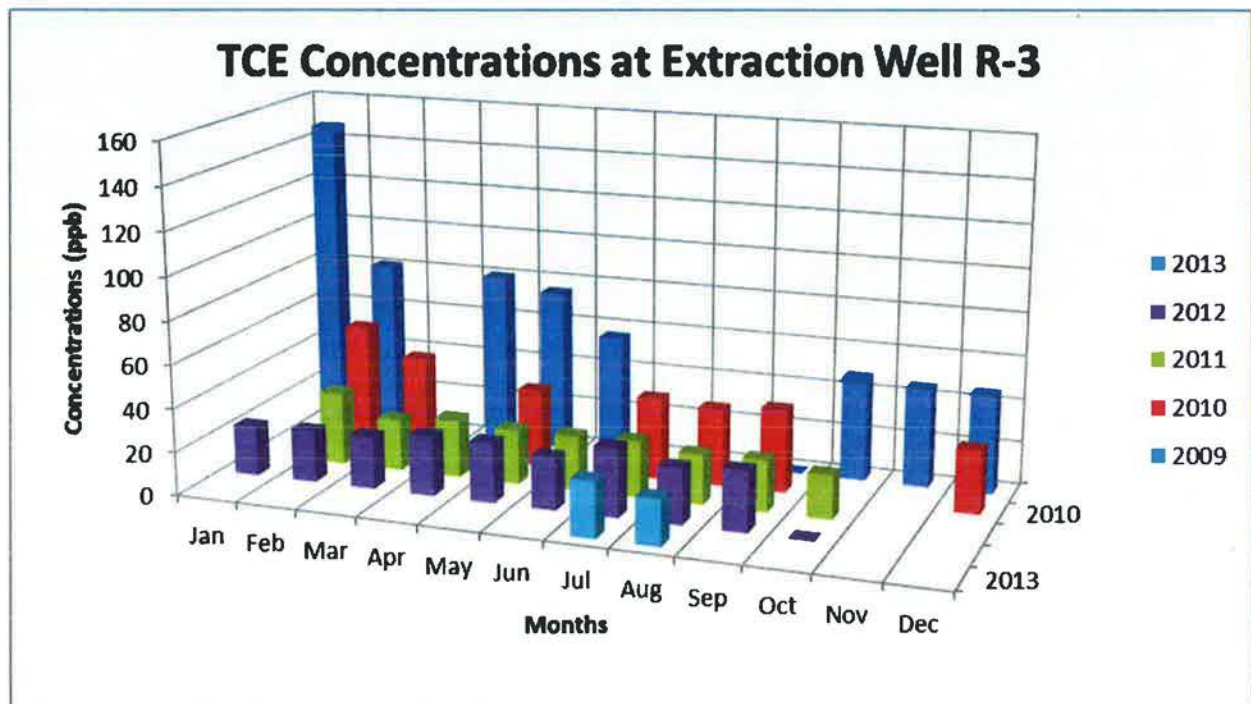
Figure 6. TCE Concentration at Extraction Well R-3

The extraction wells are being pumped at a depth of 135 feet for well RW-1 and 190 feet for RW-3. Well RW-3 is a replacement well drilled in 1999 due to the collapsed of the original well MW-3D. The pumping rate identified in the CD was a combined rate of 60gpm. During an optimization study (2005), EPA determined that the pumping rate should be approximately
