**Federal On-Scene Coordinator's After Action Report**

**Big John Salvage Hoult Road**

**Photos by START Region III - West**

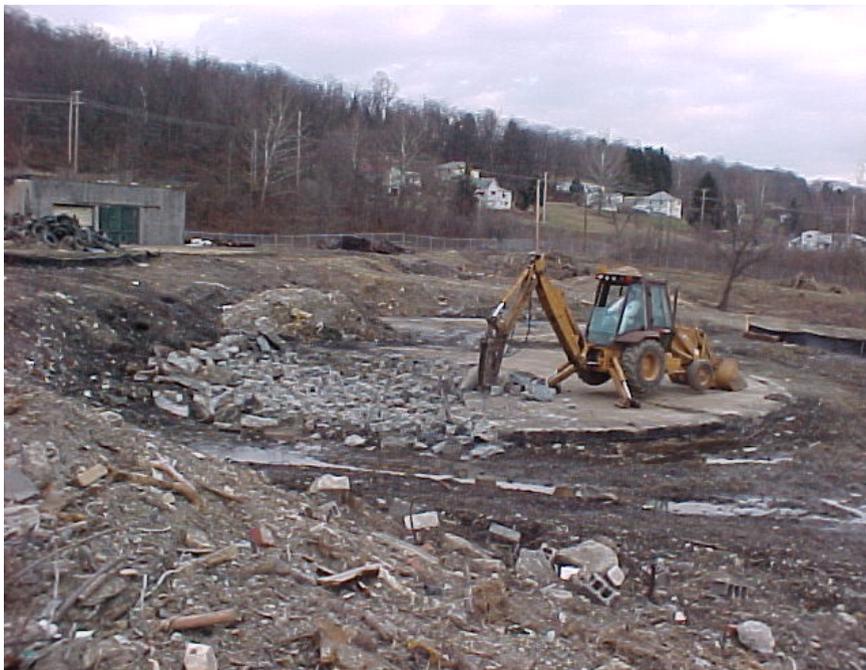
Frame #: 9

Description: **ERRS breaking concrete pad into small pieces. The pieces were power-washed to remove coal tar contamination. Contaminated soil under the pad was then removed.**

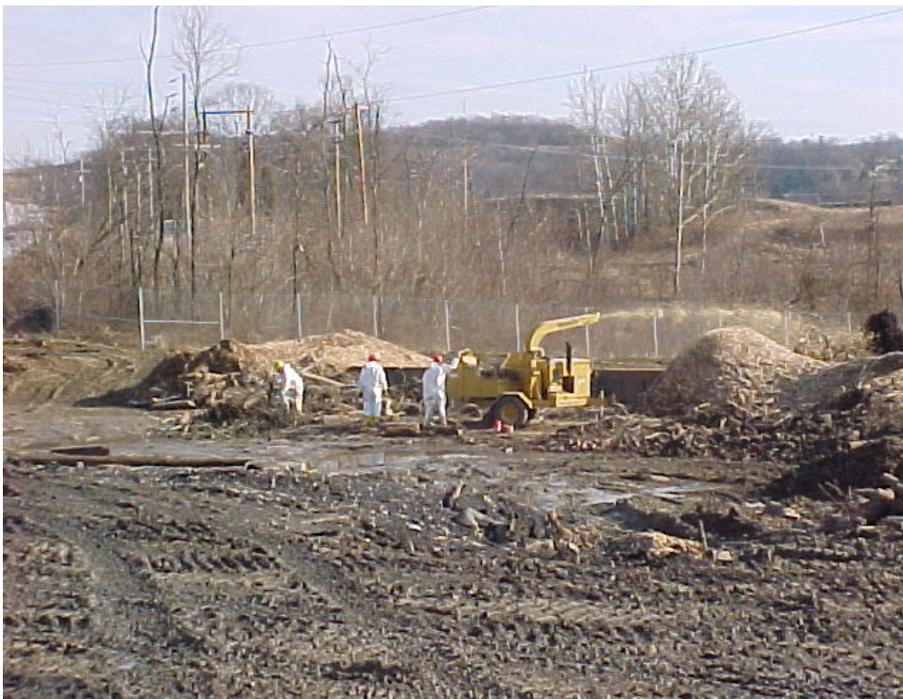
Frame #: 6

Description: **ERRS chipping wood. The wood originated from onsite clearing and grubbing activities.**

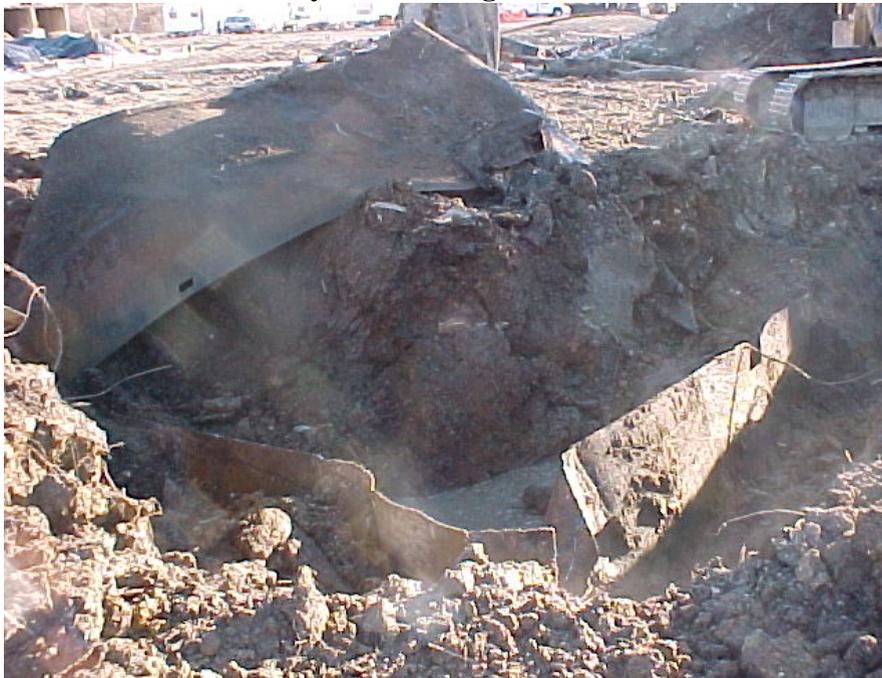
Frame #: 4

Description: **ERRS uncovering a wash basin that was suspected to be used under the ownership of Big John Salvage Inc. to wash glass cullet. The structure was filled with glass cullet, perched water, and some coal tar.**

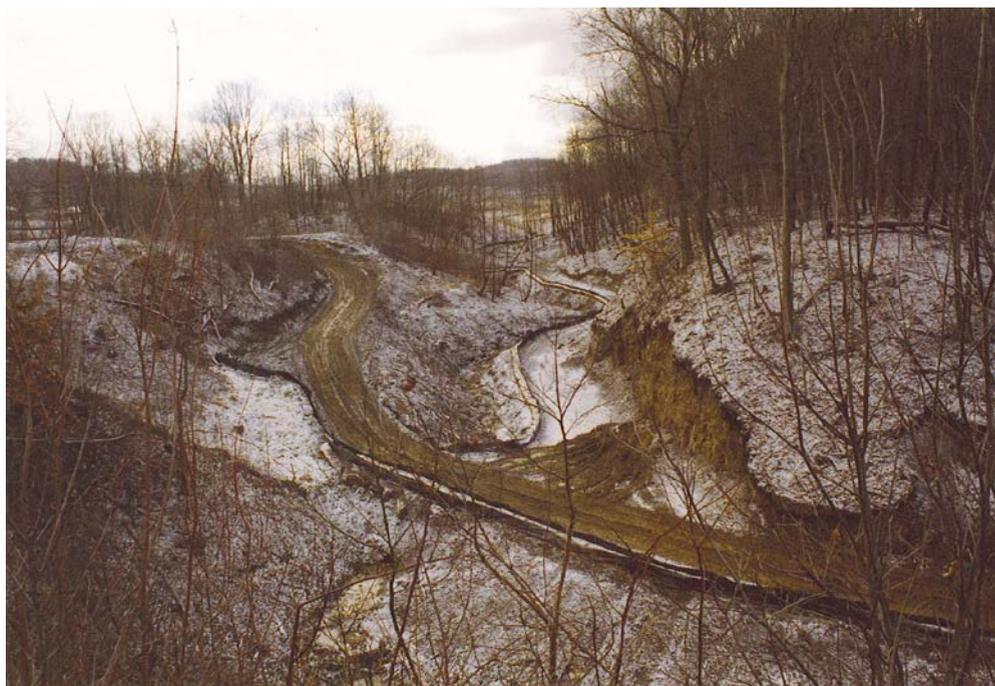
Frame #: 19

Description: **Road along Unnamed Tributary #1 that ERRS constructed. The road was used to excavate and transport contaminated sediments from the tributary and from the pond.**

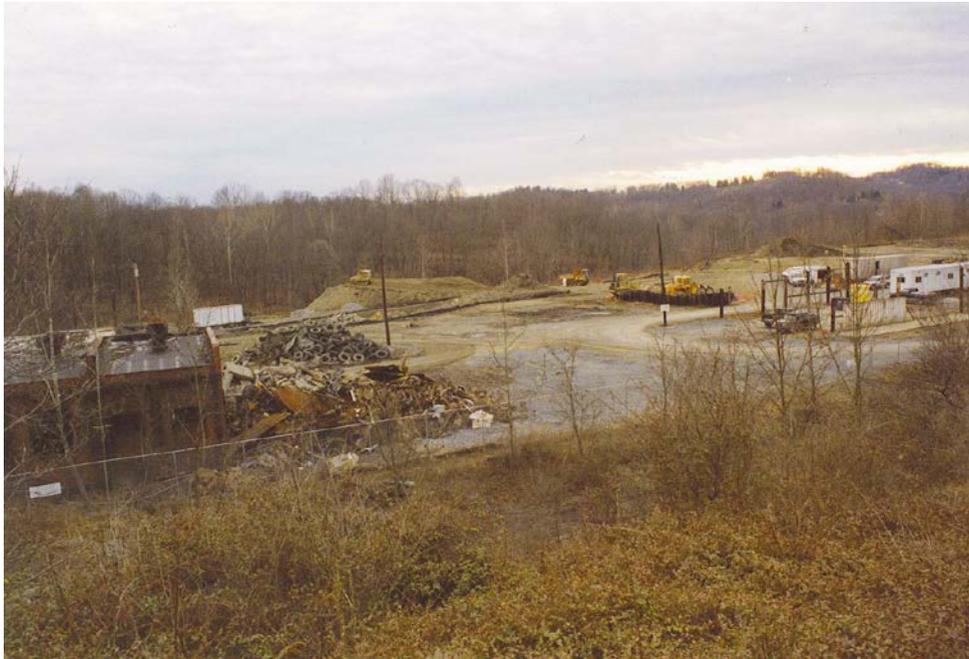
Frame #: 10

Description: **Removal activities at the Site.**

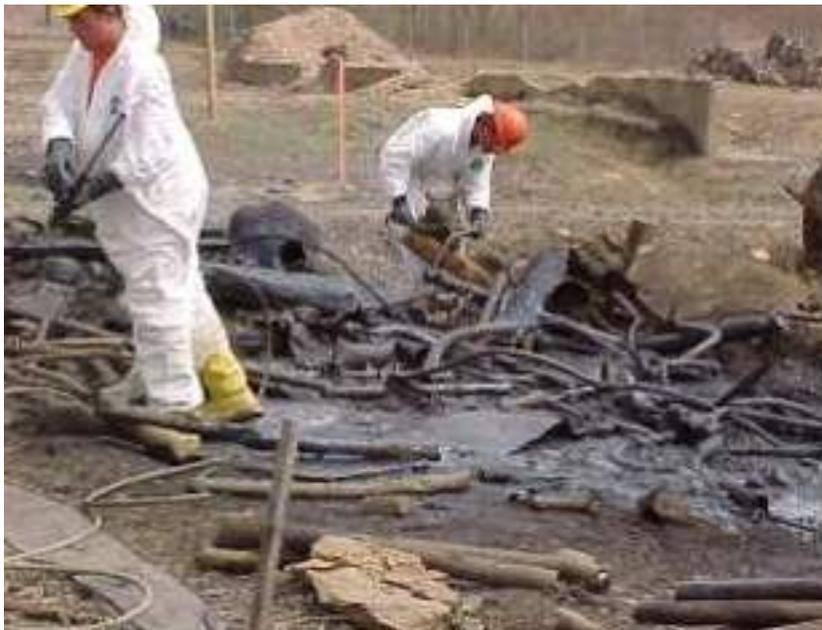
Frame #: 2

Description: **Contaminated pipes and other metal debris discovered during removal activities. The metal debris was power-washed to remove contamination and then disposed of.**

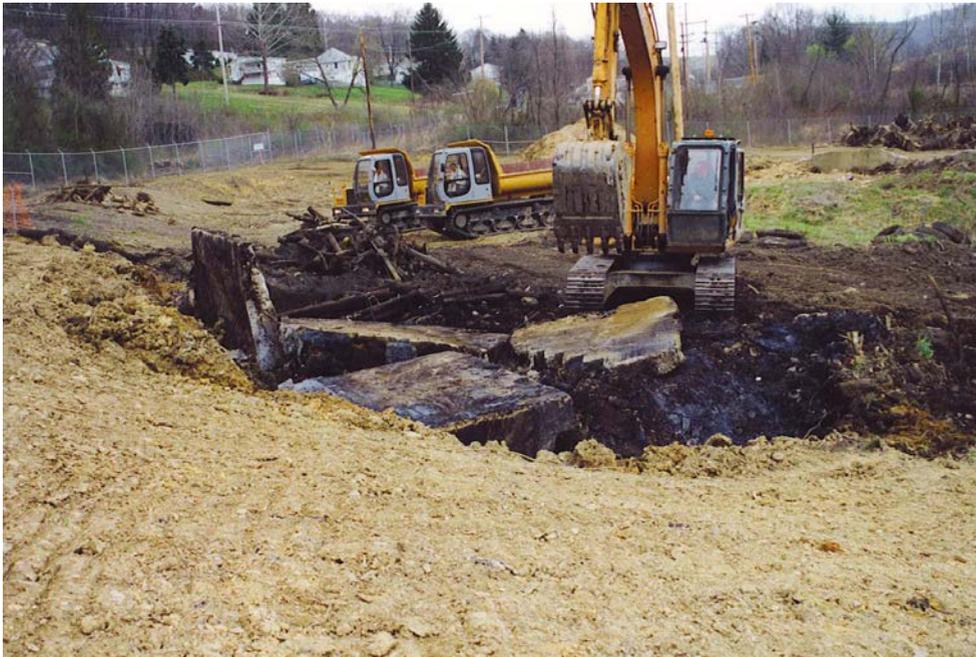
Frame #: 3

Description: **Coal tar contamination discovered underneath a concrete pad and wall which was located approximately 75 feet south of the abandoned building.**

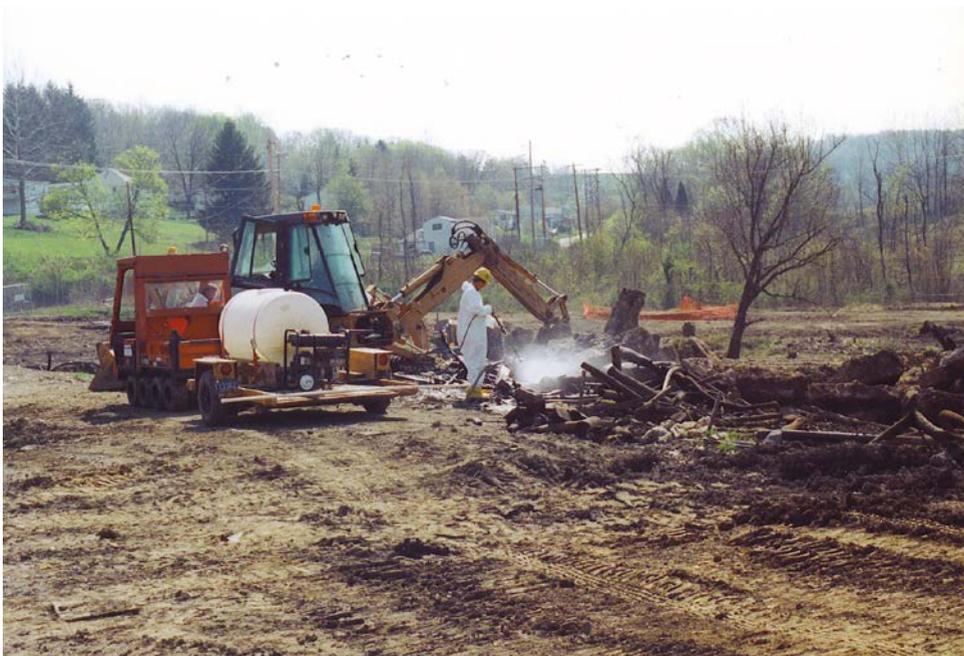
Frame #: 21

Description: **ERRS pressure washing the contaminated metal debris discovered onsite. Dust suppression is also being performed on the dirt roads using a small water trailer.**

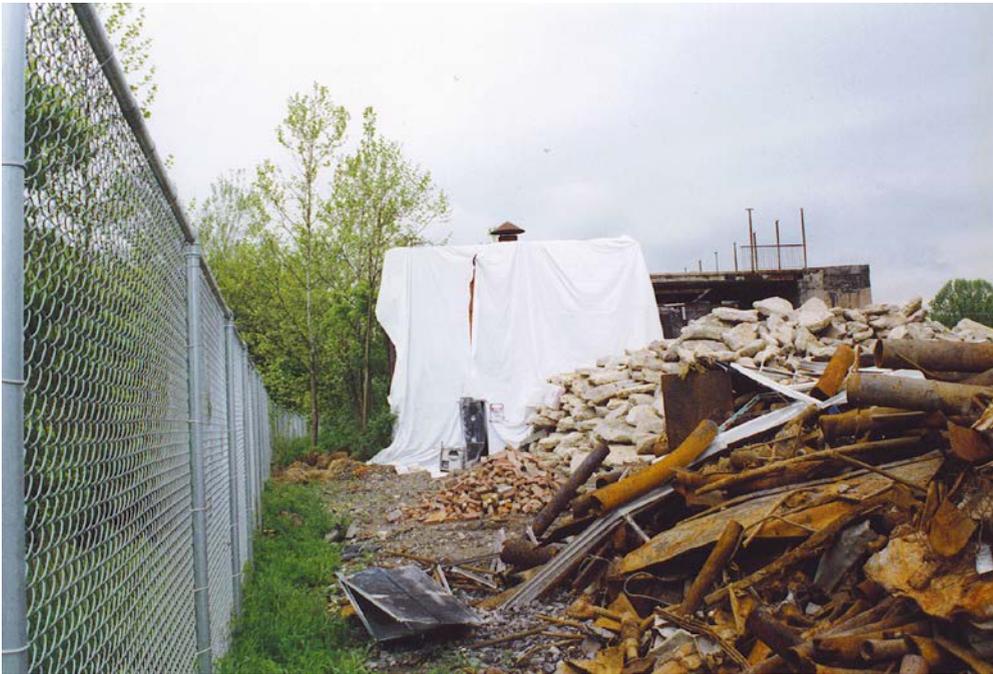
Frame #: 8

Description: **Asbestos removal being performed on the abandoned building by ERRS sub-contractor AMI.**

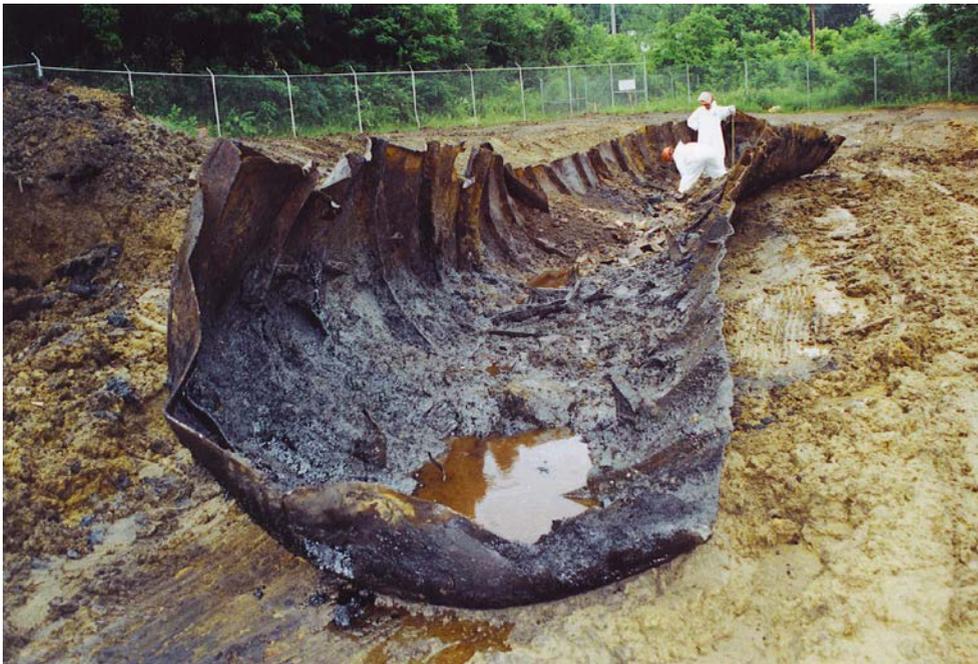
Frame #: 17

Description: **A 65 foot tank discovered during excavation of contaminated soil. The tank was extremely corroded and coal tar was seeping into the surrounding soil. The contents of the tank were removed by ERRS and staged in onsite stockpiles. The tank was cut into smaller pieces, power washed, and disposed of.**

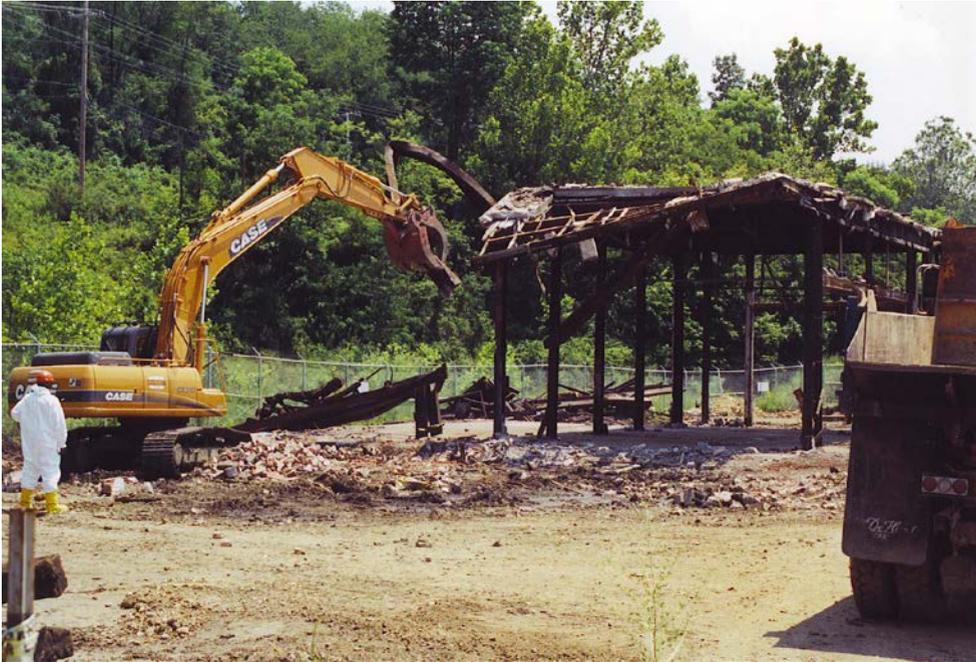
Frame #: 10

Description: **ERRS demolishing the abandoned building onsite. The building had been condemned by the City of Fairmont.**

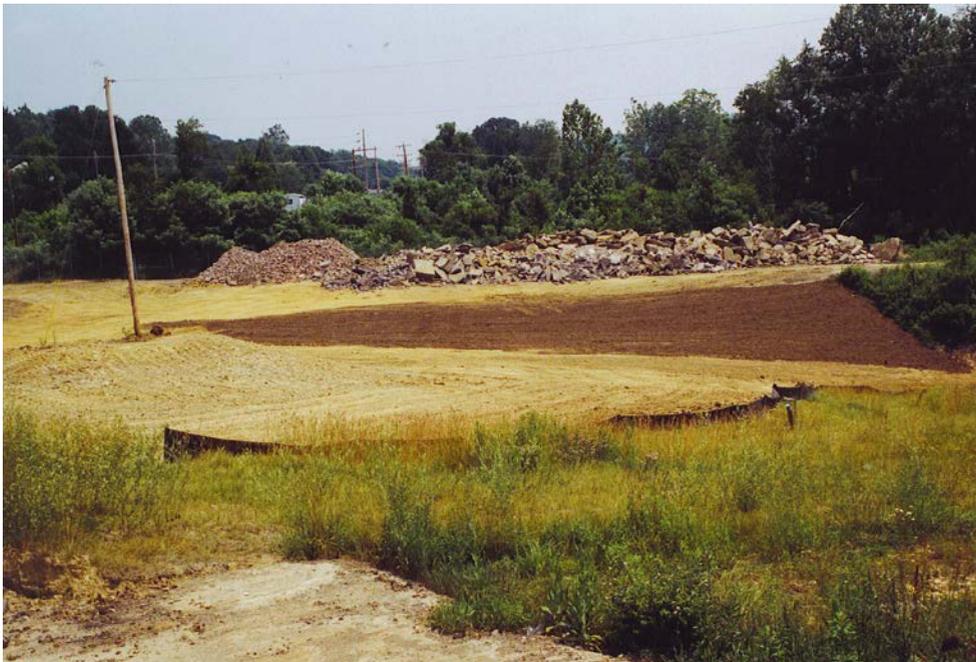
Frame #: 9

Description: **Concrete and bricks stockpiled on eastern side of the site. They have been pressure washed to remove the contamination. Wood chips are also spread on the remediated slope.**

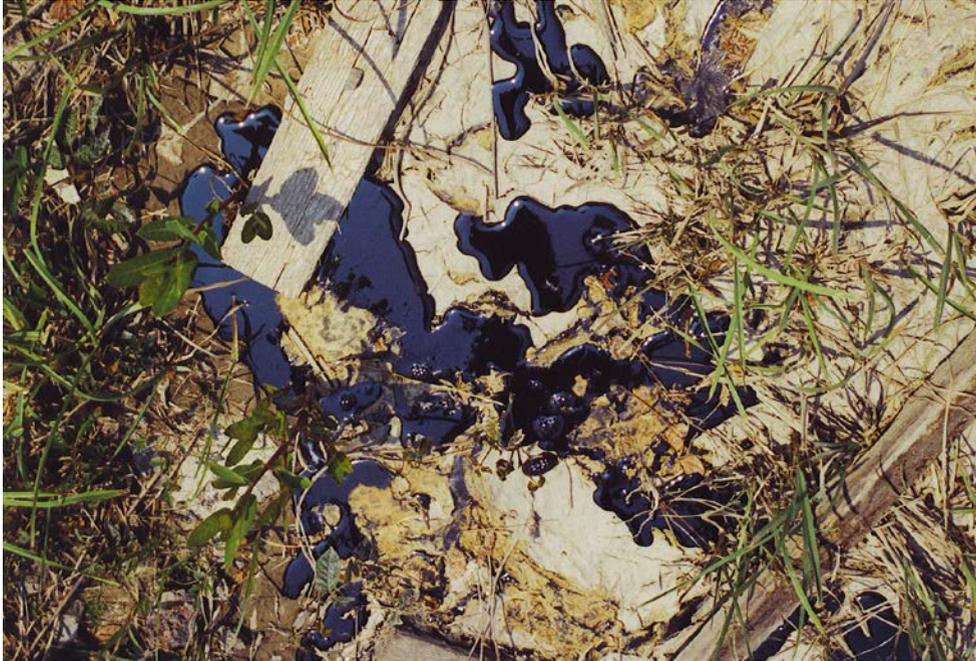
Frame #: 6

Description: **Coal tar seeping from the ground.**

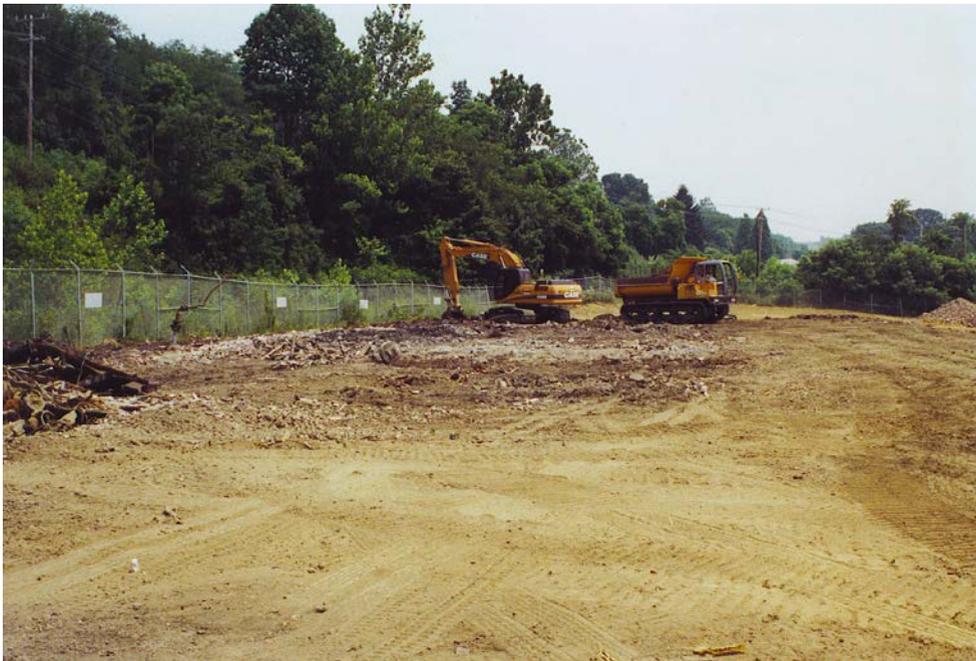
Frame #: 1

Description: **The remains of the demolished building. ERRS removed all remaining debris and then excavated the contaminated soil which was located underneath the building.**

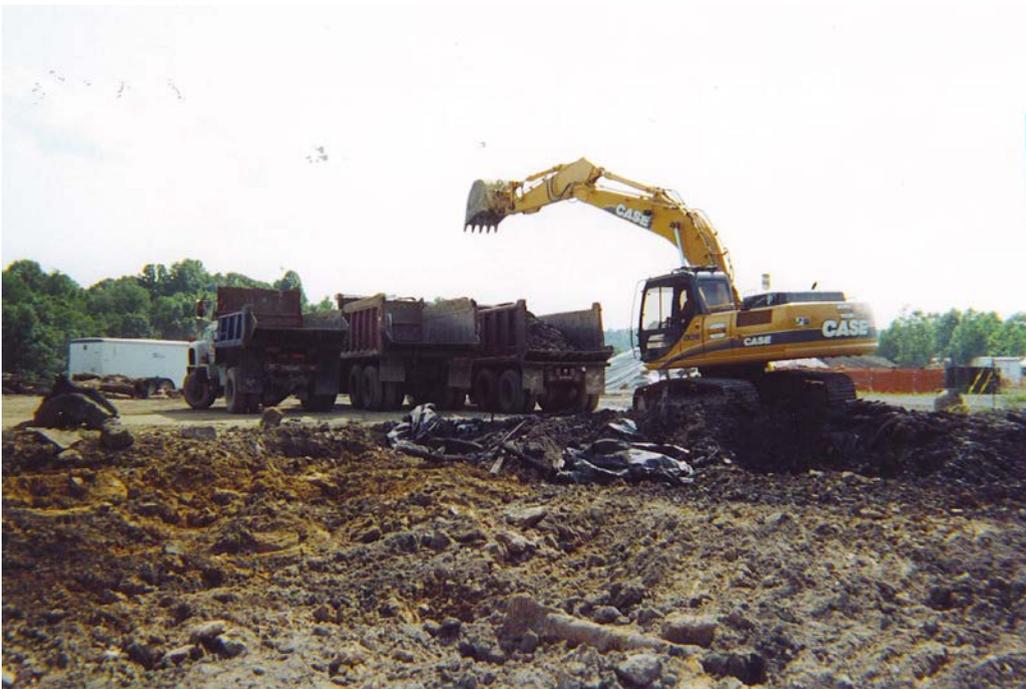
Frame #: 18

Description: **ERRS loading contaminated soil from the area northwest of the demolished building. The soil was transported to onsite stockpiles.**

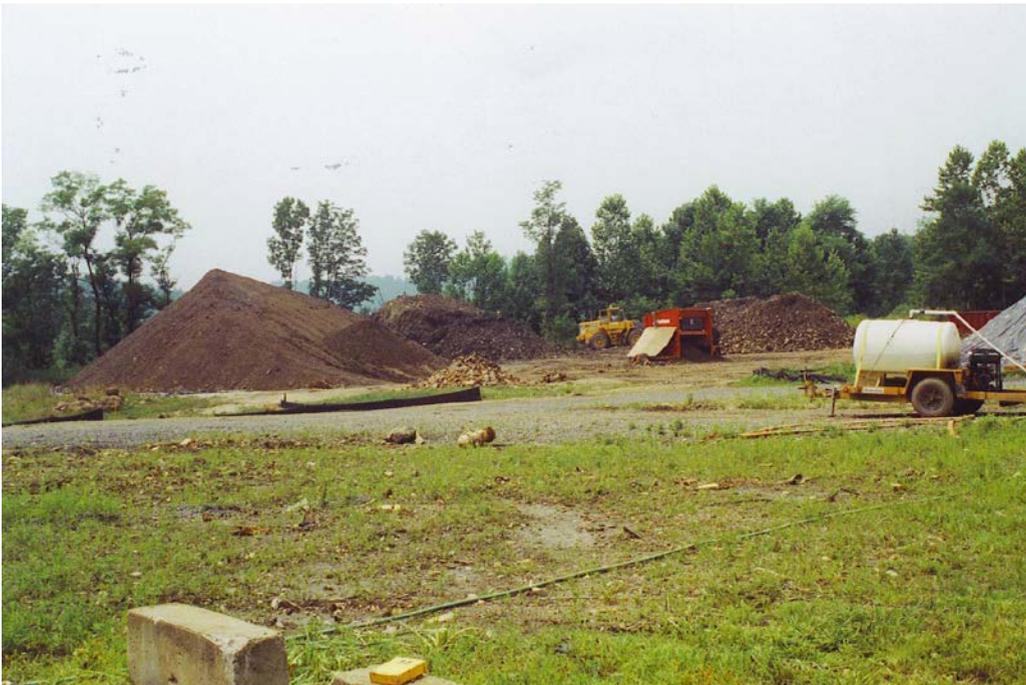
Frame #: 15

Description: **Stockpiles of sifted overburden removed during removal activities. The sifted soil was then used as backfill.**

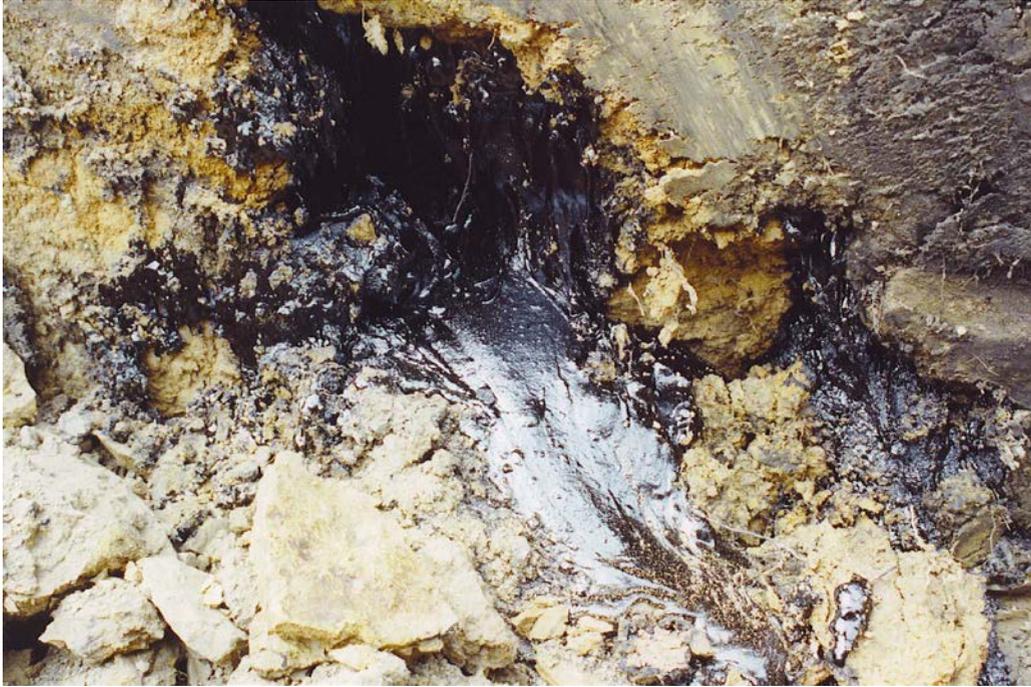
Frame #: 10

Description: **Coal tar oozing from a test pit excavated at SE area of the site. Located in area above the manhole of the East Tributary.**

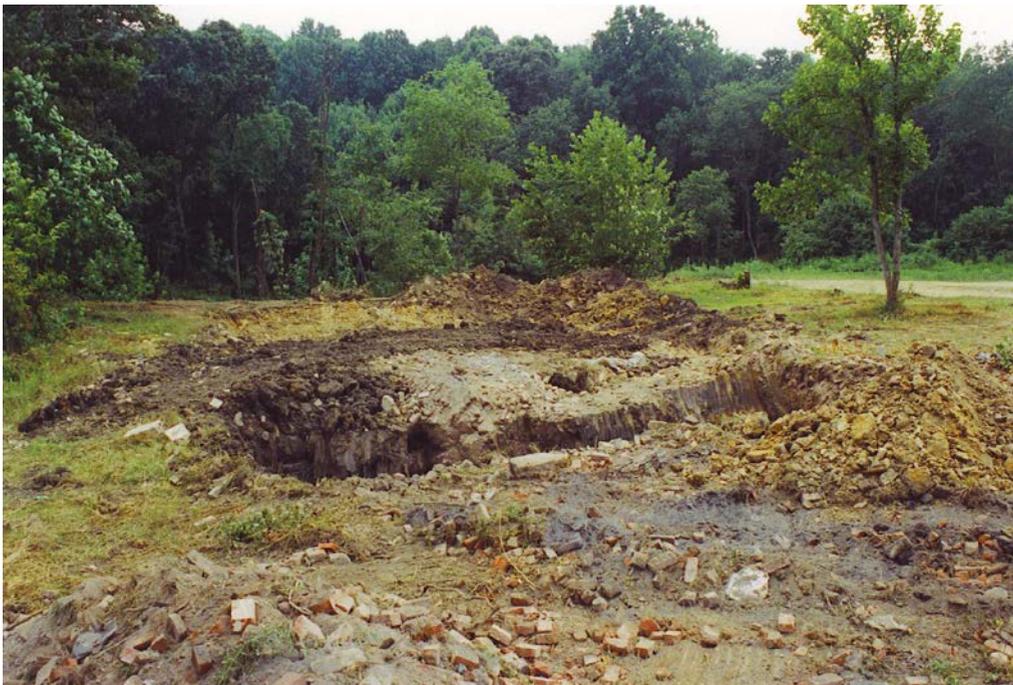
Frame #: 8

Description: **Test pits in contaminated area above East Tributary's manhole. Area was found to be highly contaminated with coal tar discovered up to 15 feet below ground. Area was contained with the construction of a clay barrier surrounding the contamination.**

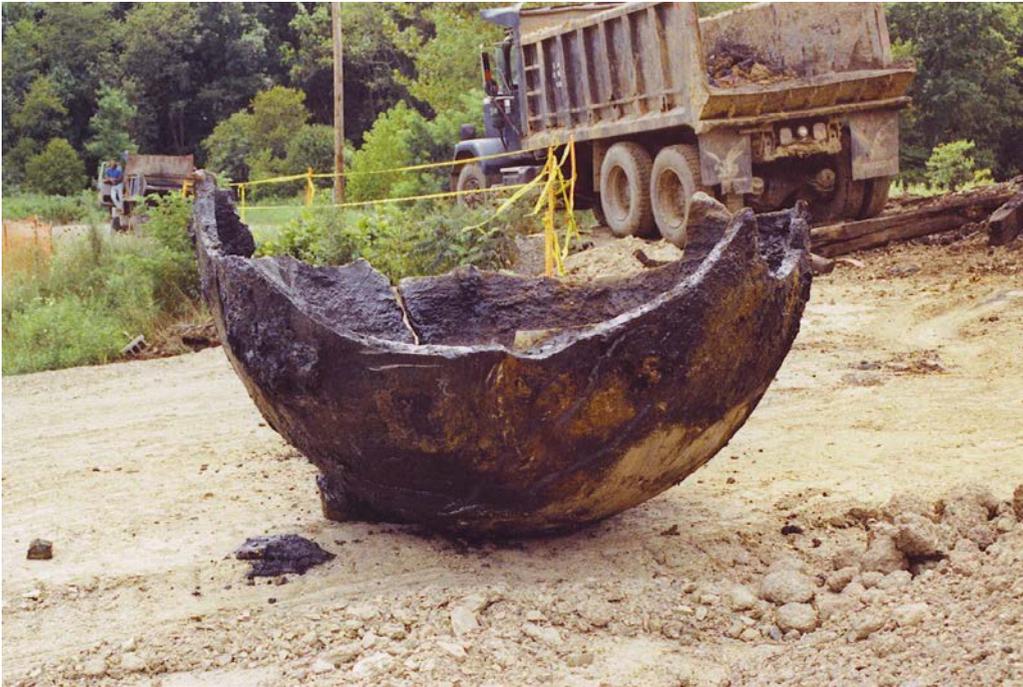
Frame #: 24

Description: **Spherical tank excavated by ERRS near the edge of the road leading to the PRP's treatment system. The tank was power washed.**

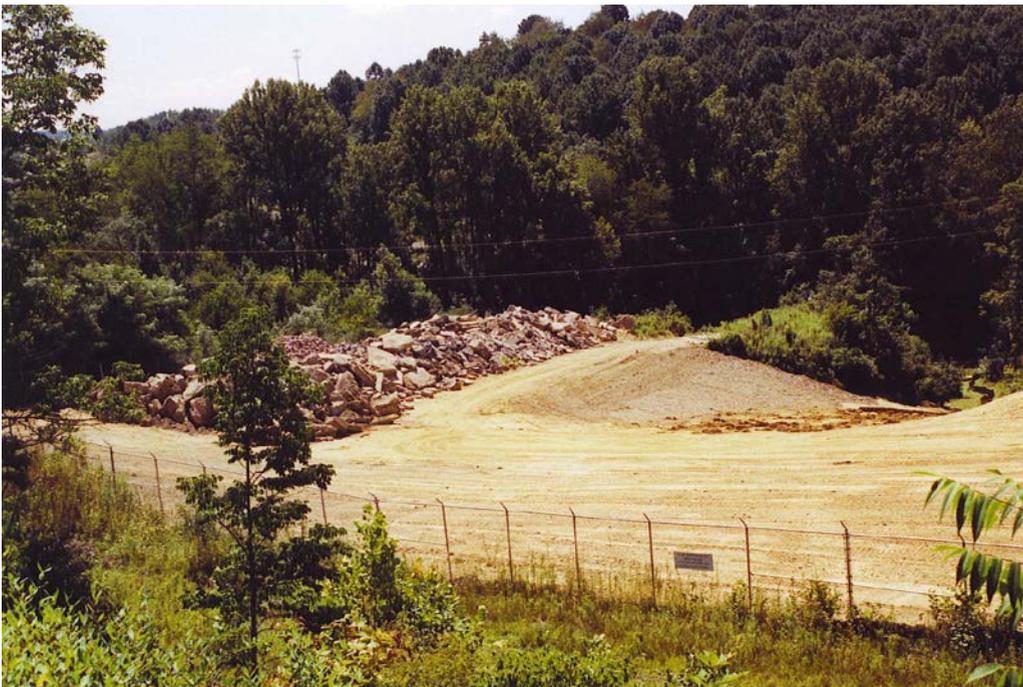
Frame #: 13

Description: **Uncontaminated concrete and brick staging area. Area has had excavation activities occur and has been backfilled and graded to promote surface water drainage.**

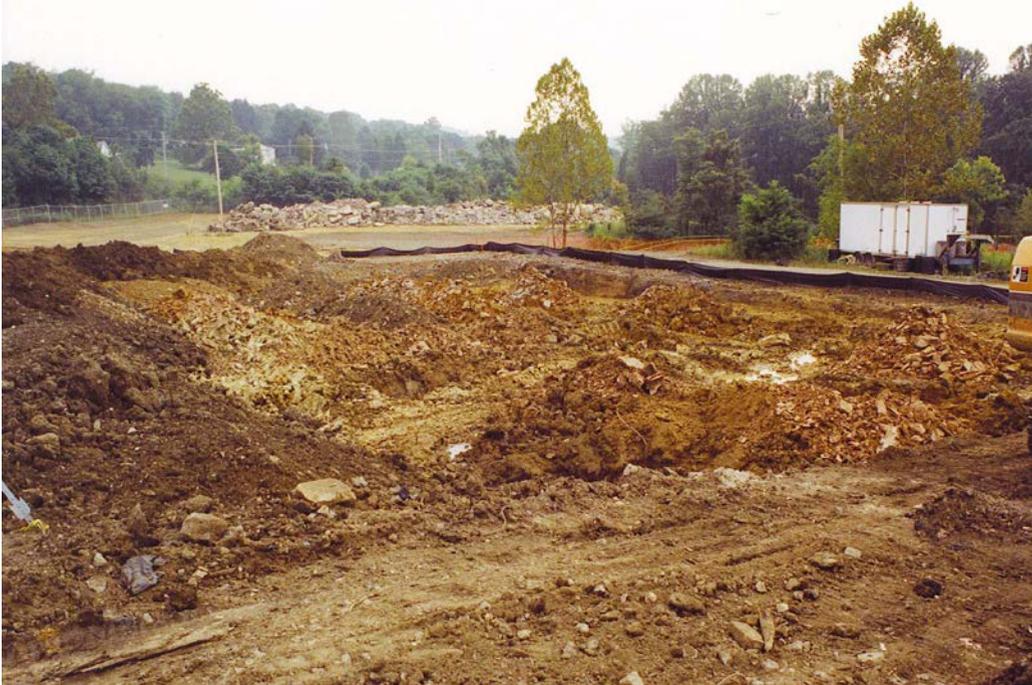
Frame #: 10

Description: **Excavation activities onsite. Test pits were dug to determine the depth of contamination.**

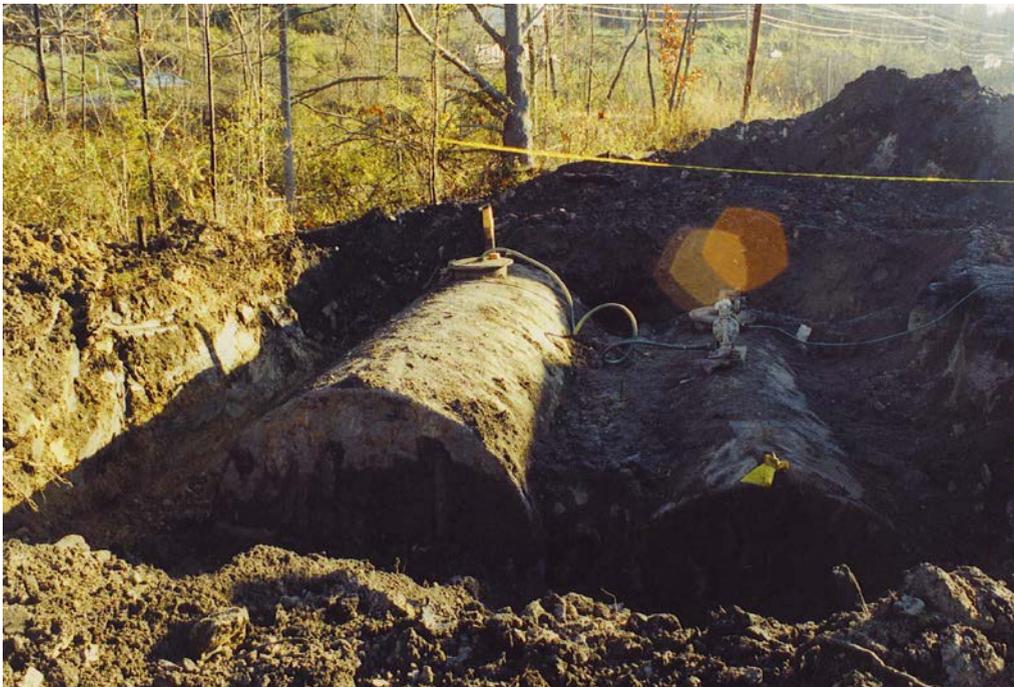
Frame #: 6

Description: **Underground storage tanks discovered west of the concrete shed. The contents of the tanks were removed and disposed and the tanks were removed from the ground and staged onsite. The tanks had contained approximately 65 gallons of gasoline and 2,700 gallons of diesel fuel.**

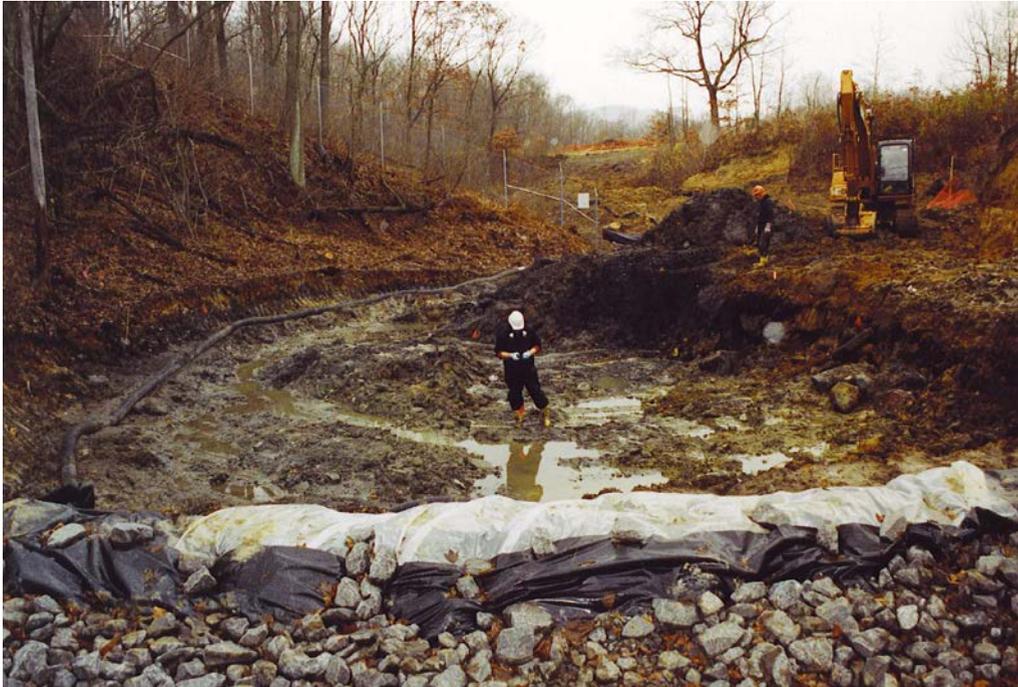
Frame #: 15

Description: **START collecting post-excavation sediment samples from Unnamed Tributary #1. The surface water had been routed past the excavation area using a 6 inch pipe. The excavated sediments have been transported to an onsite stockpile. The sample locations were recorded using a GPS unit.**

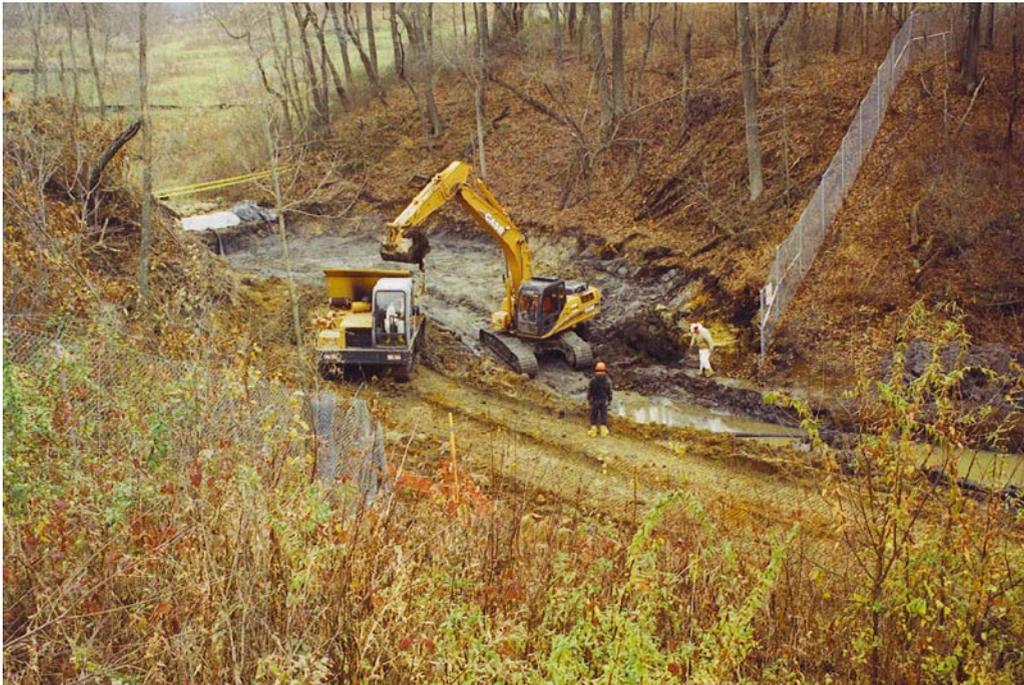
Frame #: 10

Description: **ERRS excavating the contaminated sediments in Unnamed Tributary #1. The contaminated sediments were transported to an onsite stockpile.**

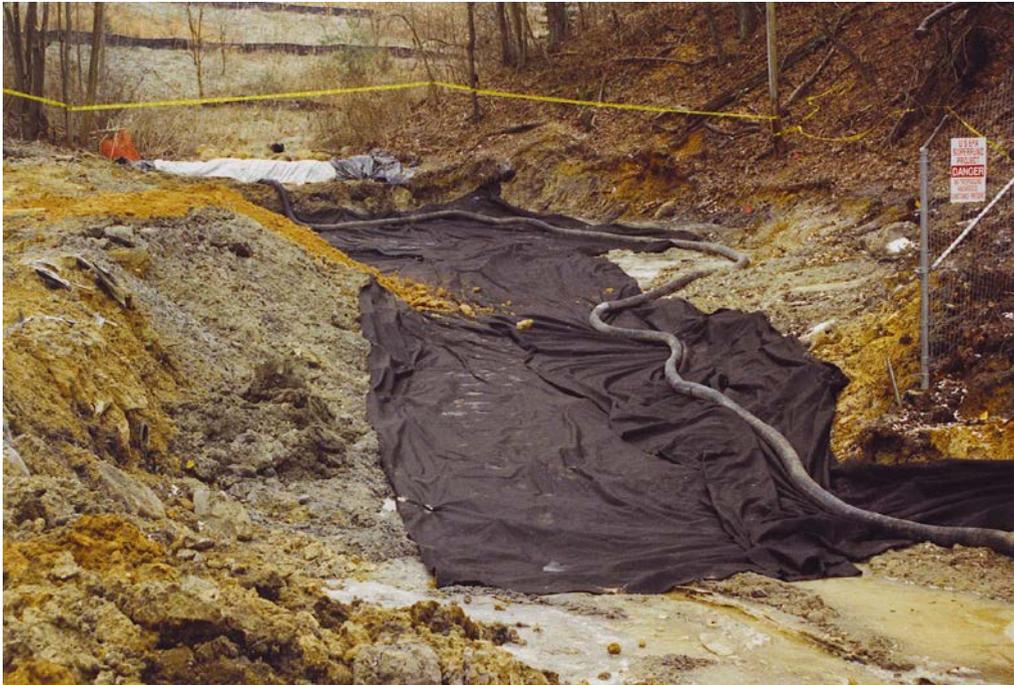
Frame #: 4

Description: A geotextile liner placed on the excavated section of Unnamed Tributary #1. Imported backfill was then placed on the fabric. Gravel was placed in the surface water channel.

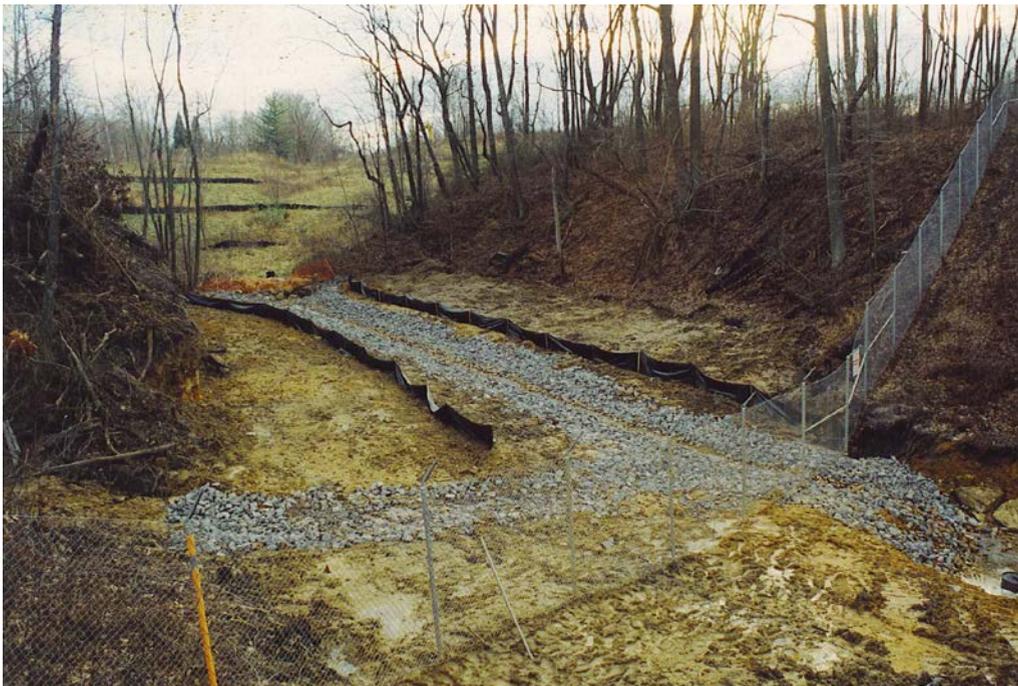
Frame #: 14

Description: The restored upper portion of Unnamed Tributary #1.

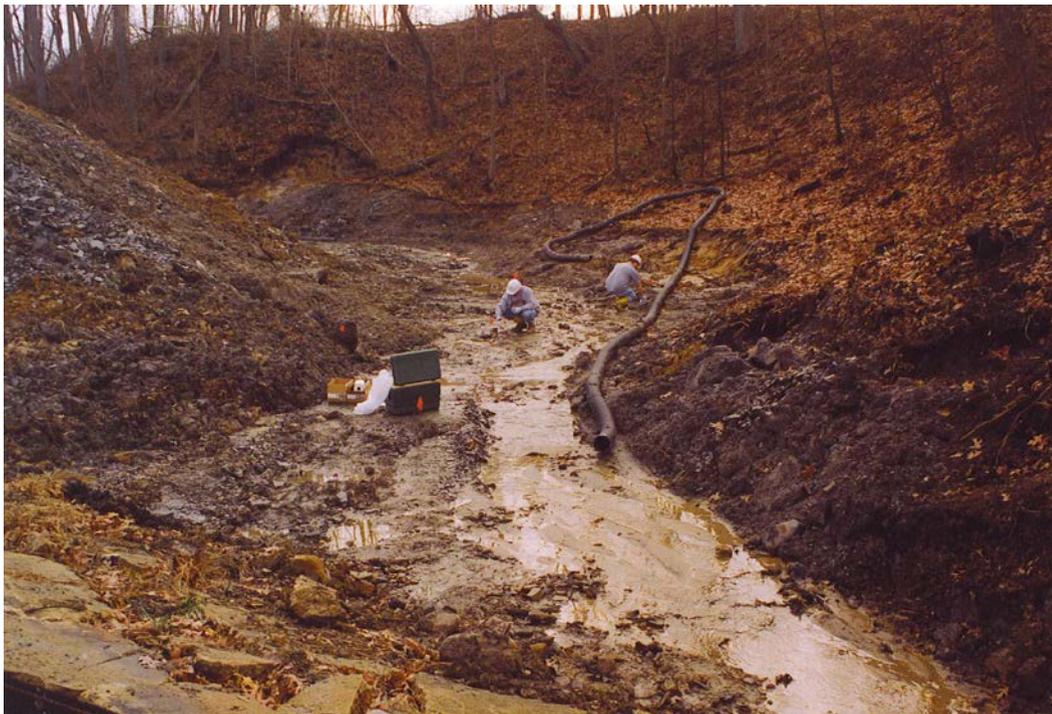
Frame #: 23

Description: **START collecting post-excavation sediment samples from Unnamed Tributary #1.**

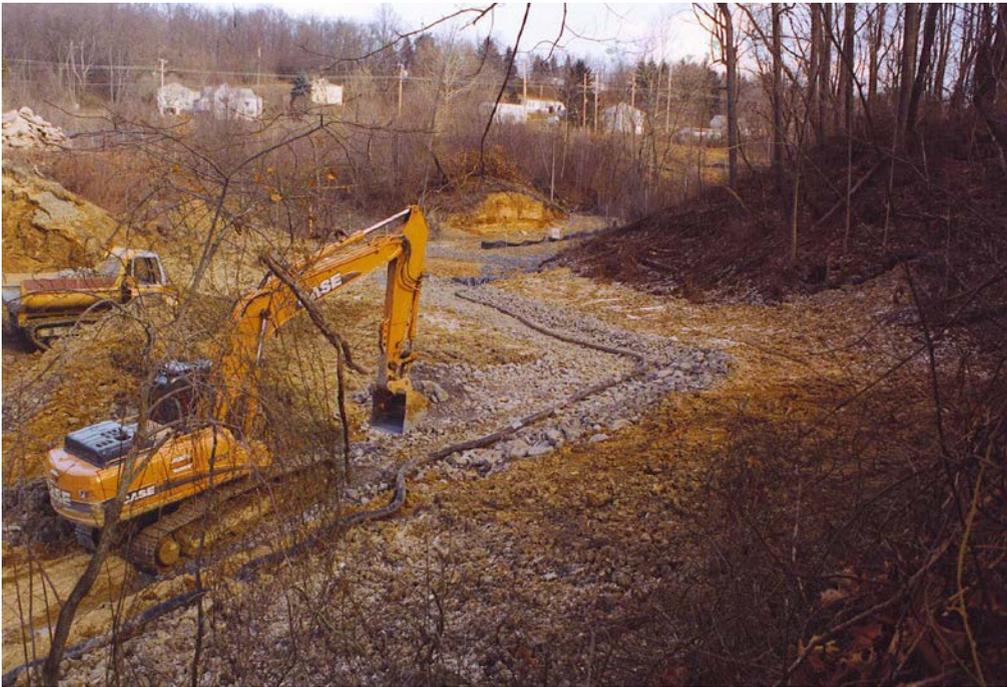
Frame #: 15

Description: **ERRS restoring Unnamed Tributary #1 after contamination has been excavated.**

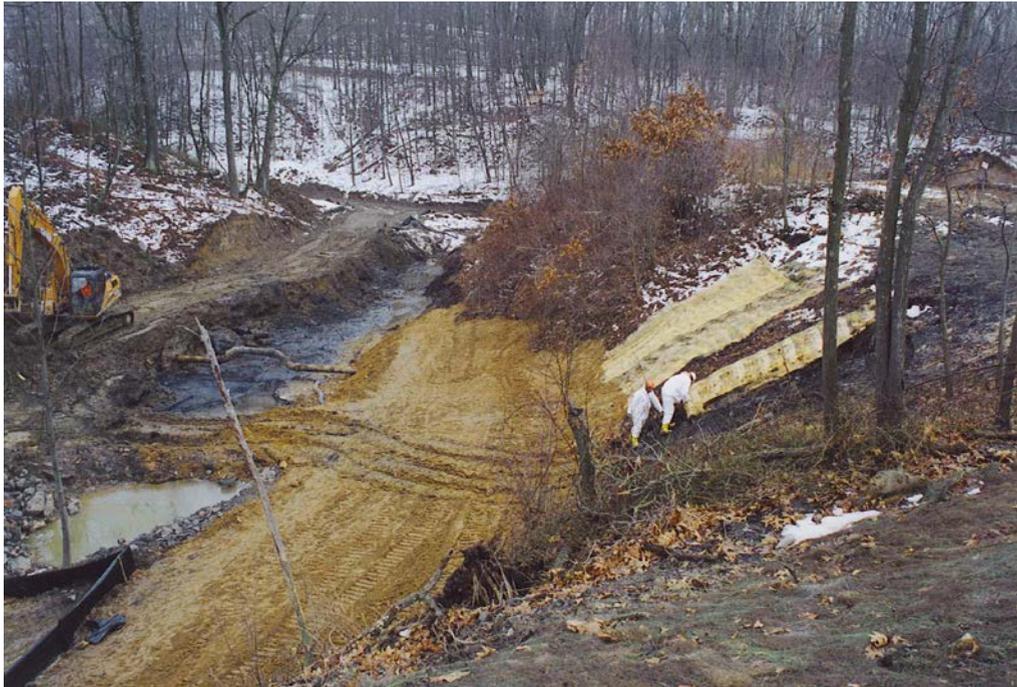
Frame #: 15

Description: **Excavation area in Unnamed Tributary #1. ERRS also placing erosion control matting on hillside to minimize erosion.**

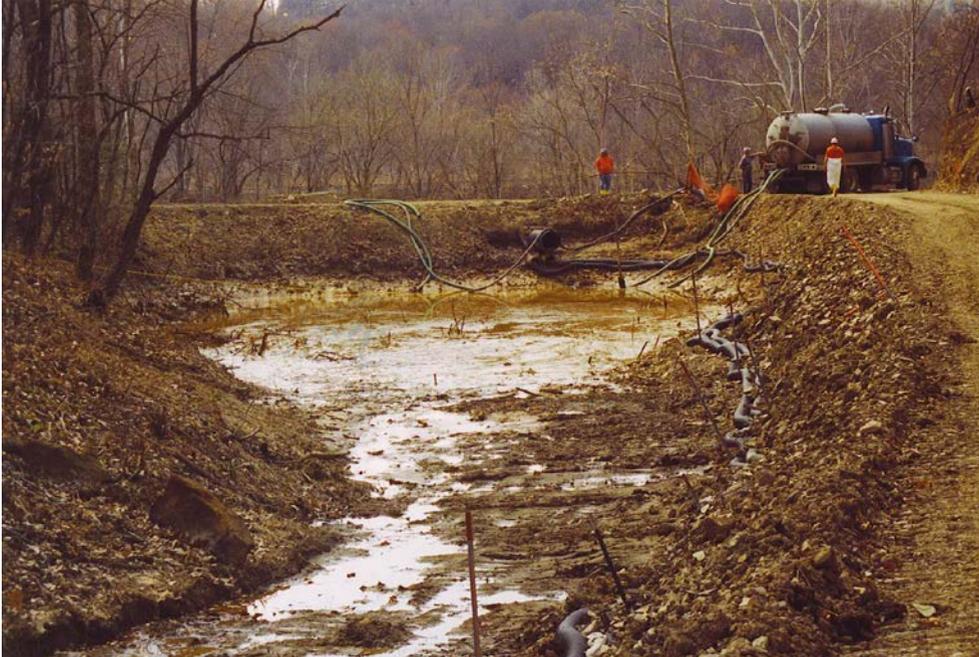
Frame #: 16

Description: **ERRS sub-contractors, R&J Waters, pump pond water and transport it to the city sewer manhole. The City of Fairmont had previously issued a permit allowing the pond water to be disposed into the sewer system.**

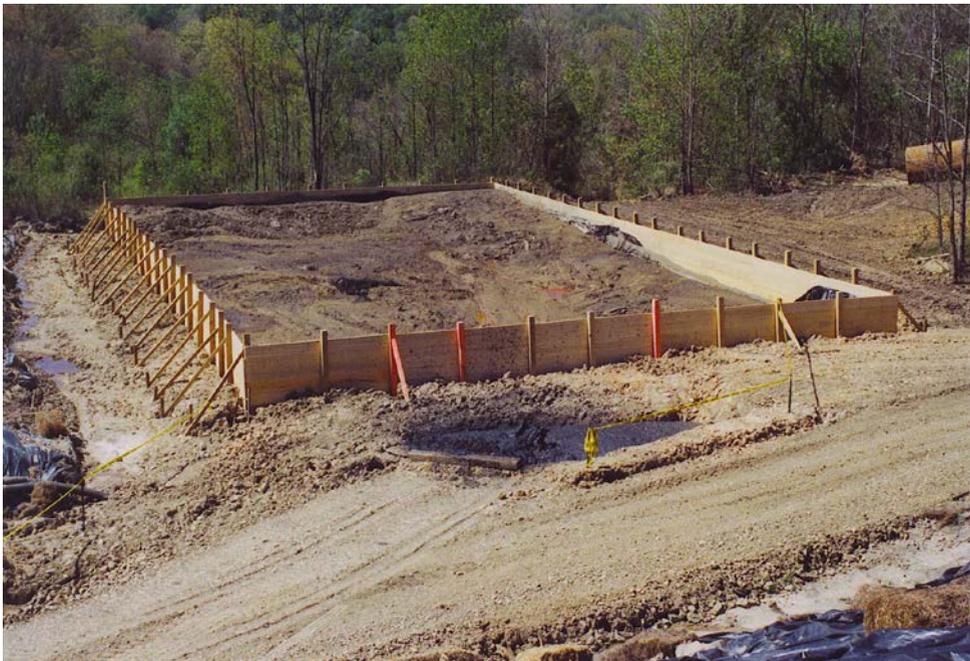
Frame #: 3

Description: **Containment cell #1 staged contaminated sediments excavated from the pond. A temporary staging pit, located in front of the containment cell was used by the dump trucks to dump the excavated materials. As the pit became full, an excavator transported the sediments into the cell. When the temporary pit was no longer needed, the surrounding soils were dug up and placed into the containment cell.**

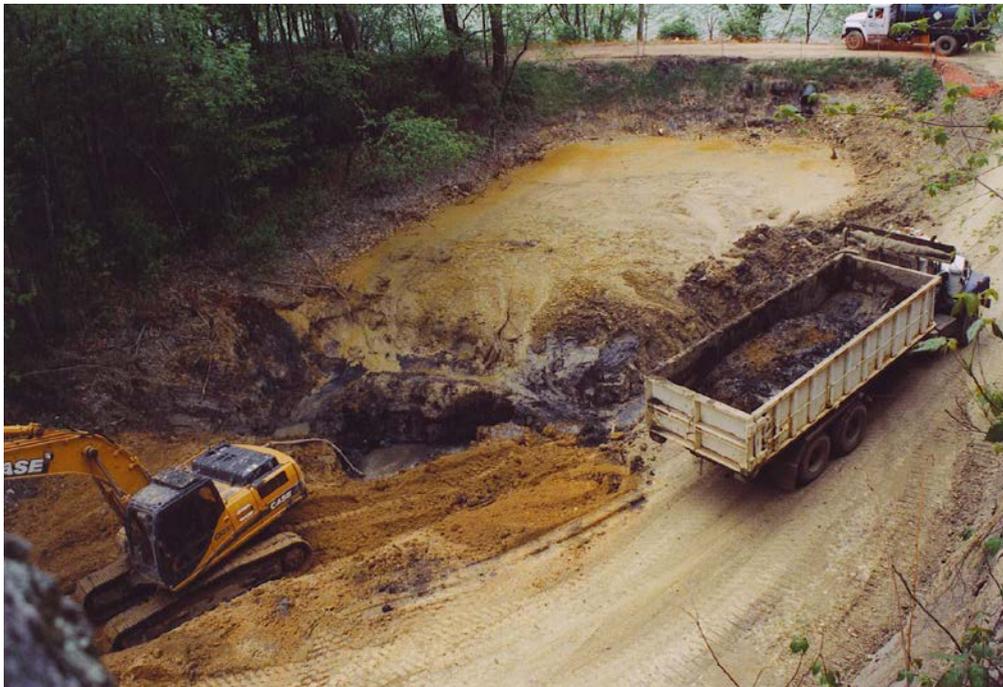
Frame #: 10

Description: **ERRS excavating and transporting contaminated sediments from the pond.**
