**Federal On-Scene Coordinator's After Action Report**

**Big John Salvage Hoult Road**

**Photos by START Region III - West**

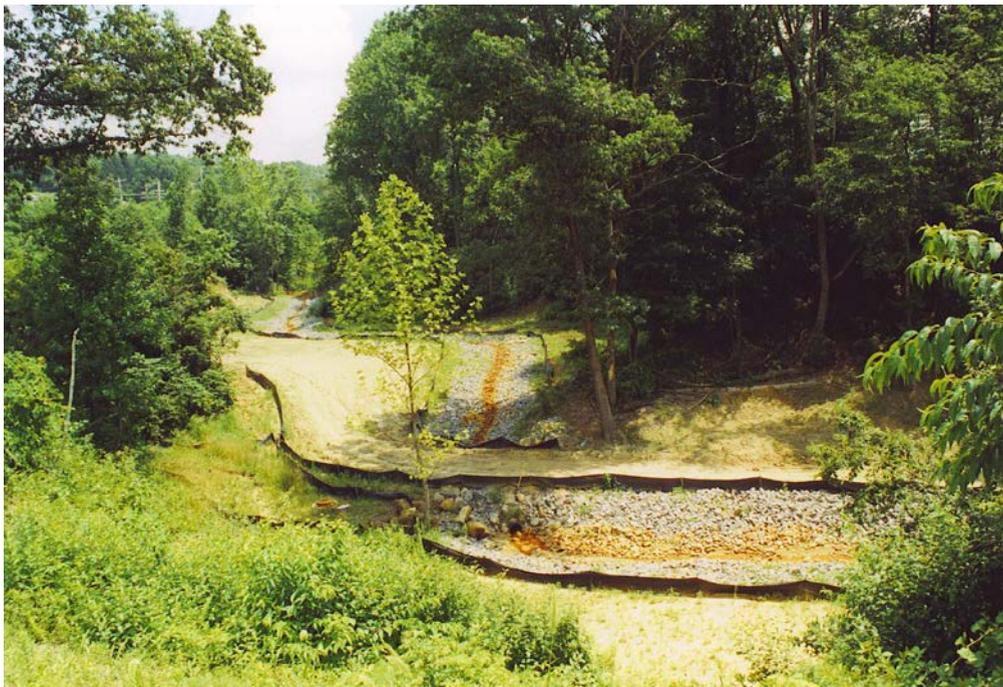
Frame #: 16

Description: **Restored Unnamed Tributary #1.**

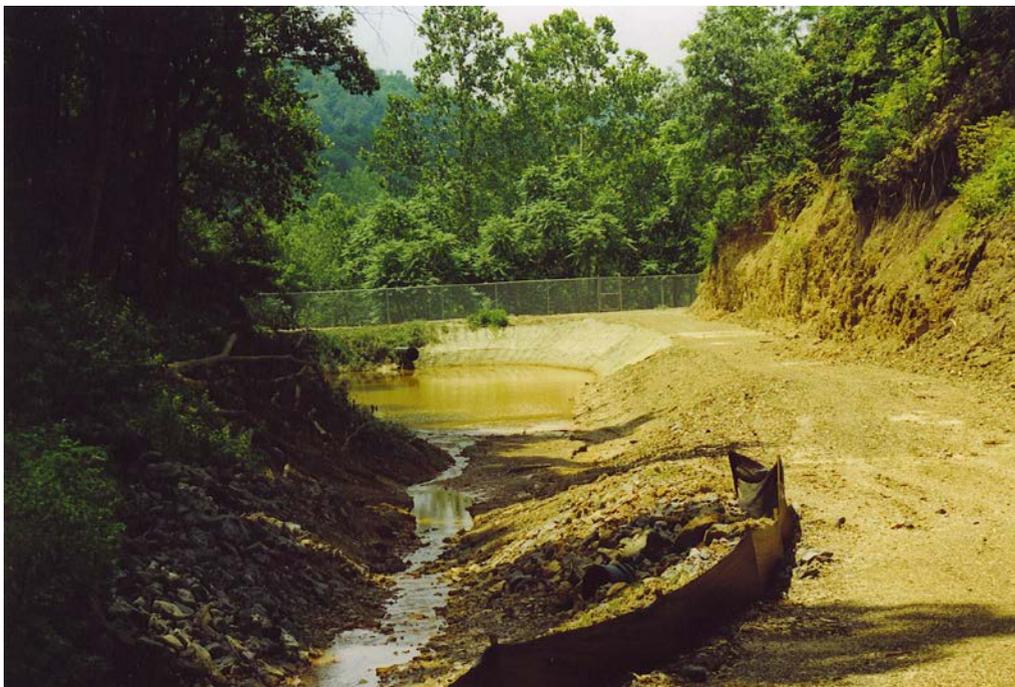
Frame #: 15

Description: **Restored pond.**

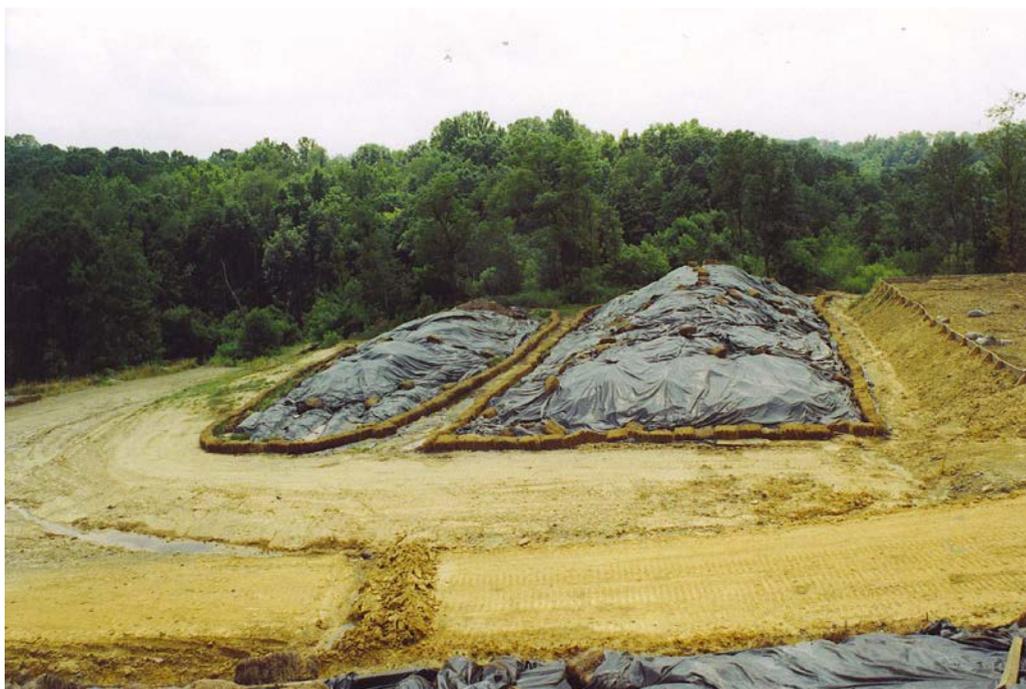
Frame #: 10

Description: **Covered contaminated stockpiles (#4 and #5) with haybales surrounding them to minimize migration.**
