UNITED STATES ENVIRONMENTAL PROTECTION AGENCY  
REGION 8

**MEMORANDUM**

**SUBJECT:** Request for Region 8 Superfund Emergency Response Program Assistance for the Carpenter-Snow Creek (CSC) Superfund Site located in Neihart, Cascade County, Montana

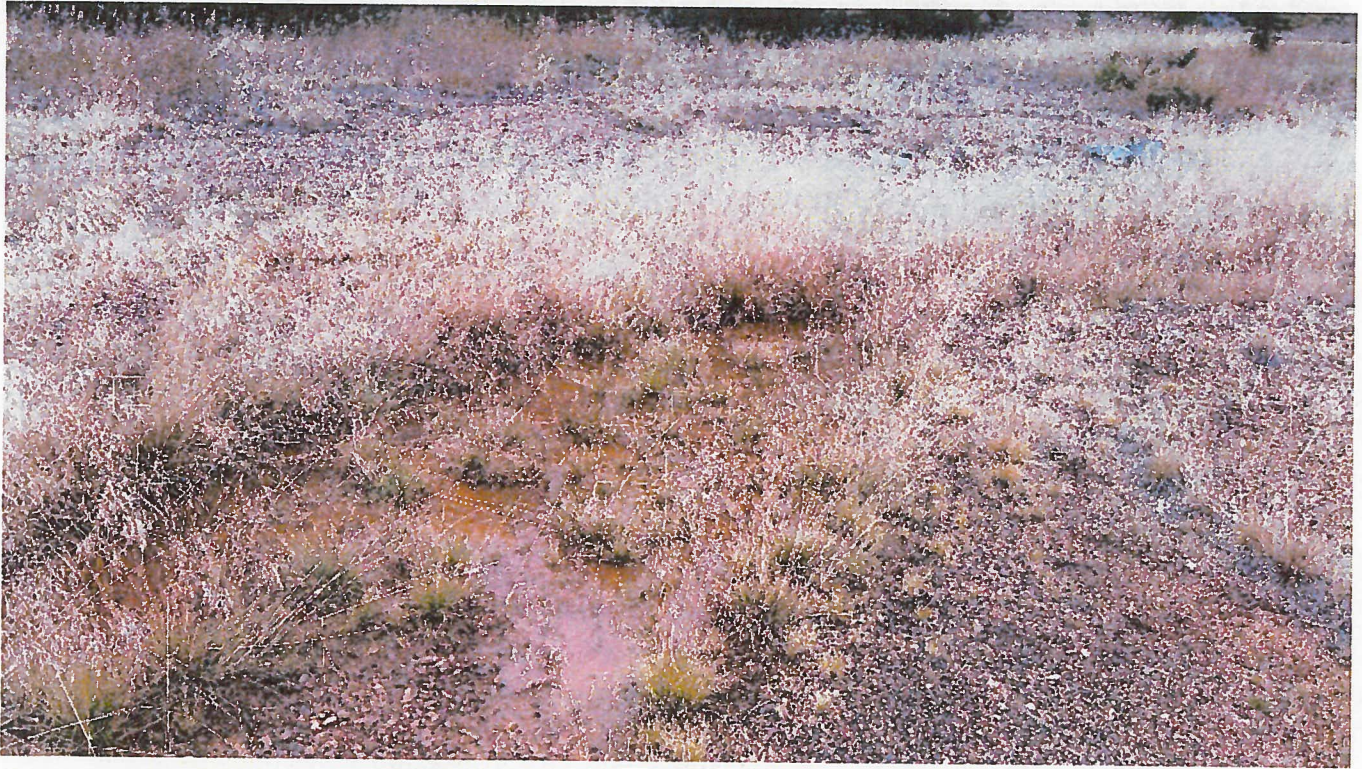
In 2011, an unusually high snowfall was followed by significant spring rainfall. This resulted in Sih-Mem flowing out of its historic stream channel between Pioneer Road and Carpenter Creek. Sih-Mem Creek now flows over the surface to the west of its former channel before it enters Carpenter Creek several hundred feet below its historic confluence. In the past couple of years, this creek has pooled near the home of an adjacent property owner during Spring runoff. Figure 2 shows iron staining of surface soils near the residence property from surface flow of Sih-Mem Creek while Figure 3 shows the existing confluence of Sih-Mem Creek.

Figure 2  
Orange staining on the surface near the residential structure

Redirect Sih-mem Creek back into its historic channel to eliminate future channel migration to the west and infiltration of contaminated water near the residential structure. Activities contemplated include construction of an infiltration gallery just below the Pioneer Road culvert to inject base flow into the alluvial aquifer and construction and armoring of the diversion channel to allow higher discharges to flow into Carpenter Creek. Since the area is already heavily impacted by tailings, all material excavated will be hauled to the repository and restored with borrow soil. A Record of Decision is anticipated to be issued in 2022 that will identify a remedy to address the tailings within the Carpenter Creek floodplain. Rip rap will need to be brought to the site to armor the diversion channel. It is estimated that activities will require about 5 days to implement and will cost approximately \$70,000.

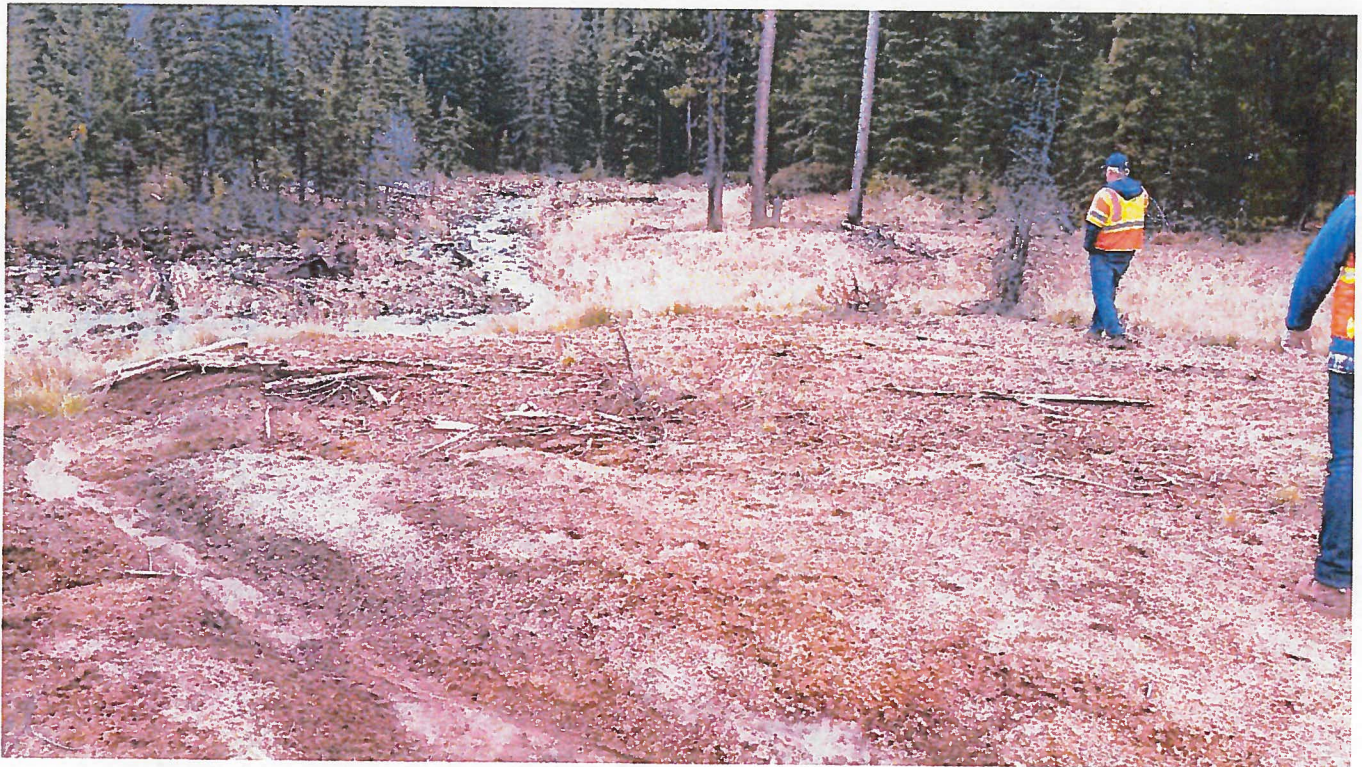
Figure 3  
Confluence of Sih-mem Creek (foreground) and Carpenter Creek (background)

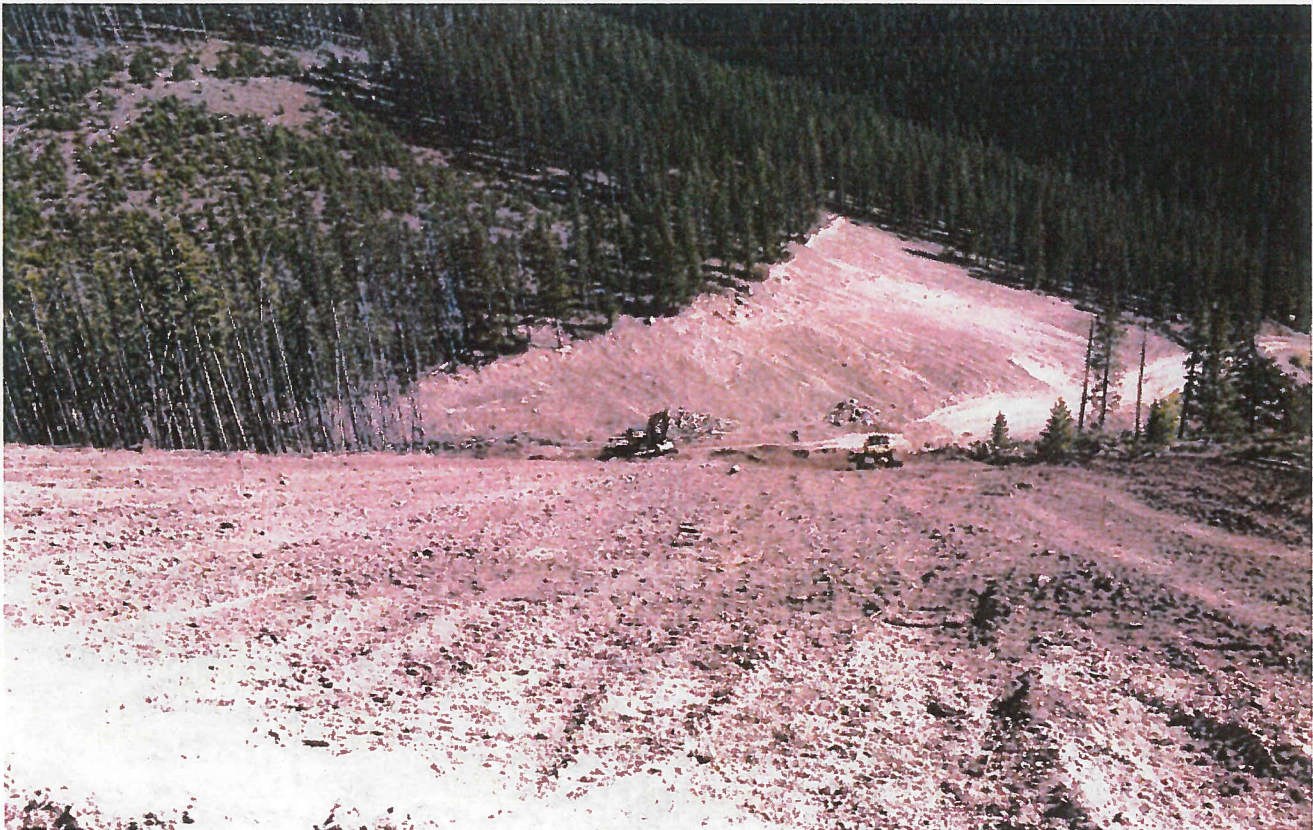
Figure 4

Since the removal action was completed, the upper removal area has experienced significant erosion damage from summer storms. Rill erosion is quite evident and is cutting into previous reclaimed areas (see attached memo). A large gully has cut through the center of the erosion blanket, threatening to discharge sediment into No Name Creek. Rill erosion is also evident in the western removal area, particularly just below the tree line area.

Looking down Silver Dyke Tailings impoundment hillside during 2014 removal action

These activities were designed and implemented to temporarily mitigate erosion potential and are not a permanent solution to erosion in the upper removal area. Removal support is requested to implement engineering control measures to prevent further erosion on the hillside. The proposed measures consist of erosion matting, terracing and 6 inches of top soil with seed mix.

Corrective action activities will be implemented to ensure that future erosion of the upper removal area is limited and vegetative cover is established and maintained. Activities include but are not limited to providing corrective action measures including, but not limited to: reseeding, fence building, installation of erosion controls such as waddles, woody debris, terraces, rip rap and straw bales or mats. It is estimated that activities will require about 7 days to implement and will cost \$100,000.

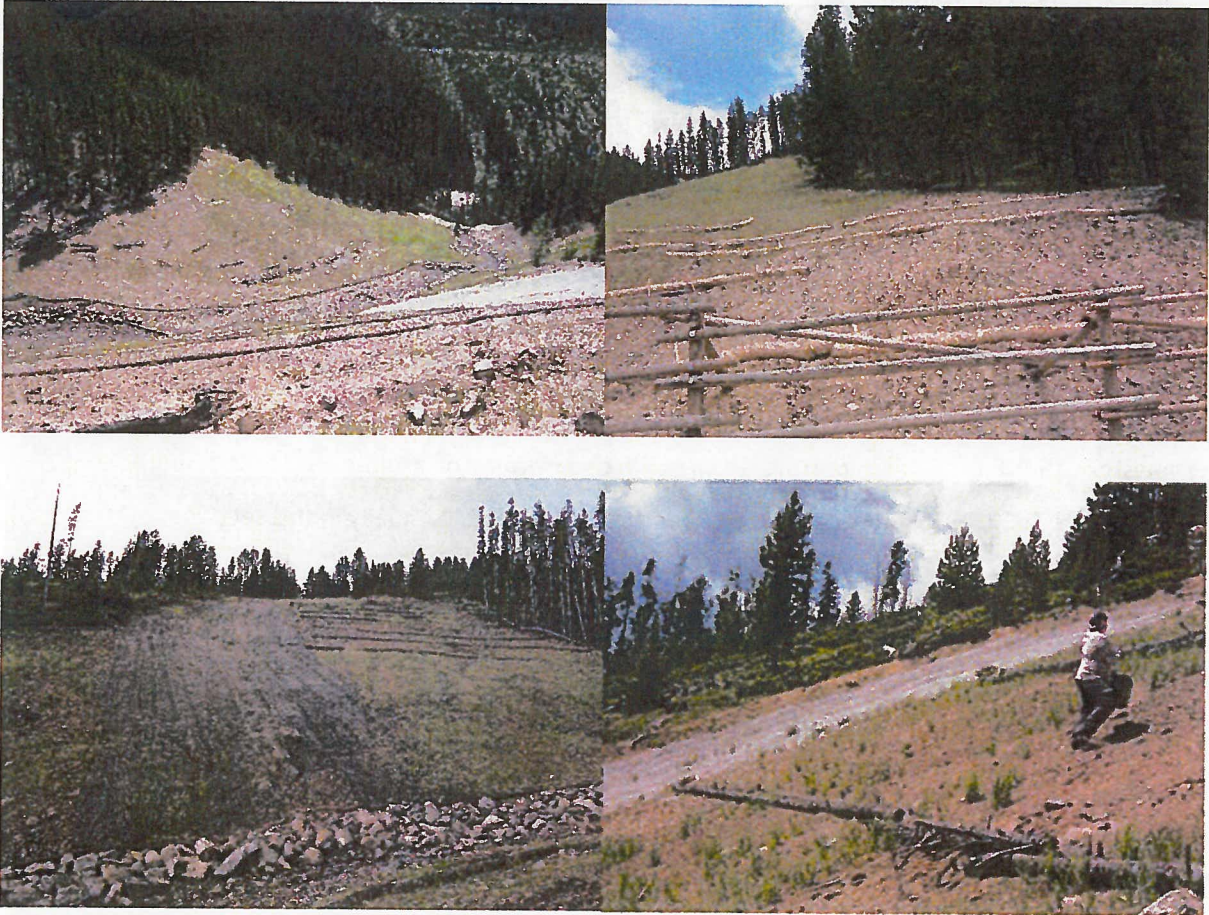
**Exhibit 1** : Photographs from Silver Dyke Tailings Removal Area on June 13 and 14, 2016

**[Upper left]:** Looking down toward the lower removal area (looking southeast). Vegetation reestablishment is good in the southern half of the area, but vegetation is more sparse on hillsides to the north (left side of picture). **[Upper right]:** Barren area directly adjacent to Carpenter Creek Road (looking north). **[Lower left]:** Upper removal area showing poor vegetation recruitment under erosion control blanket and in areas where hydroseeder did not reach (looking west). **[Lower right]:** Barren areas in the upper removal area where mine waste persists. Erosion control blanket in background (looking south).

Hydroseeding in the lower removal area was generally successful at establishing perennial grasses and forbs. Vegetation was denser near No Name Creek and sparser on the eastern hillside, particularly in the northern quadrant. Only two areas in the lower removal area were barren. The first area was directly adjacent to Carpenter Creek Road behind the jack fence (see Exhibit 1). The lack of vegetation in this area may be attributed to soil compaction of a decommissioned haul road used during the 2014 removal action. The second area is on the eastern hillslope and based on XRF data collected after the removal action, had some residual mine waste.

Revegetation of the upper removal area was less successful than in the lower removal area. Little to no plant recruitment was observed on the south side of the area where the erosion control blanket was installed. Patches of intact vegetation were observed on the north side, but were punctuated with barren areas. The poor recruitment in this area is likely attributable to both poor hydroseeding and the remnant mine waste.

Lime was applied to barren areas where residual mine waste was suspected to be present. Lime was added to increase base-cation concentrations in soil solution as a means to limit metal toxicity to plant roots. Previous investigations indicated that the mine tailings associated with the Silver Dyke Mill are not acidic (Tetra Tech 2013). Lime was applied to 0.06 acre in the lower removal area and 0.17 acre in the upper removal area (Figure 2).

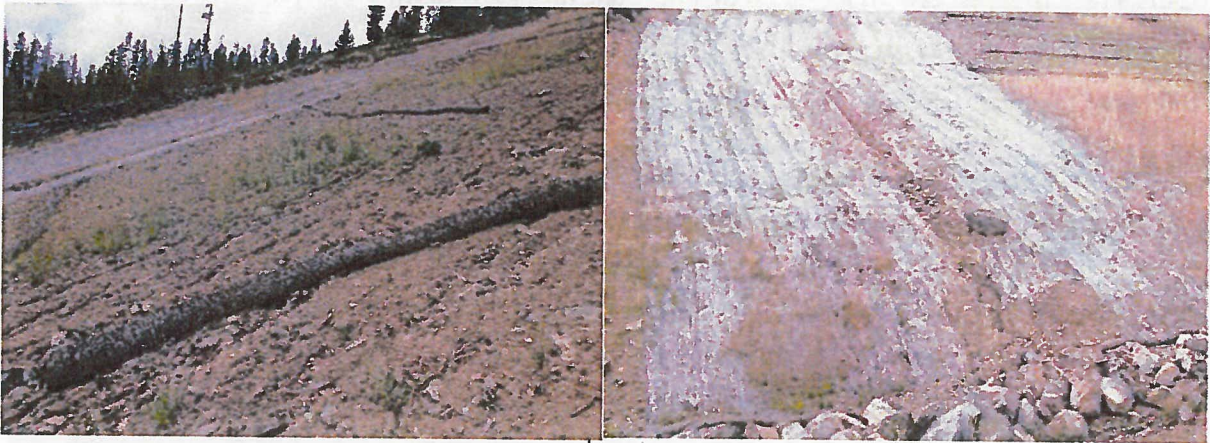
**Exhibit 2- Photos from the Silver Dyke Removal Area on August 25, 2016**

Storm damage to the Silver Dyke removal area was assessed during the August visit. Many erosion control wattles had been displaced and rilling was observed at multiple locations. Additionally, a large gully had begun to form at the base of the erosion control blanket in the upper removal area. The lower removal area did not appear to be as significantly damaged.

**[Left]:** August 7 storm damage in upper removal area. Displaced wattles and initiation of rills (looking southwest). **[Right]:** Initiation of gully erosion at the base of the erosion control blanket (looking northwest).

Field personnel replaced the displaced wattles on August 6, 2016 (Exhibit 2).

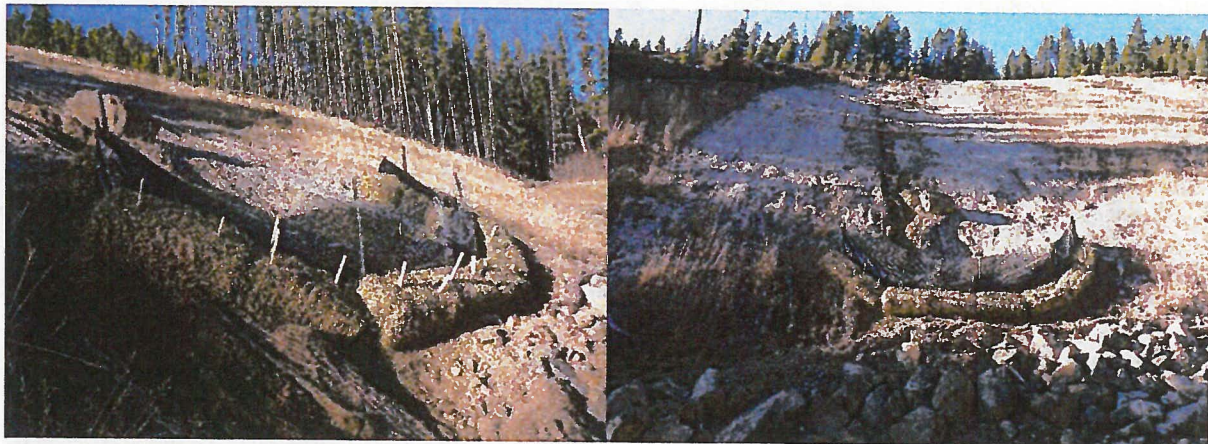
**Exhibit 3 :** Photographs from Silver Dyke Removal Area on November 10, 2016

In contrast, erosion damage from summer storms to the upper removal area was marked. Rill erosion is quite evident and is cutting into mine waste in some areas (see Exhibit 3 below). A large gully had cut through the center of the erosion blanket, threatening to discharge sediment into No Name Creek. Rill erosion was also evident in the western removal area, particularly just below the tree line among areas

**[Left]:** Reinforced silt fencing used to prevent sediment from reaching No Name Creek. Silt fencing was anchored by trench excavation, steel fence posts, and straw bales secured with wooden posts (looking northeast). **[Right]** Silt fence below with additional erosion control wattles above to slow down water and sediment movement into the gully. Riprap at the bottom of photo is just above the No Name Creek Channel (looking west-northwest).

**November:** Tetra Tech performed its final site control at the removal area on November 10, 2016. Activities included erosion control in the upper removal area to reduce further incising of the gully developing in the erosion control blanket. In total, 72 feet of wattles were installed at three locations within the incipient gully to slow water movement and to catch sediment (**Figure 3**). At the base of the hill, a reinforced silt fence was installed to prevent sediment from reaching No Name Creek. These activities were designed and implemented to mitigate erosion potential from spring runoff in 2017 and are not a permanent solution to erosion in the upper removal area. Pictures of the erosion control measures are shown in Exhibit 3.
