## **Lisbon Valley Mining District**

### **Removal Site Update**

**Operations Period:** 01 October 10-16, 2022

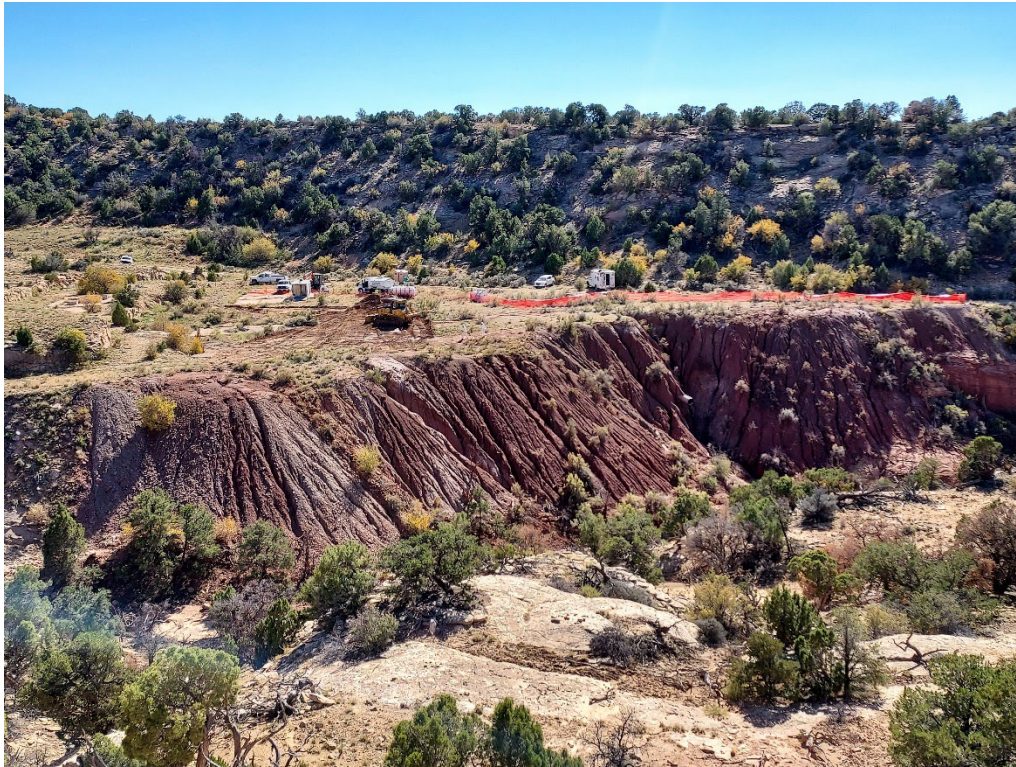
**View of the Radon Mine at the beginning of the Operations Period:**

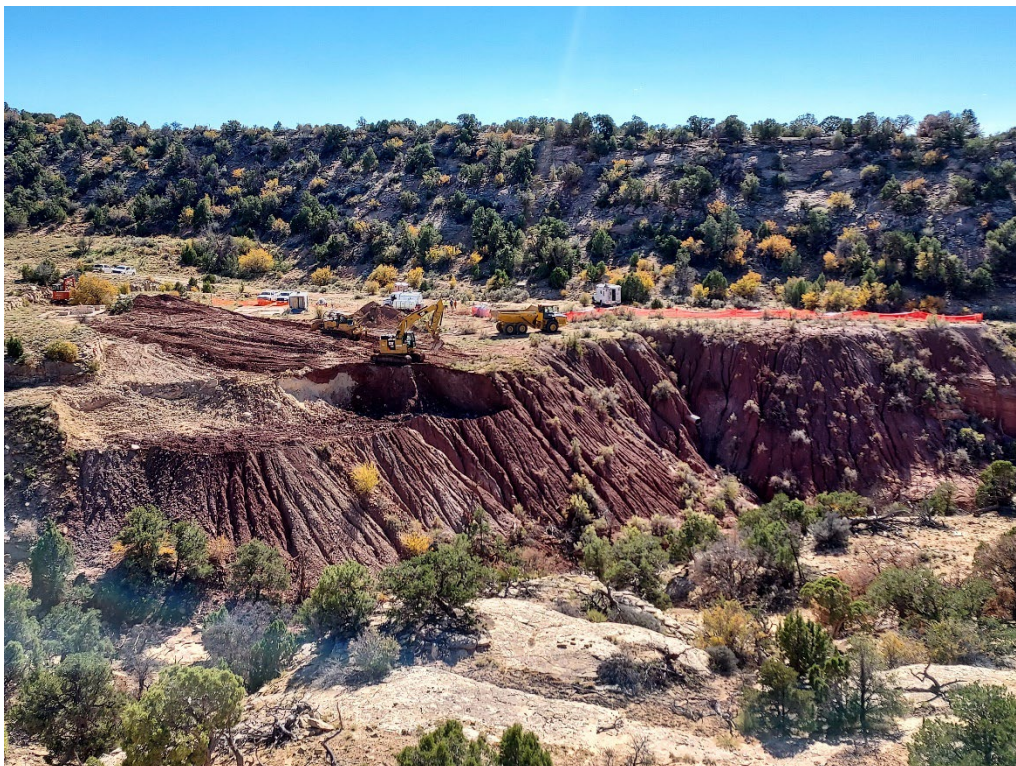
**View of the Radon Mine at the end of the Operations Period:**

The Response Team then cleared and saved organic material from the area where material excavated from the waste pile will be placed and began excavating the pile. The Team started by removing the upper portion of the metal debris on the slope as well at a hot spot on the pile's flank. The crew then began removing the top 12-15 feet of material along the crown of the waste pile to lower the elevation at which the top of a ramp down to the ephemeral drainage will eventually be constructed.
