## **EPA and EGLE Update: Pilot Diesel Spill, Ottawa Lake, MI**

*This document provides daily on-site activities in response to the Pilot diesel spill in Ottawa Lake, Michigan.*

**Saturday, April 6, 2024**

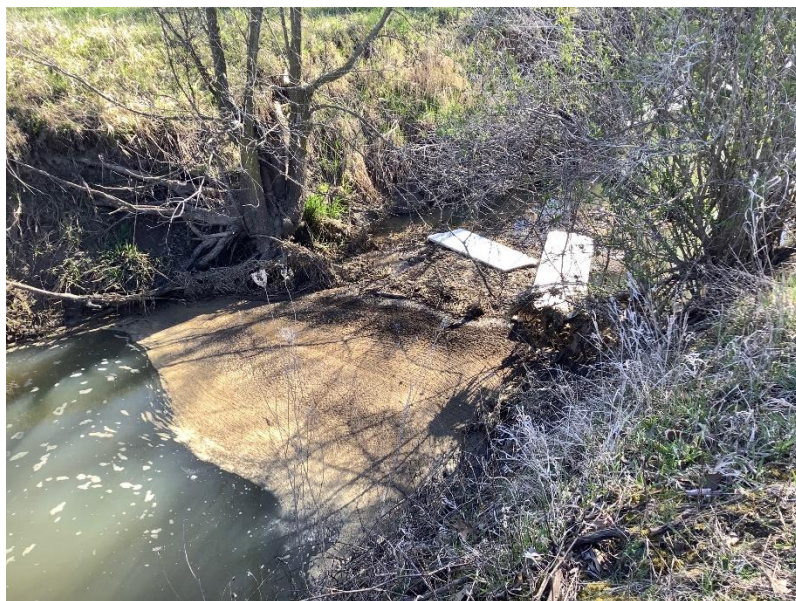
A: Containment measures such as containment booms and underflow dams have been installed on North Tenmile Creek to prevent downstream migration of any sheens released by cleanup activities. While the purpose of these booms is to capture any oil on the surface of the water, other materials such as pollen, algae, sediments, and debris can also collect in front of them over time. An example of this is shown in today's photo below. One thing that can distinguish the two is that absorbent booms and pads are oleophilic meaning that while they absorb oil and hydrocarbons, they repel water and other materials. If you see buildup in front of a booming location and it is not being absorbed by the pads, it may not be oil. EPA is monitoring the two underflow dams and six containment boom locations on North Tenmile Creek several times per day. If a resident believes they see or smell oil in North Tenmile Creek outside of the work area, please contact EPA or EGLE.

Buildup of natural materials in North Tenmile Creek on April 6, 2024
