EPA Emergency Response Site Update

Helena Mercury Release

Operations Period 05

June 5, 2024

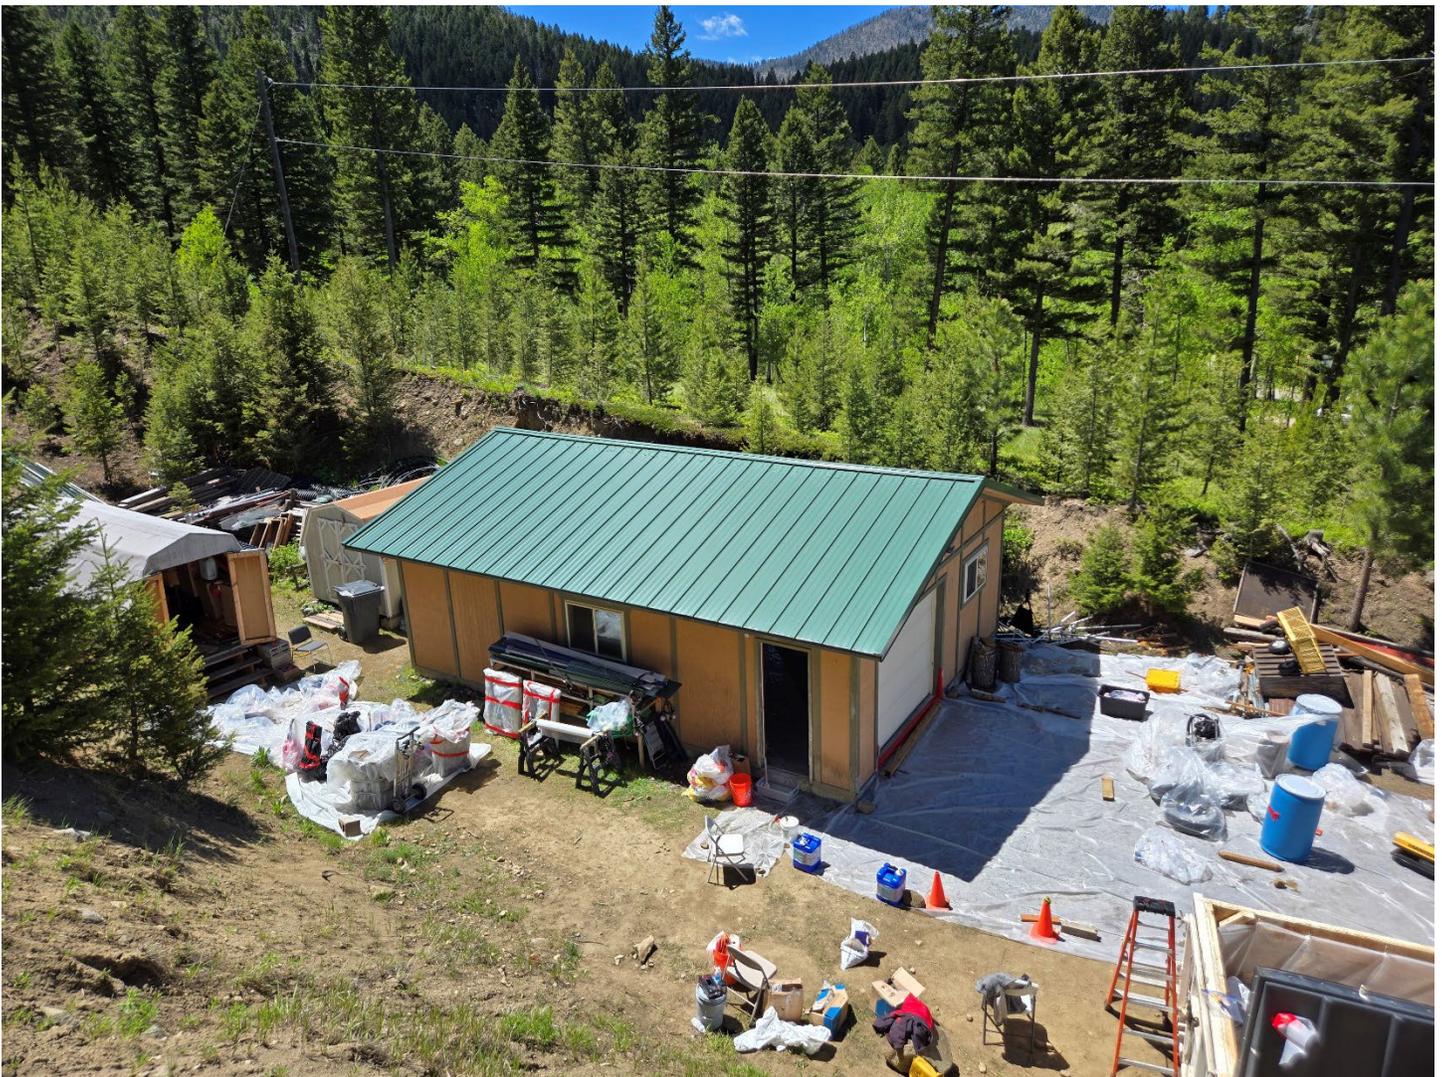
View of garage.

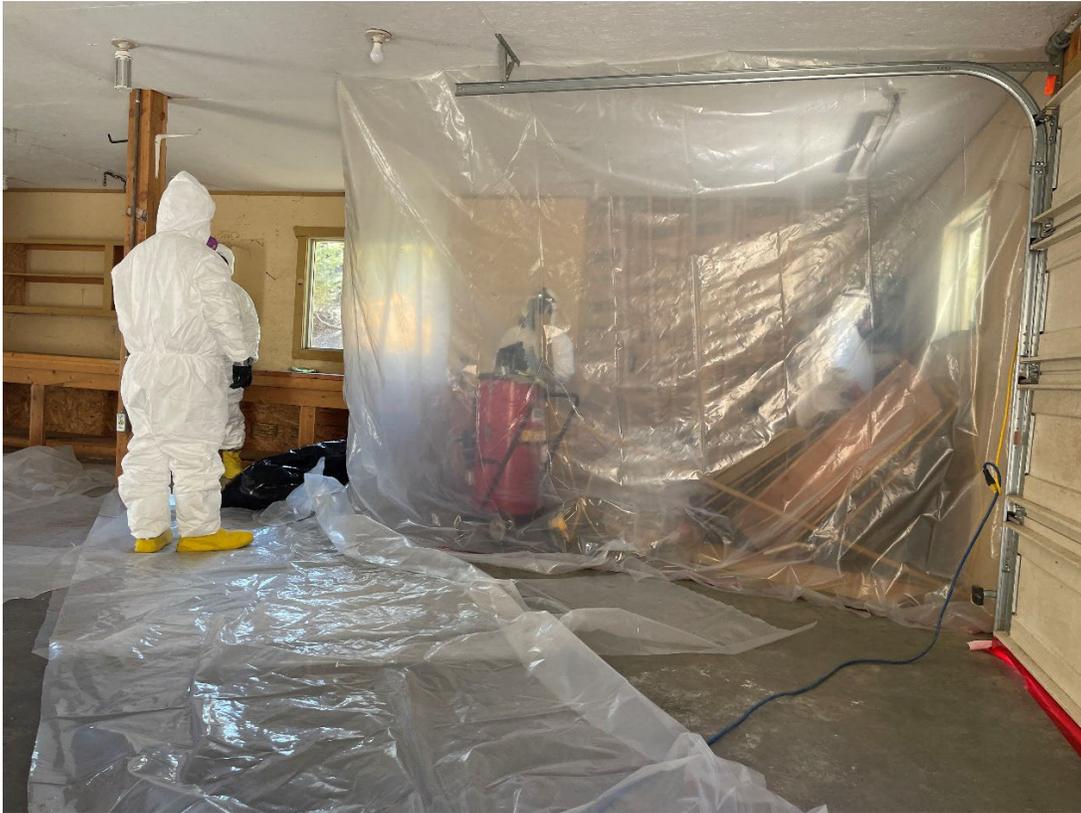
The response team improved the plastic sheeting isolating the workbench area and created a second contaminant reduction zone outside this area. The team continued to slowly dismantle the shelves and bench. The shelves and plywood wall above and behind the workbench were also removed. Elemental mercury beads

were encountered throughout this process and the team often stopped the demolition to vacuum the floor within the exclusion zone.

Demolishing the work bench area.

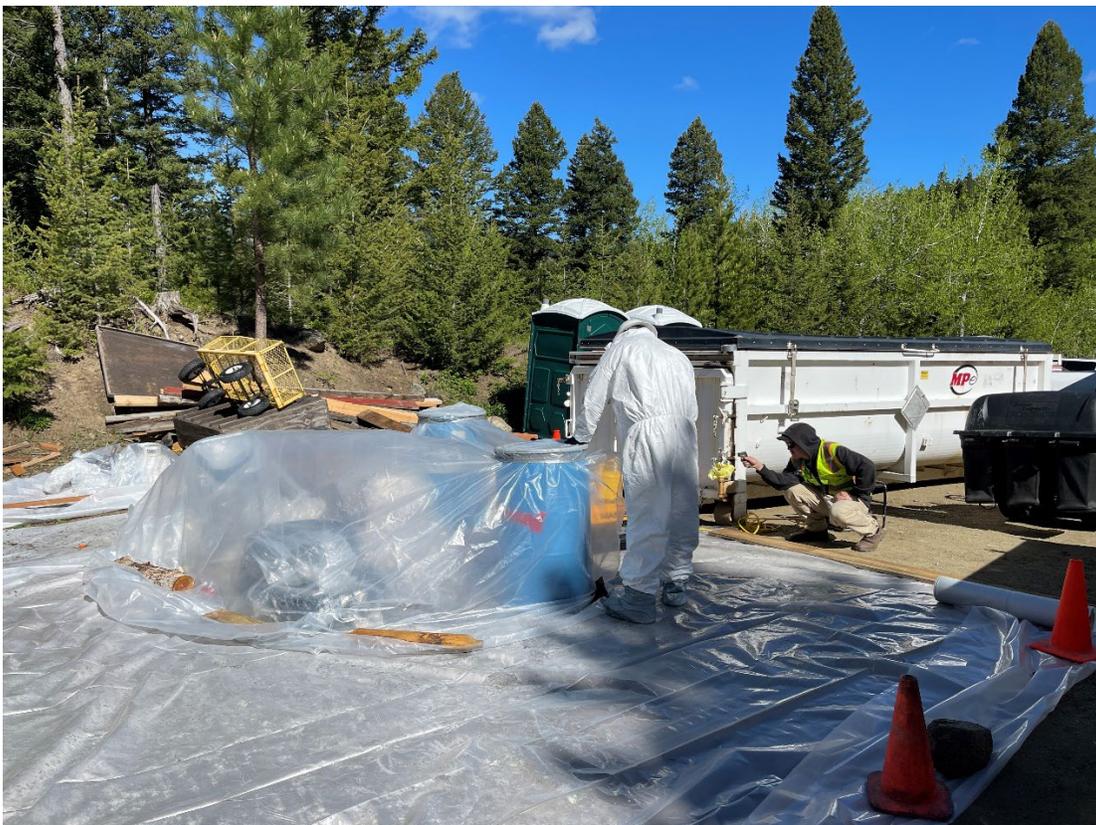
The response team continued to decontaminate several items that the non-profit would have difficulty replacing and requested that EPA salvage. Several power tools, the riding mower and other items were released to the property owner. Other items continue to be decontaminated.

Decontaminating items to be returned to property owner.
