**ANALYTICAL RESULTS REPORT
SITE INSPECTION**

**GOLD HILL TAILINGS SITE
EPA ID# COD983801275**

**U.S. ENVIRONMENTAL PROTECTION AGENCY
REGION VIII**

October 14, 1994

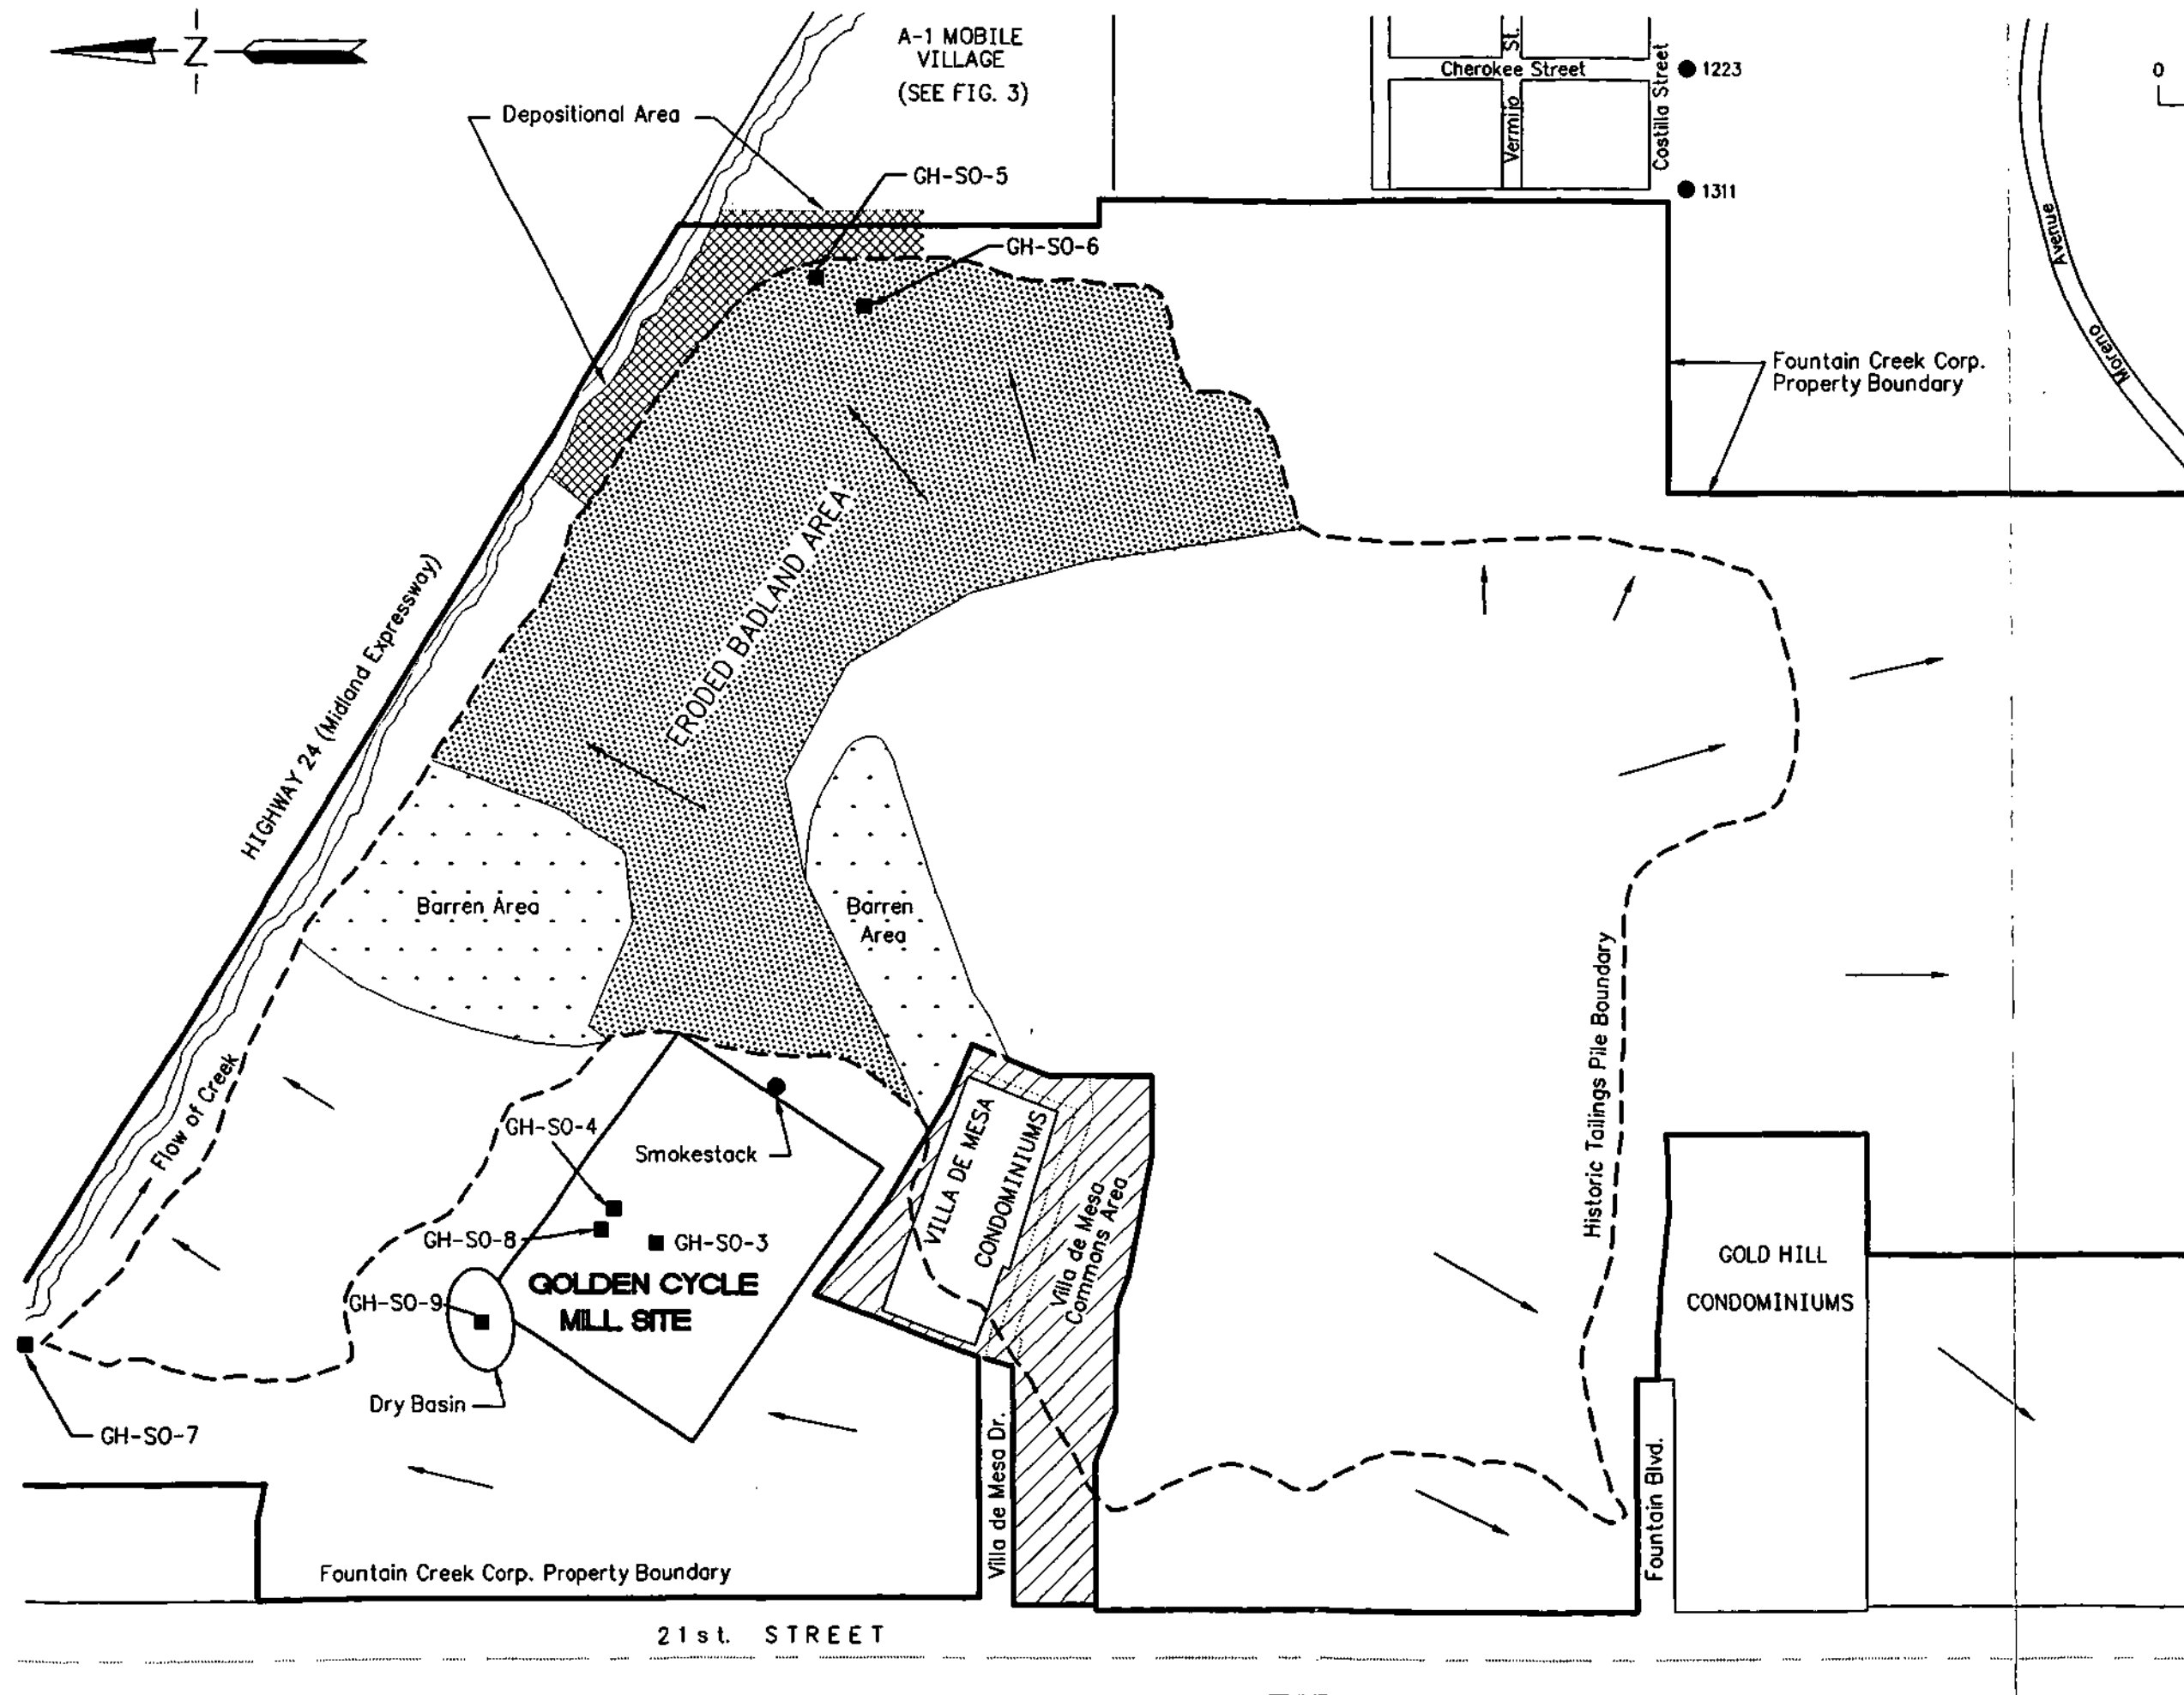
Figure 3
ON SITE SAMPLE LOCATIONS

Soil samples GH-SO-3, GH-SO-4 and GH-SO-8 were collected from the millsite area. GH-SO-3 was collected in the former sand leach tank area of the millsite. GH-SO-4 and GH-SO-8 were collected in the former slime room area of the millsite (see Figure 3). Inorganic results for the background and millsite area soil samples are shown in Table 2. Mercury and cyanide were detected in all of the millsite area samples, but not in the background samples. Concentrations of twelve additional metals were elevated in the millsite area relative to background levels. Concentrations of several analytes were quite high relative to background levels including arsenic at 385 mg/kg, lead at 1,630 mg/kg, mercury at 4.7 mg/kg, zinc at 3,720 mg/kg and cyanide at 393 mg/kg. GH-SO-9 was collected from a dry basin north of the millsite area and contained elevated levels of manganese and mercury.

Soil samples GH-SO-5 and GH-SO-6 were collected at or near the base of the northeast face of the tailings pile. Soil sample GH-SO-7 was collected from an exposed soil face above the south bank of Fountain Creek in the northwest corner of the site. Soil samples GH-SO-10 through GH-SO-12 were collected from visible areas of tailings deposition within the northwest portion of A-1 Mobile Village (see Figure 4). Results for these samples are shown in Table 3. Cyanide and eight of the fourteen metals found to be elevated at the millsite/basin areas also were elevated along the northeast face and/or Fountain Creek bank. Each of the three samples collected from the A-1 Mobile Village contained elevated concentrations of arsenic, lead, silver and cyanide, with mercury and copper elevated in two of the samples.
