Field Report for Airborne Data Collected In Support of US EPA Region VI South 4 Group Fire 27 November 2019

Background

On 27 November 2019 an explosion and subsequent fire was reported at the TPC Group facility located near Port Neches, TX. Local information indicated that at approximately 0100 (central) a large explosion rocked the area. The explosion subsequently caused a massive fire at the facility in a short amount of time. Local official ordered a 4-mile evacuation order which as of 0800 on 27 November 2019 was still in effect. Reported onsite products include various olefins, butadiene, and isobutylene. The geographical coordinates of the facility are 29.9222N, 95.0547W (figure 1).

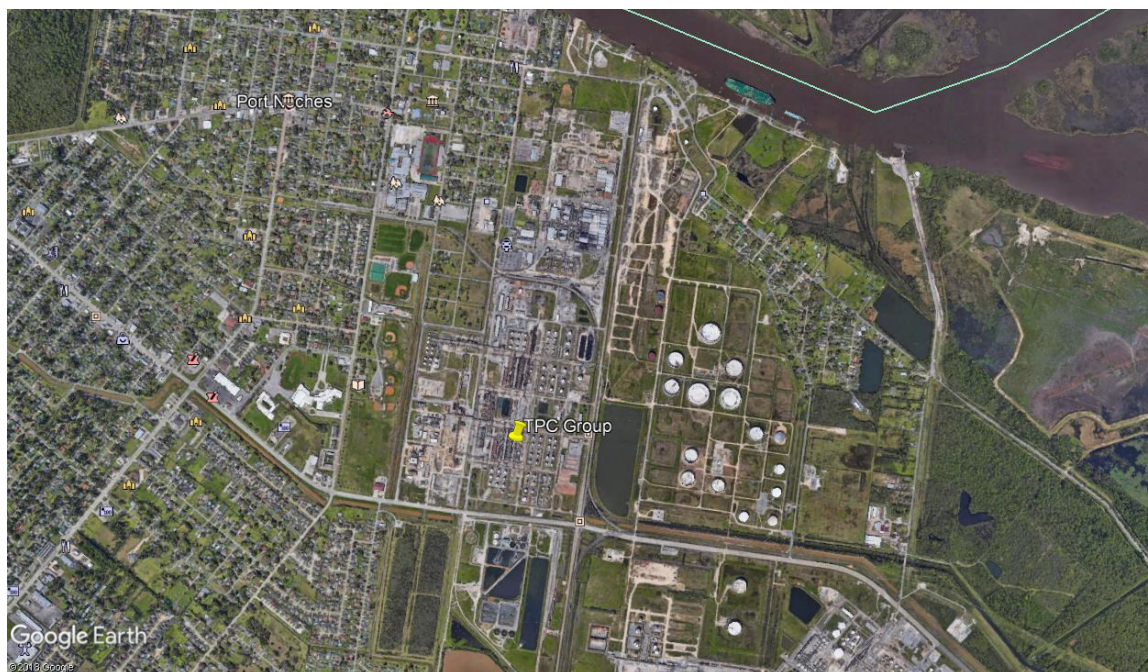
Figure 1: TPC Facility, Port Neches, TX

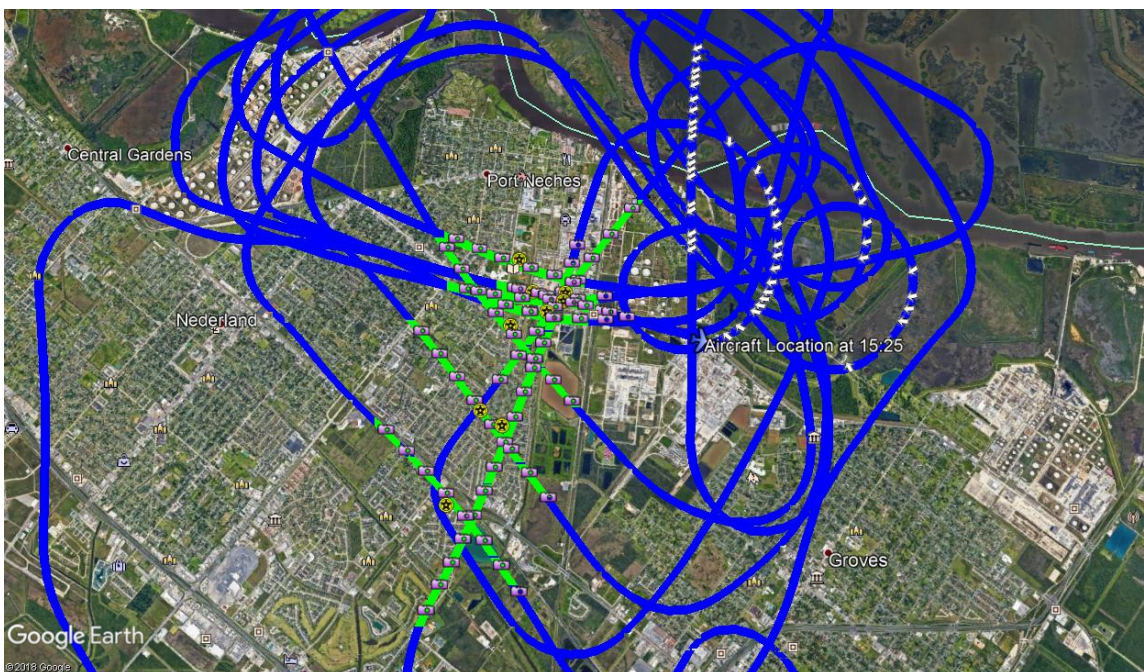
Figure 2: Data collection passes, TPC Group Fire, Port Neches, TX. The blue lines represent the ASPECT flight path, green lines represent when the FTIR was actively collecting data, the yellow icons with star is the centroid of the line scanner image, and the camera icons represent when a photo was taken.

The order to launch the aircraft was given at 0530 local on 27 November 2019 and the aircraft was airborne at 0635. The initial data collection run over the site was at 0750 (central) The aircraft made a total of 12 data collection passes; flight information is summarized in Appendix A and Figure 2.

As illustrated in figure 2, ASPECT conducted several passes over and downwind of the site. Analysis of both automated and manual analysis of the data showed no significant detections. A complication which may have influenced this was that the FTIR telescope was slightly ajar in the sensor mount. After flight was completed (during a fuel stop) the telescope was checked, and the mounts tightened.

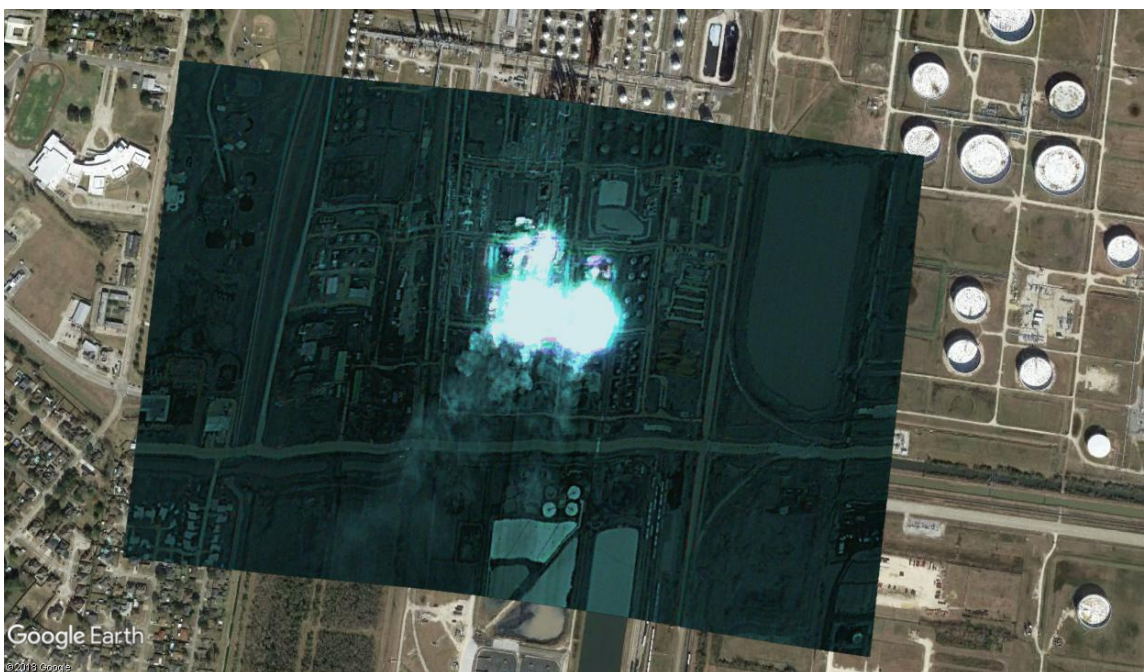
A total of 1 test and 11 data collection passes were made in the proximity of the fire and an infrared line scanner image was generated for each pass. Figure 3 shows a typical 3-band infrared image obtained from data collected for Run 2. This image was generated by flying approximately 100 meters downwind of the facility. The white area within the image is the hot signature of the fire. A thermal plume can be seen being emitted from the active fire location within the facility perimeter with no evidence of a chemical plume being generated by the fire.

Figure 3: – 3 band IR image, Run 5, TPC Group Fire

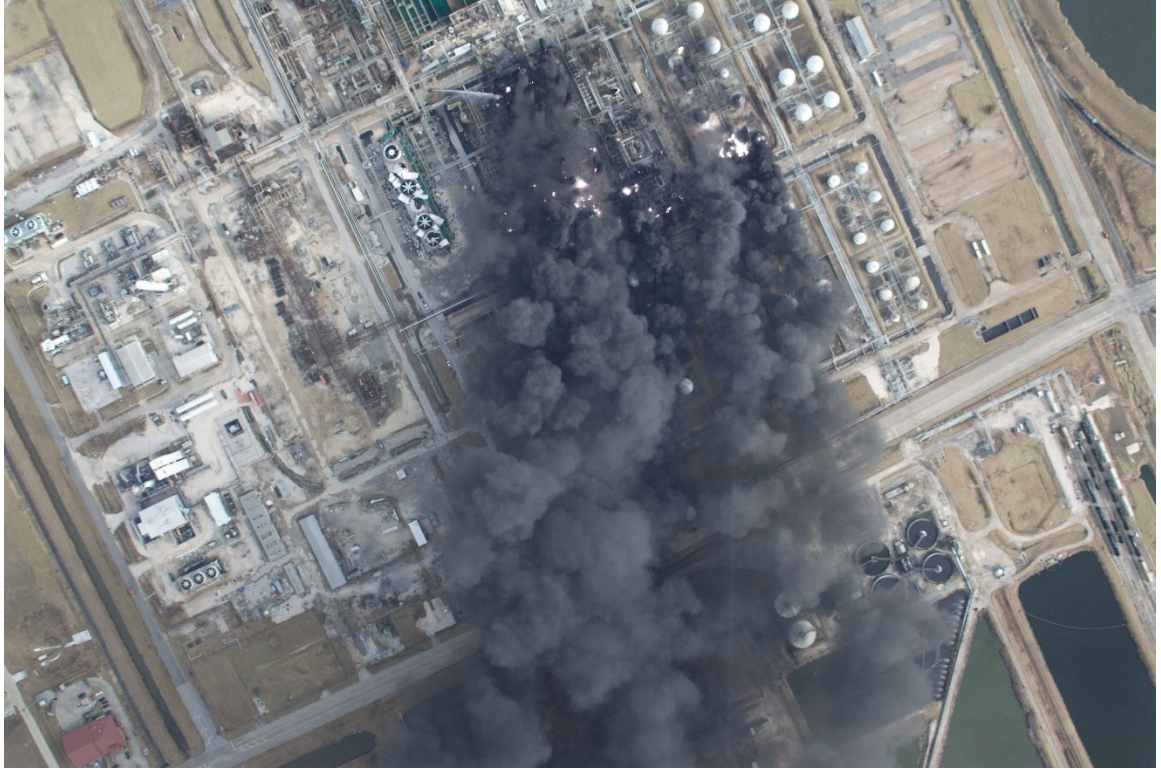
A full set of high resolution aerial digital photography were collected as part of the flight. Figure 4 shows a representative image collected as part of each pass. The image illustrates that several fires are present in the field of view and the plume generated by the fire was moving to the south. Figure 5 shows a representative oblique collected from the copilot station. As with the aerial image, the frame shows multiple fires contributing to the generation of the smoke plume.

Figure 4: Aerial Image of the TCP Group Fire

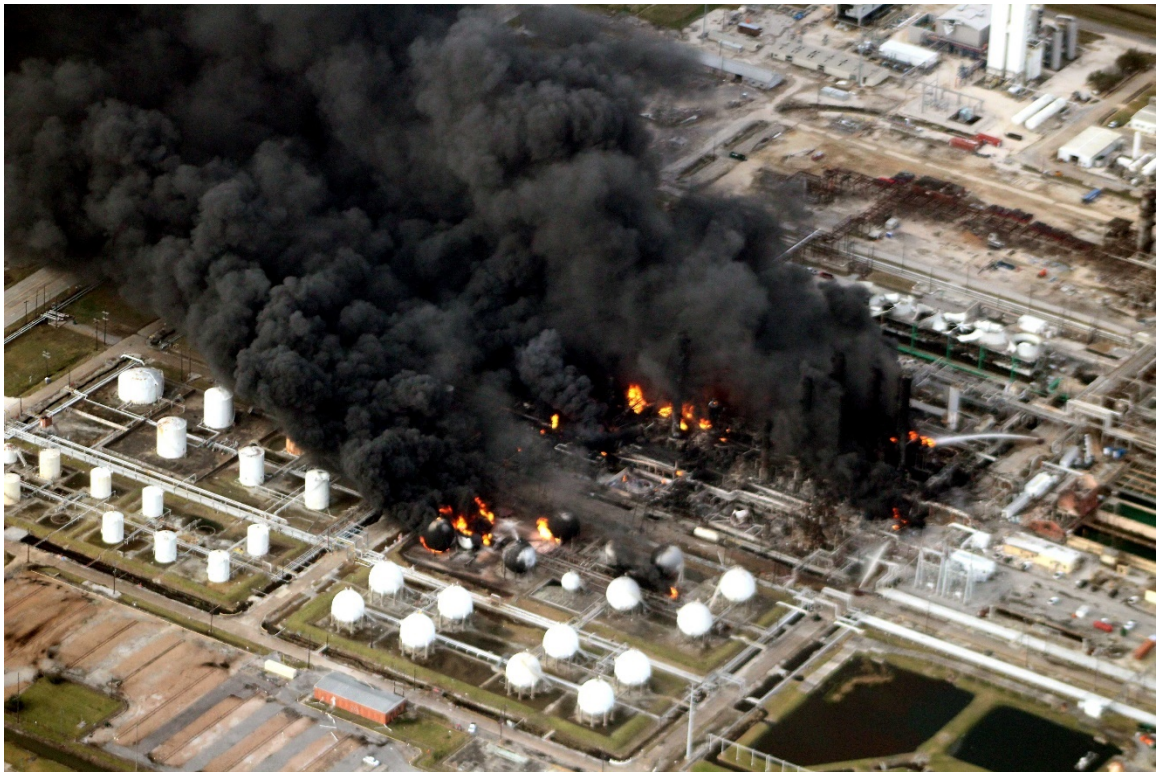
Figure 5: Oblique Image of the TCP Group Fire

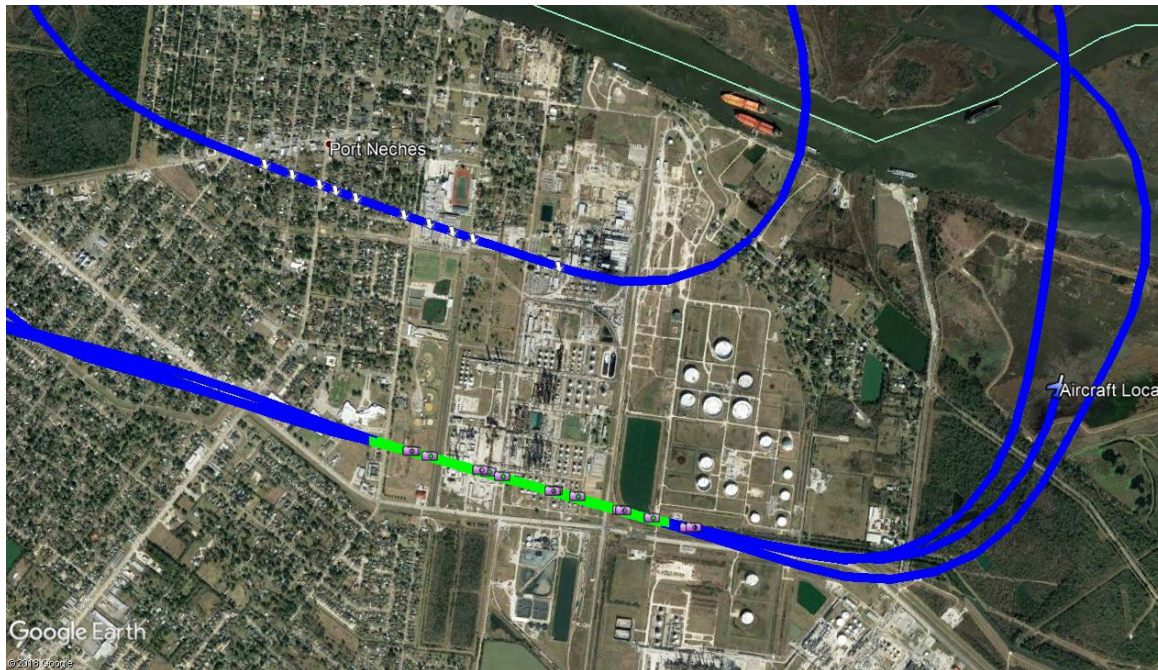
Figure 6: Data collection passes, TPC Group Fire, Port Neches, TX. The blue lines represent the ASPECT flight path, green lines represent when the FTIR was actively collecting data, the yellow icons with star is the centroid of the line scanner image, and the camera icons represent when a photo was taken.

A second flight was conducted with the aircraft reporting wheels up at approximately 1145 local with the first data collected at 1209. The aircraft made two passes with flight information is summarized in Appendix A and Figure 6.

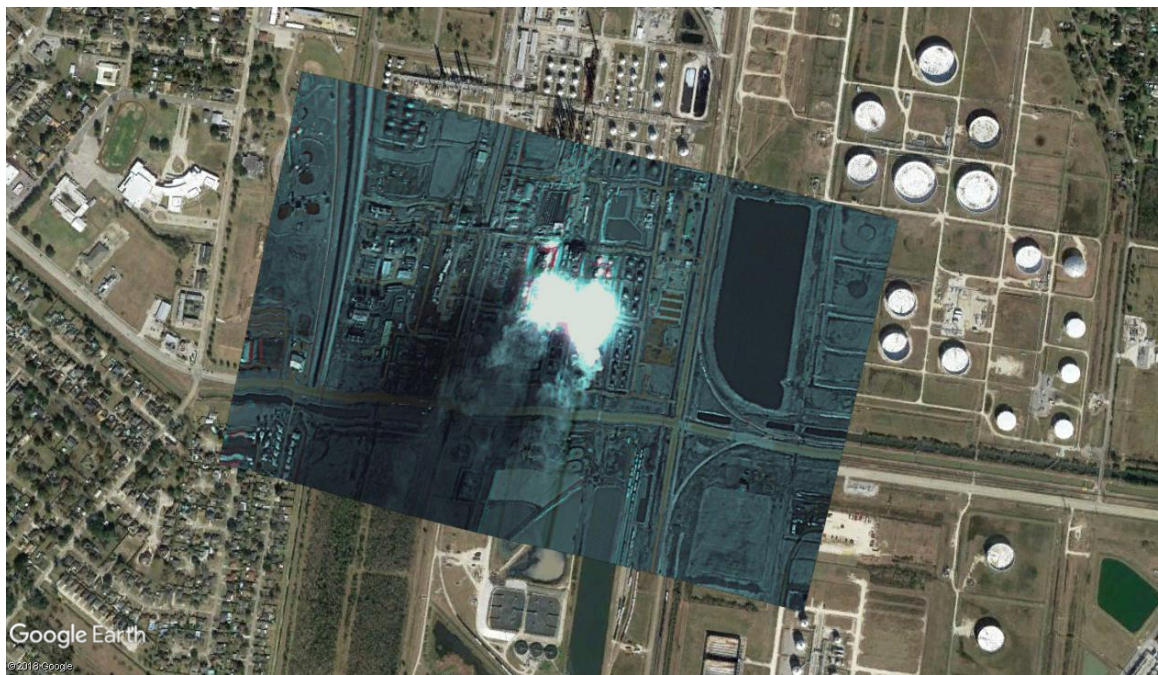
A total of 2 test and 2 data passes were made in the proximity of the fire and an infrared line scanner image was generated for each pass. In a similar fashion to data collected on flight 1, line scanner data continues to show a very hot environment due to the fires in the facility.

Figure 7: – 3 band IR image TPC Group Fire, Flight 2, Run 3

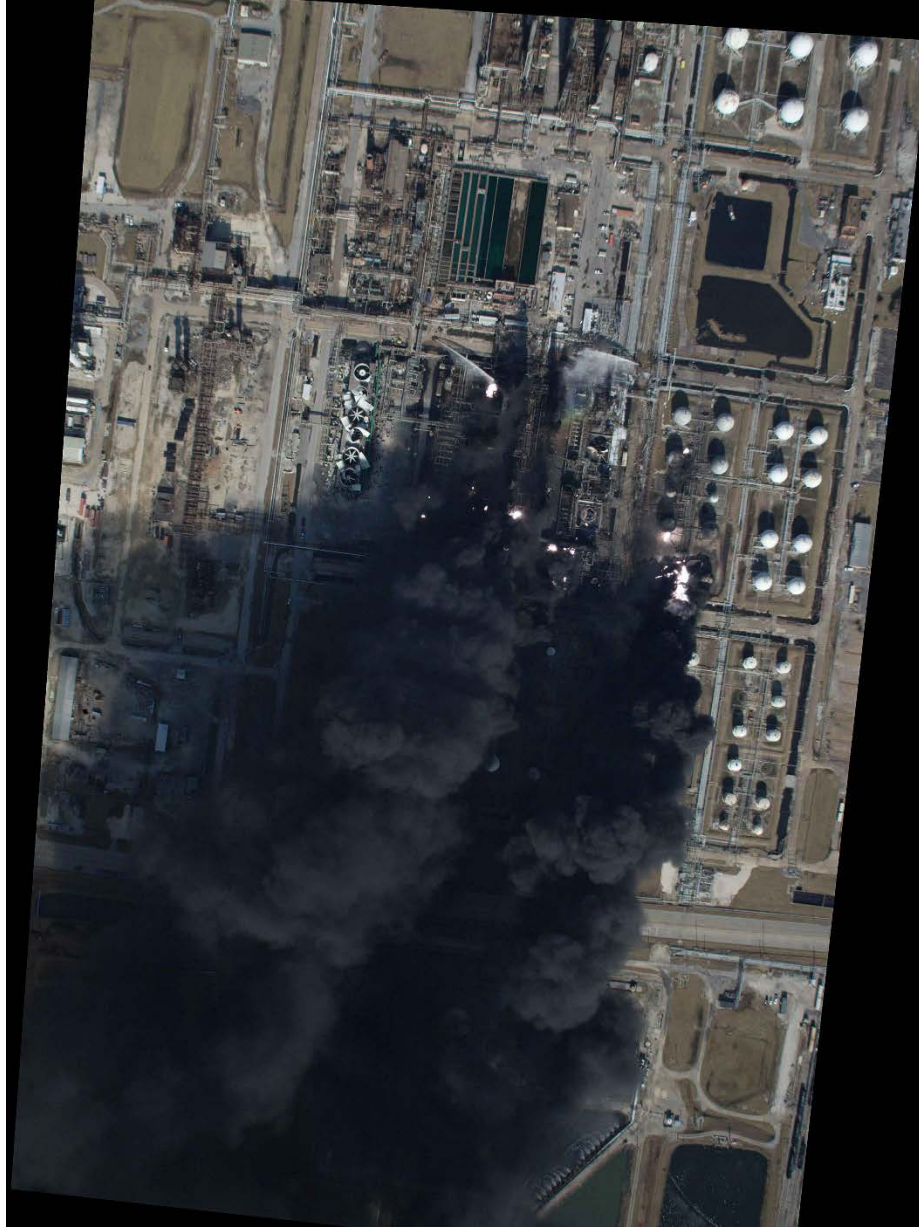
A full set of high resolution aerial digital photography were collected as part of the flight. Figure 8 shows a representative image collected as part of each pass. The image illustrates that several fires continue to burn in the area, but the intensity of the smoke appears to be somewhat diminished. Figure 9 shows confirms that several fires are present with some indication that the number of individual fires has expanded.

Figure 8: Aerial Image of the TCP Group Fire, Flight 2

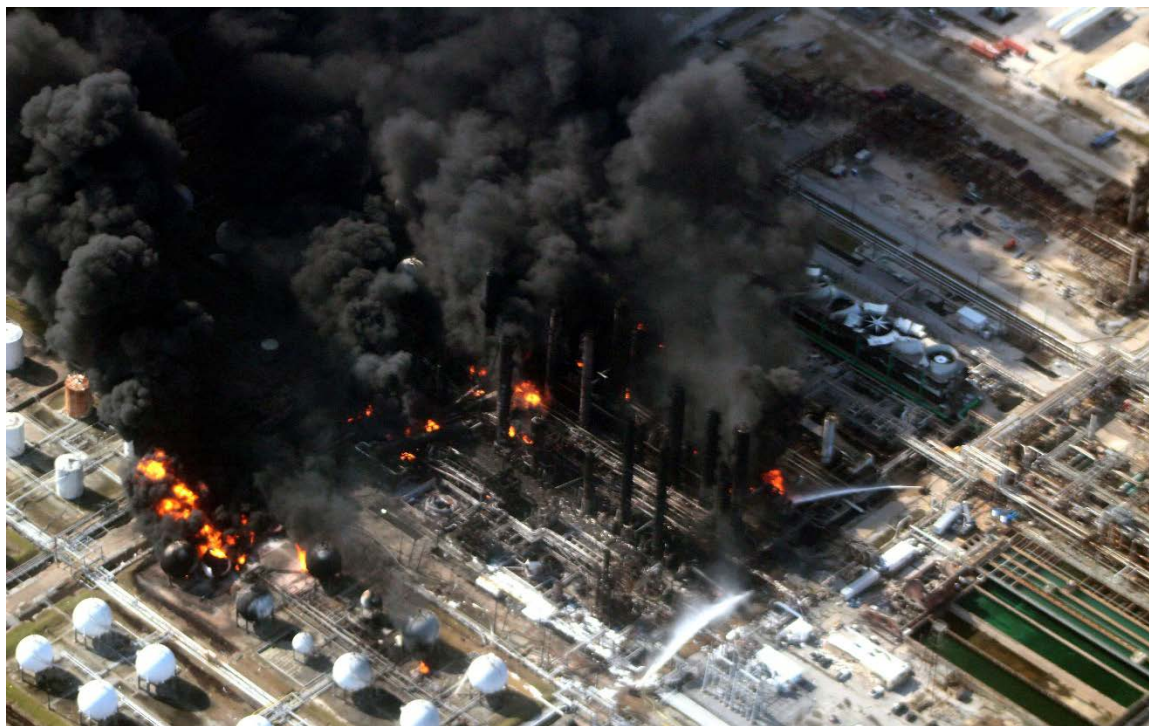
Figure 9: Oblique Image of the TCP Group Fire, Flight 2

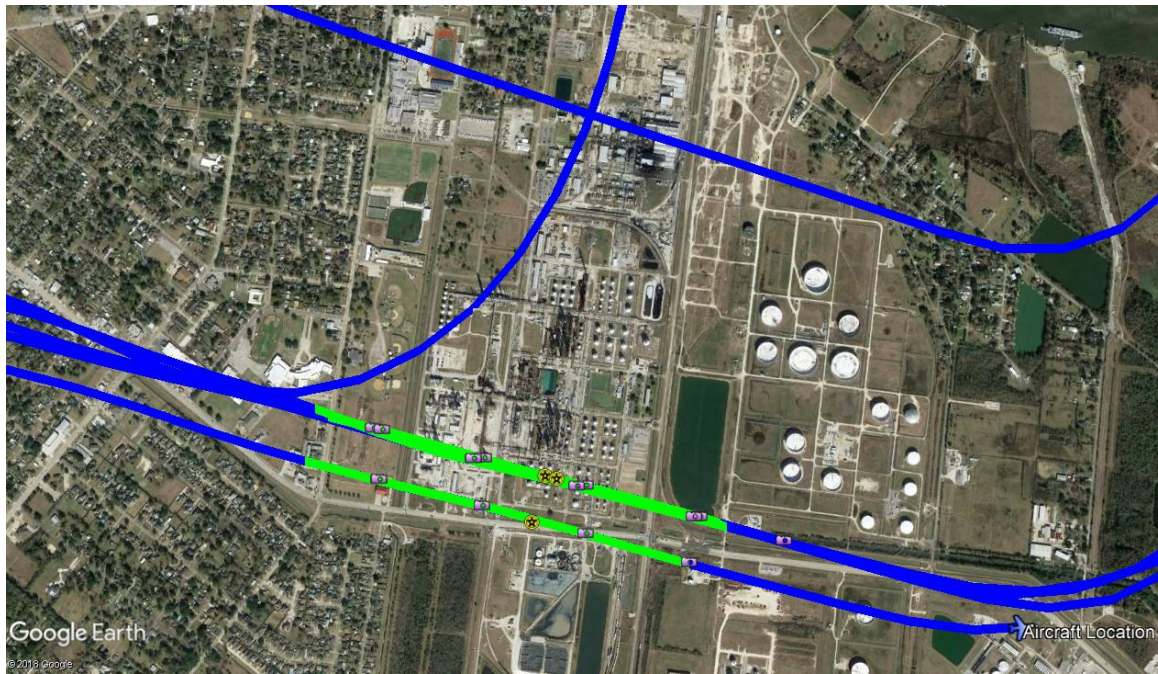
Figure 10: Data collection passes, TPC Group Fire, Port Neches, TX. The blue lines represent the ASPECT flight path, green lines represent when the FTIR was actively collecting data, the yellow icons with star is the centroid of the line scanner image, and the camera icons represent when a photo was taken.

The third flight conducted on 27 November 2019 initiated at 1417 with the first of three data passes conducted over the facility. Flight information is summarized in Appendix A and Figure 10.

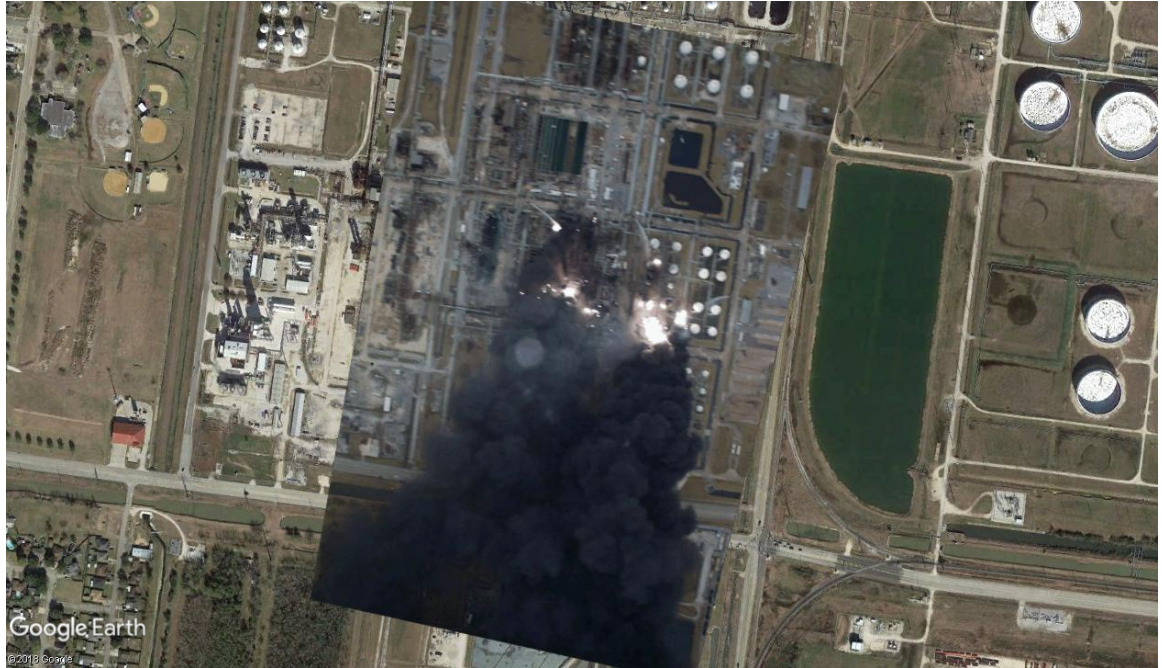
A partial set of high resolution aerial digital photography were collected on the last flight of the day with a representative image given in figure 12. It should be noted that the image is slightly blurring due to the long exposure time needed to collect the image under low light conditions. The image shows that fires continue to burn with no apparent spreading in structures or tanks. Due to the time of day and lack of enough light, oblique images were not collected on this flight.

Figure 12: Aerial Image of the TCP Group Fire, Flight 3
