# **Field Report for Airborne Data Collected In Support of US EPA Region 6 South 4 Group Fire 30 November 2019**

## **Flight 6 -- 30 November 2019**

## **Flight 7 -- 30 November 2019**

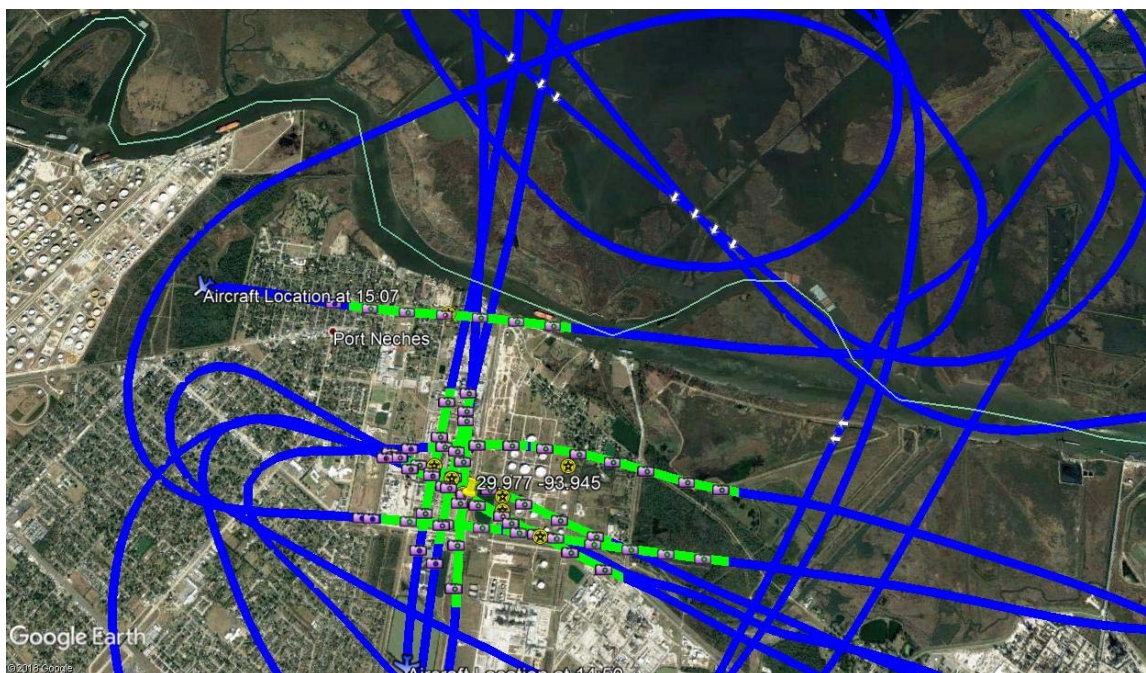
Figure 2: Data collection passes, South 4 Group Fire, Port Neches, TX. The blue lines represent the ASPECT flight path, green lines represent when the FTIR was actively collecting data, the yellow icons with star is the centroid of the line scanner image, and the camera icons represent when a photo was taken.

Note that flights 1,2, and 3 were conducted on 27 November. On 28 November 2019 flight 4 was conducted but weathered out due to port conditions. On 29 November 2019 while transiting to the site, an attempt was made to see if enough of a clearing was available to collect data. This mission was labeled as flight 5 and did not result in any data due to a low ceiling. The order to launch flight 6 was given at 0630 central on 30 November 2019 with the aircraft reporting wheels up at 0635. The initial data collection run over the site was at 0754 (central) The aircraft made a total of 8 data collection passes; flight information is summarized in Appendix Flight #6 and Figure 2.

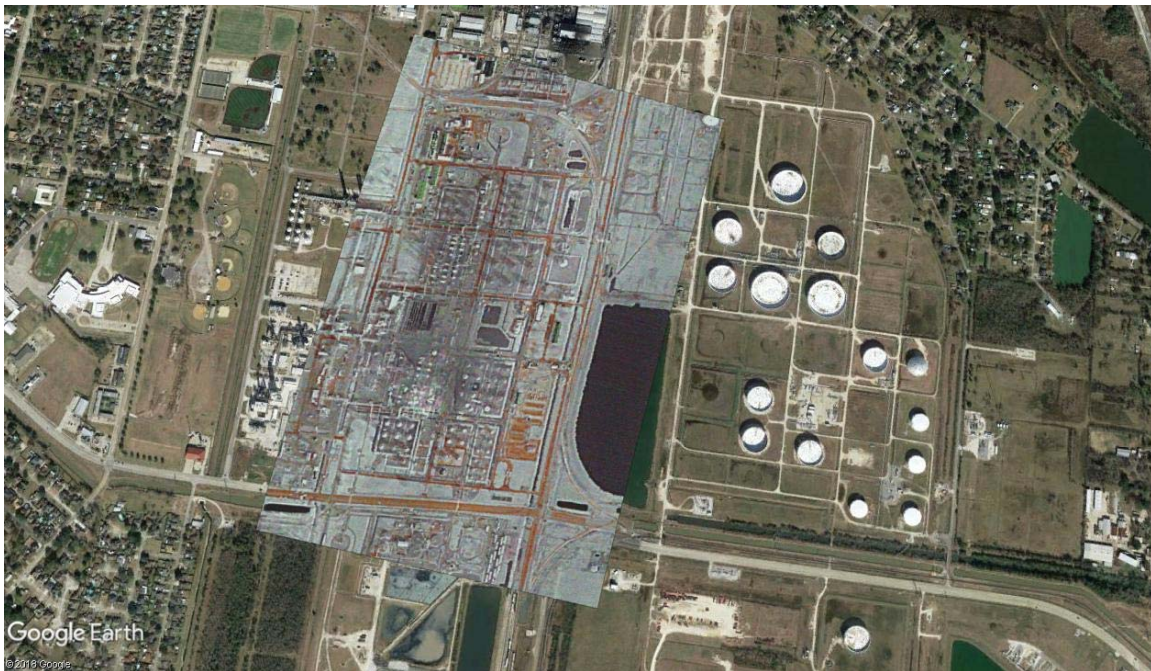
A total of 2 test and 9 data collection passes were made in the proximity of the fire and an infrared line scanner image was generated for each pass. Figure 3 shows a typical 3-band infrared image obtained from data collected for Run 8. This image was generated by flying approximately directly over the facility on a northerly flight path. The color of the image is a result of the blackbody settings and generally shows greatly reduced thermal content from prior flights. Figure 4 shows a close-up of the facility. The white content of the image shows the hottest targets which corresponds to reactors,

pipng, and tanks within the production unit. Close examination of the image does show the presence of water streams directed into the unit. There does not appear to be any plumes leaving the site.

Figure 3: – 3 band IR image, Run 8, South 4 Group Fire

On 30 November 2019 ASPECT collected aerial remote sensing data over the South 4 Group facility located near Port Neches, TX. Analysis of FTIR data did not show any chemical detections. IR image analysis showed the presence of elevated temperatures within the reactor complex, but the magnitude was substantially reduced from prior missions. Visible imagery showed only a light grey plume being generated at the facility with no active fires immediately visible. Damage to the facility and nearby spherical tanks is clearly evident in the aerial and obliques images.

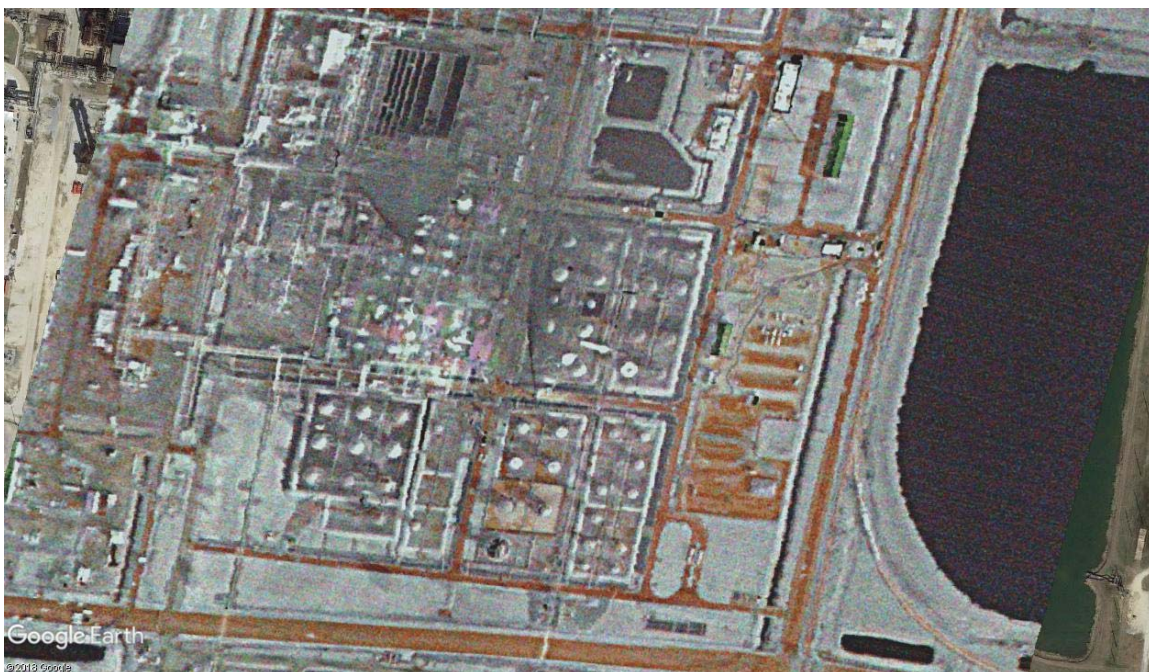
Figure 4: -- 3 band IR Image, Run 8, South 4 Group Fire Closeup

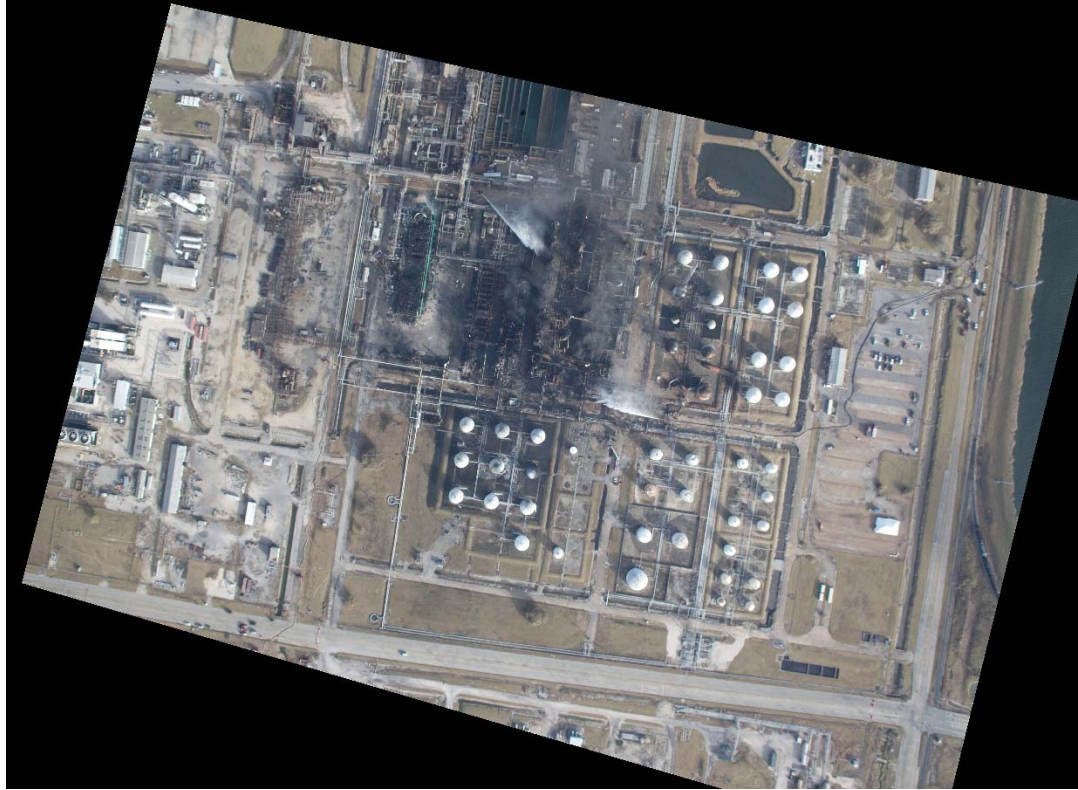
A full set of high resolution aerial digital photography were collected as part of the flight. Figure 5 shows a representative image collected as part of each pass. The confirms finding from IR analysis that the active fires at the facility appear to be suppressed. In addition to damage at the reactor area, several spherical tanks to the east of the unit appear to be damaged. Light grey smoke can be seen leaving the site. Figure 6 shows a representative oblique collected from the copilot station. This image clearly shows damage to the reactor columns as brown looking discoloration to the structure. Mist from the water jets clearly shows that a brisk wind is blowing from the south pushing a light smoke plume to the north.

Figure 5: Aerial Image of the South 4Group Fire

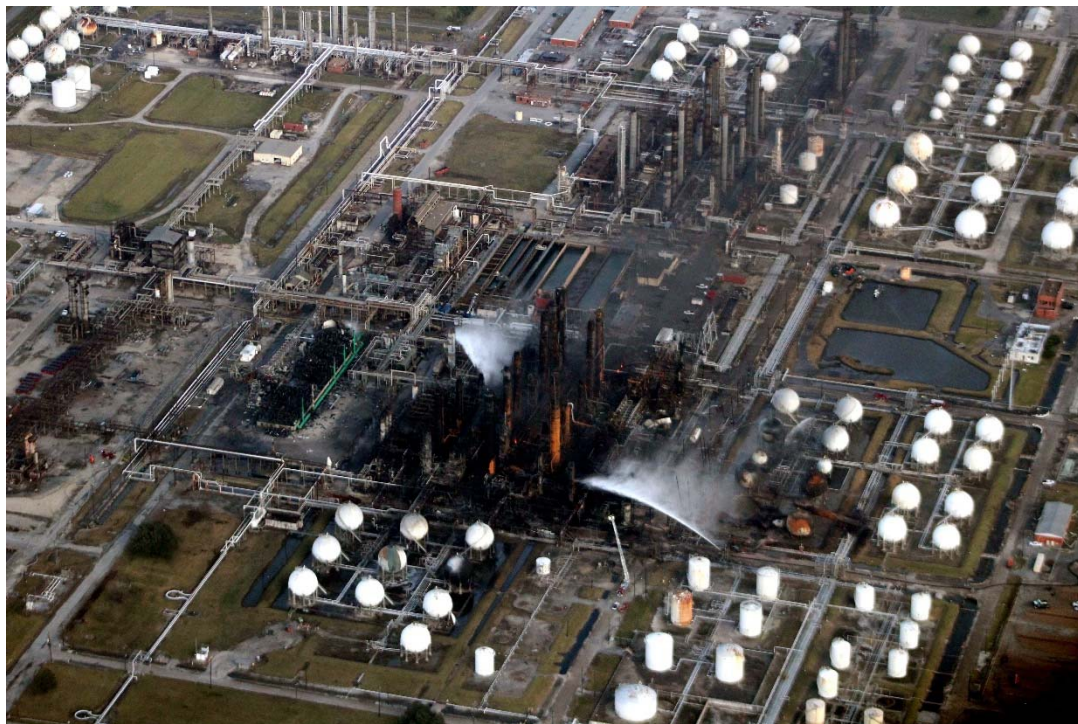
Figure 6: Oblique Image of the South 4 Group Fire

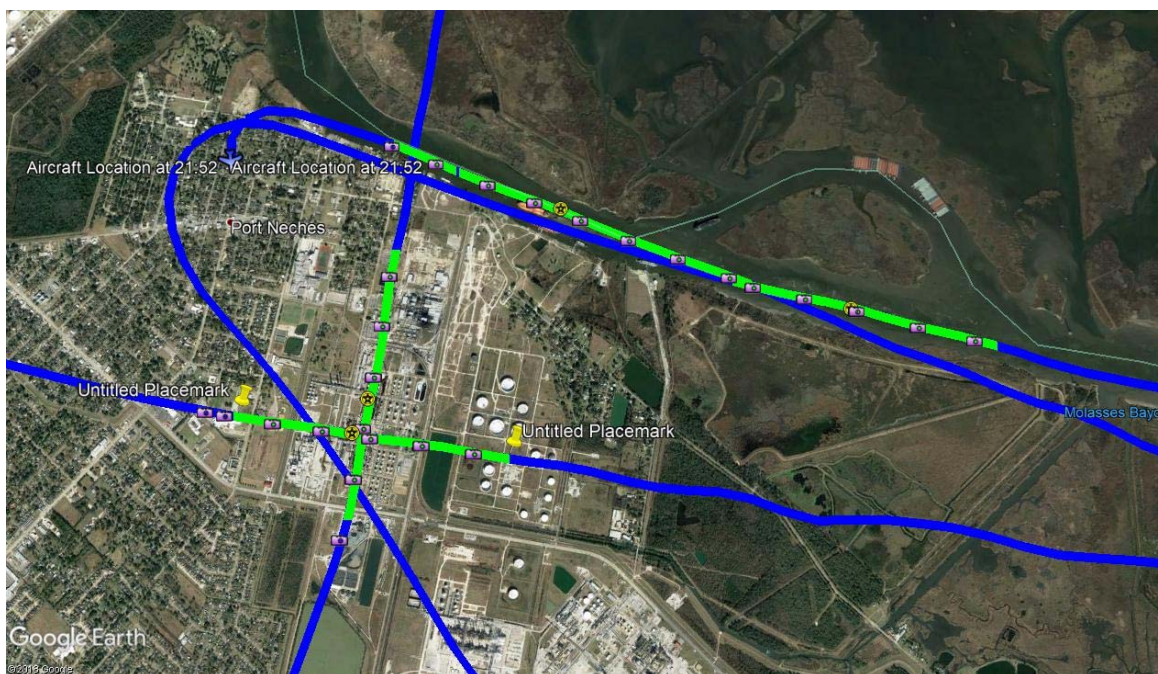
Figure 7: Data collection passes, South 4 Group Fire, Port Neches, TX. The blue lines represent the ASPECT flight path, green lines represent when the FTIR was actively collecting data, the yellow icons with star is the centroid of the line scanner image, and the camera icons represent when a photo was taken.

The aircraft was airborne at 1455 (central) was over the site at 1525 (central). A total of 2 test and 4 data collection passes were completed before IFR conditions forced a termination of the data collection due to low ceiling. Flight information is summarized in Appendix Flight #7 and Figure 7.

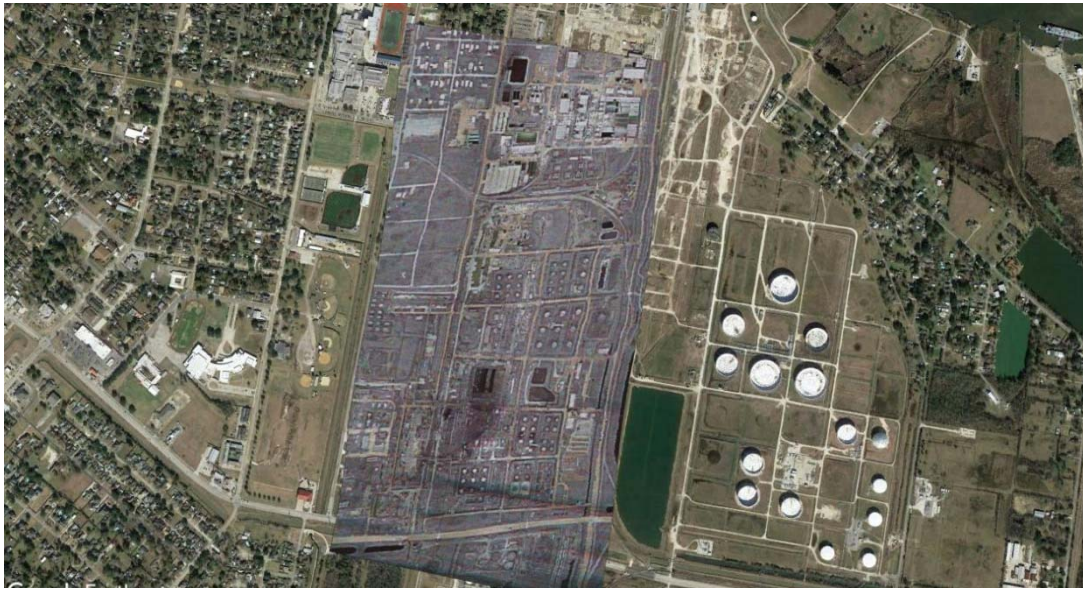
A total of 2 test and 4 data collection passes were made in the proximity of the fire and an infrared line scanner image was generated for each pass. Figure 8 shows a typical 3-band infrared image obtained from data collected for Run 8. This image is somewhat distorted due to an extreme crosswind at the flight altitude. Analysis of the image generally shows minimal elevated thermal sources with a cooler signature leaving the site; most likely water spray from the water cannon. No chemical plume can be seen being emitted from the site. Figure 9 was generated by flying the system over the Neches river in an effort to image any oil sheen in the waterway. No sheen was observed. It should be noted that the image features on the east side of the image are clouds below the aircraft.

Figure 8: -- 3 band IR image, Flight 7, Run 4, South 4 Group Fire

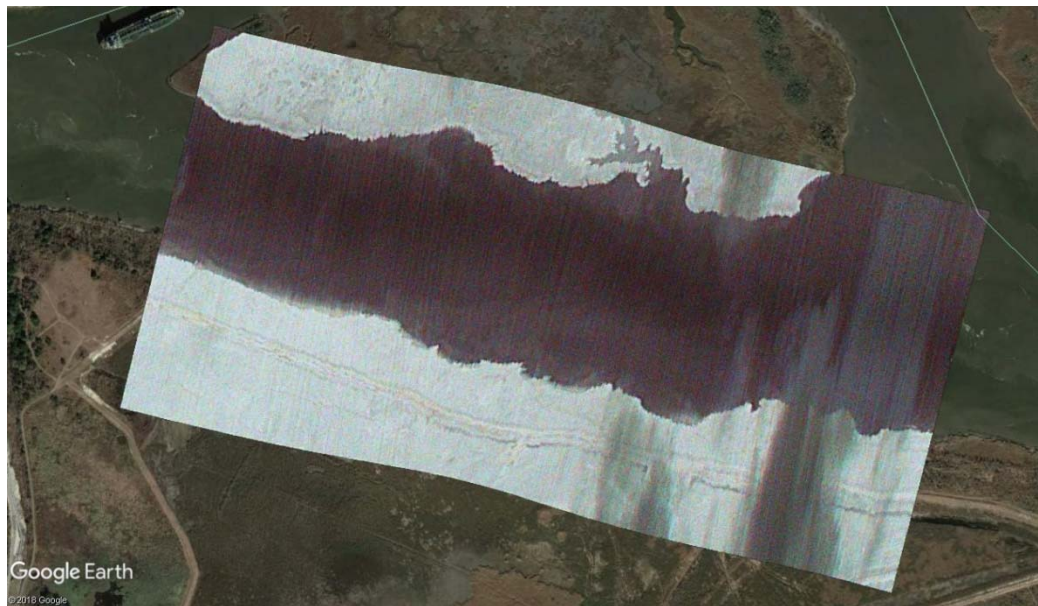
Figure 9: -- 3 band IR image, Flight 7, Run 5, South 4 Group Fire

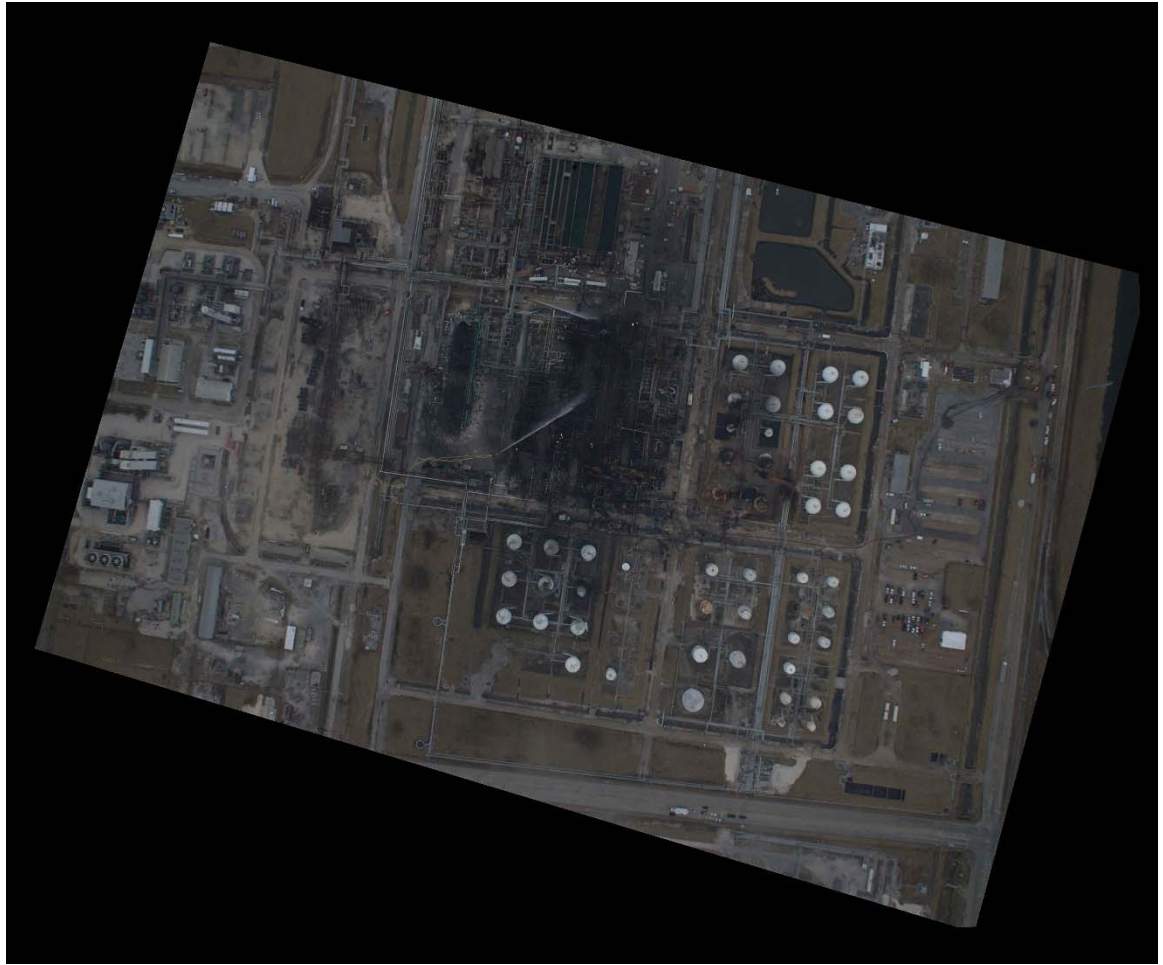
A full set of high resolution aerial digital photography were collected as part of the flight. Figure 10 shows a representative image collected as part of each pass. Due to the time of day and cloud cover the image is dark. As with flight 6, the image shows that little if any smoke is being emitted from the site. At the time of collection, only one water cannon was in operation. Oblique image collection was not possible due to the onset of IFR (low ceiling) conditions.

Figure 10: Aerial Image of the South 4Group Fire

The second flight on 30 November 2019 ASPECT indicated that thermal conditions at the site continue to show a decrease in intensity. No chemical plume or detections were observed being emitted by the site. Collected aerial imagery showed no significant change from the prior flight other than the presence of only one water cannon. IR imagery collected over the Neches River did not show any evidence of an oil sheen.
