TECHNICAL MEMORANDUM

SUBJECT: Request for Region 8 Superfund Emergency Response Program Assistance for the Carpenter-Snow Creek Superfund Site located in Neihart, Cascade County, Montana.

RE: Lead Removal Justification

SUBJECT: Request for Region 8 Superfund Emergency Response Program Assistance for the Carpenter-Snow Creek (CSC) Superfund Site located in Neihart, Cascade County, Montana

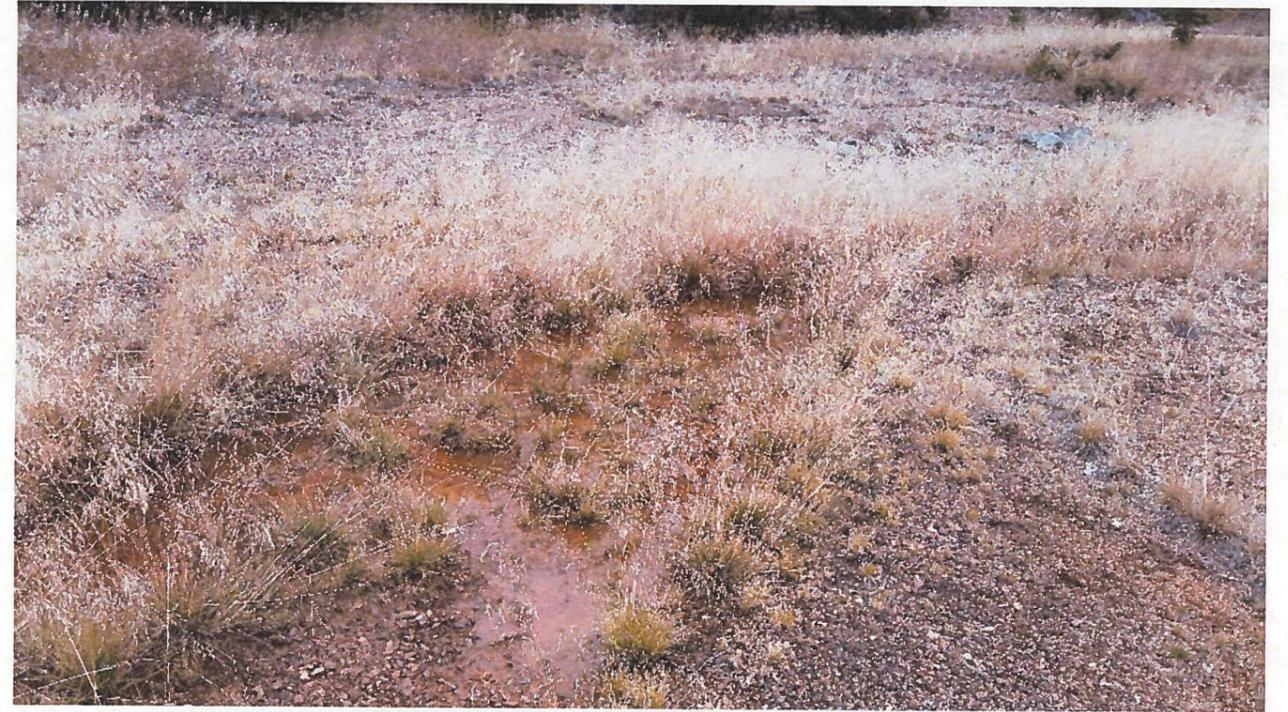
Figure 2
Orange staining on the surface near the residential structure

In 2011, an unusually high snowfall was followed by significant spring rainfall. This resulted in Sih-Mem flowing out of its historic stream channel between Pioneer Road and Carpenter Creek. Sih-Mem Creek now flows over the surface to the west of its former channel before it enters Carpenter Creek several hundred feet below its historic confluence. In the past couple of years, this creek has pooled near the home of an adjacent property owner during Spring runoff. Figure 2 shows iron staining of surface soils near the residence property from surface flow of Sih-Mem Creek while Figure 3 shows the existing confluence of Sih-Mem Creek.

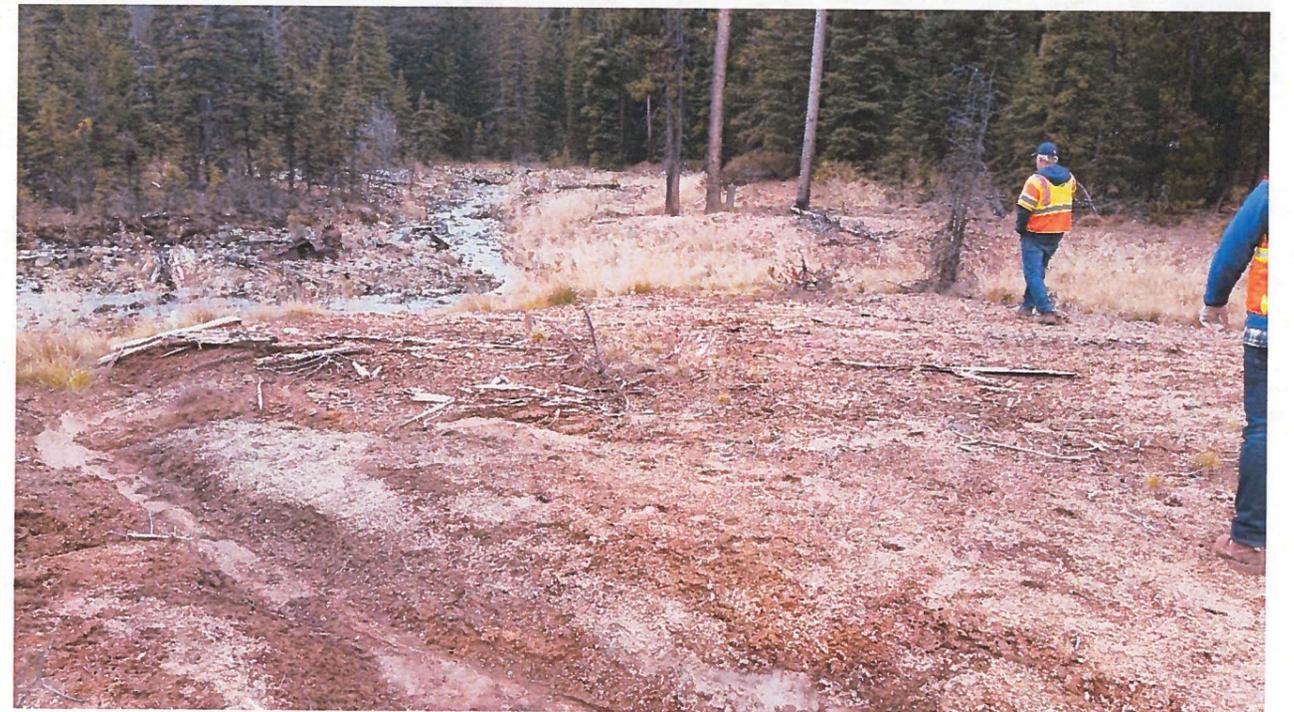
Figure 3
Confluence of Sih-mem Creek (foreground) and Carpenter Creek (background)

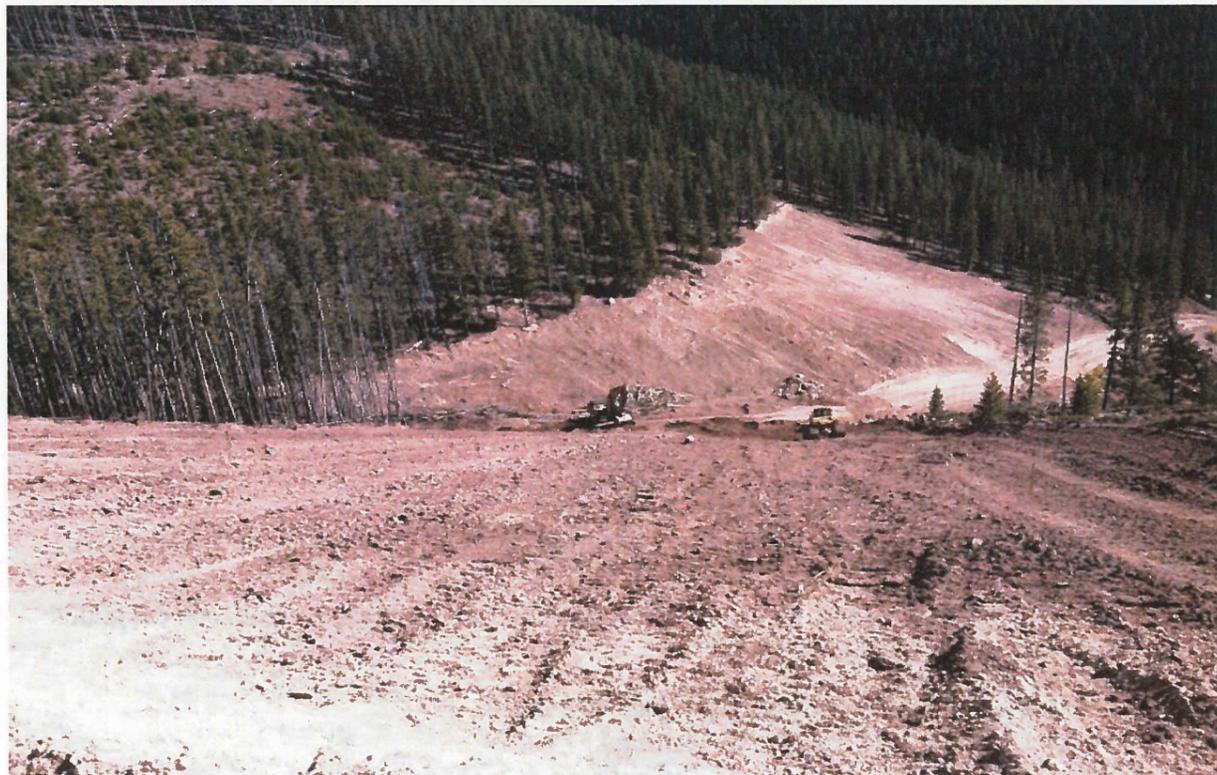
Figure 4

Looking down Silver Dyke Tailings impoundment hillside during 2014 removal action

Since the removal action was completed, the upper removal area has experienced significant erosion damage from summer storms. Rill erosion is quite evident and is cutting into previous reclaimed areas (see attached memo). A large gully has cut through the center of the erosion blanket, threatening to discharge sediment into No Name Creek. Rill erosion is also evident in the western removal area, particularly just below the tree line area.

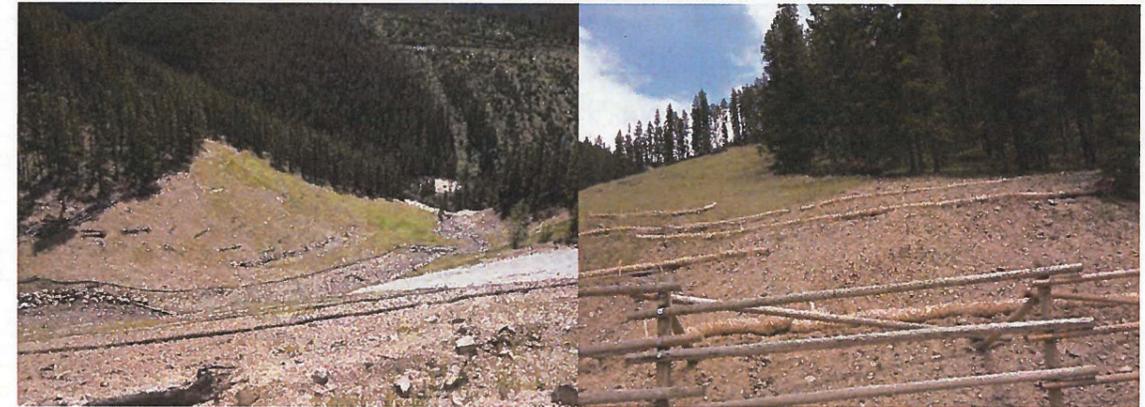
Exhibit 1 : Photographs from Silver Dyke Tailings Removal Area on June 13 and 14, 2016

[Upper left]: Looking down toward the lower removal area (looking southeast). Vegetation reestablishment is good in the southern half of the area, but vegetation is more sparse on hillsides to the north (left side of picture). **[Upper right]:** Barren area directly adjacent to Carpenter Creek Road (looking north). **[Lower left]:** Upper removal area showing poor vegetation recruitment under erosion control blanket and in areas where hydroseeder did not reach (looking west). **[Lower right]:** Barren areas in the upper removal area where mine waste persists. Erosion control blanket in background (looking south).

Hydroseeding in the lower removal area was generally successful at establishing perennial grasses and forbs. Vegetation was denser near No Name Creek and sparser on the eastern hillside, particularly in the northern quadrant. Only two areas in the lower removal area were barren. The first area was directly adjacent to Carpenter Creek Road behind the jack fence (see Exhibit 1). The lack of vegetation in this area may be attributed to soil compaction of a decommissioned haul road used during the 2014 removal action. The second area is on the eastern hillslope and based on XRF data collected after the removal action, had some residual mine waste.

Revegetation of the upper removal area was less successful than in the lower removal area. Little to no plant recruitment was observed on the south side of the area where the erosion control blanket was installed. Patches of intact vegetation were observed on the north side, but were punctuated with barren areas. The poor recruitment in this area is likely attributable to both poor hydroseeding and the remnant mine waste.

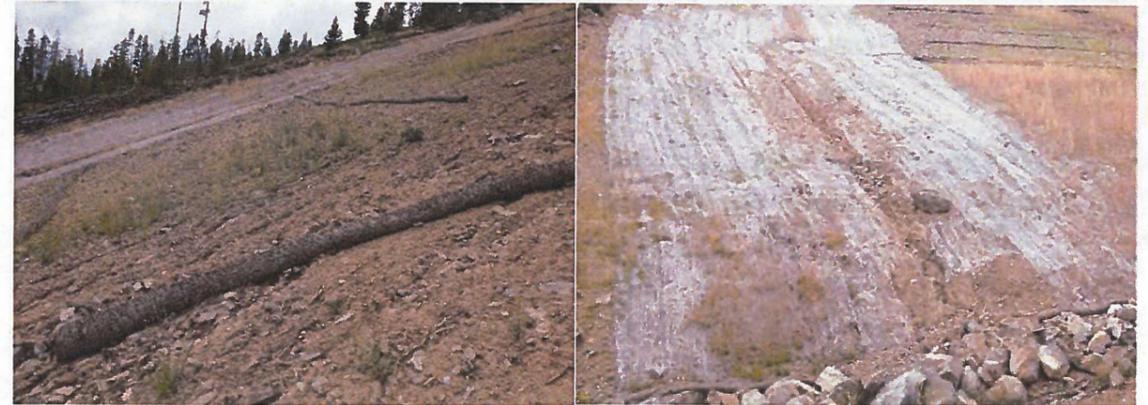
Exhibit 2- Photos from the Silver Dyke Removal Area on August 25, 2016

[Left]: August 7 storm damage in upper removal area. Displaced wattles and initiation of rills (looking southwest). **[Right]:** Initiation of gully erosion at the base of the erosion control blanket (looking northwest).

Storm damage to the Silver Dyke removal area was assessed during the August visit. Many erosion control wattles had been displaced and rilling was observed at multiple locations. Additionally, a large gully had begun to form at the base of the erosion control blanket in the upper removal area. The lower removal area did not appear to be as significantly damaged.

Field personnel replaced the displaced wattles on August 6, 2016(Exhibit 2).

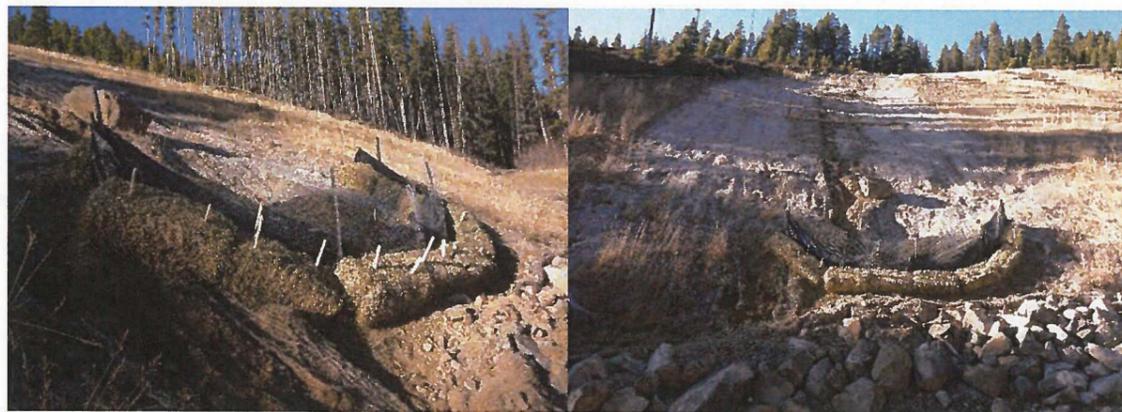
Exhibit 3 : Photographs from Silver Dyke Removal Area on November 10, 2016

[Left]: Reinforced silt fencing used to prevent sediment from reaching No Name Creek. Silt fencing was anchored by trench excavation, steel fence posts, and straw bales secured with wooden posts (looking northeast). **[Right]** Silt fence below with additional erosion control wattles above to slow down water and sediment movement into the gully. Riprap at the bottom of photo is just above the No Name Creek Channel (looking west-northwest).

In contrast, erosion damage from summer storms to the upper removal area was marked. Rill erosion is quite evident and is cutting into mine waste in some areas (see Exhibit 3 below). A large gully had cut through the center of the erosion blanket, threatening to discharge sediment into No Name Creek. Rill erosion was also evident in the western removal area, particularly just below the tree line among areas

November: Tetra Tech performed its final site control at the removal area on November 10, 2016. Activities included erosion control in the upper removal area to reduce further incising of the gully developing in the erosion control blanket. In total, 72 feet of wattles were installed at three locations within the incipient gully to slow water movement and to catch sediment (**Figure 3**). At the base of the hill, a reinforced silt fence was installed to prevent sediment from reaching No Name Creek. These activities were designed and implemented to mitigate erosion potential from spring runoff in 2017 and are not a permanent solution to erosion in the upper removal area. Pictures of the erosion control measures are shown in Exhibit 3.

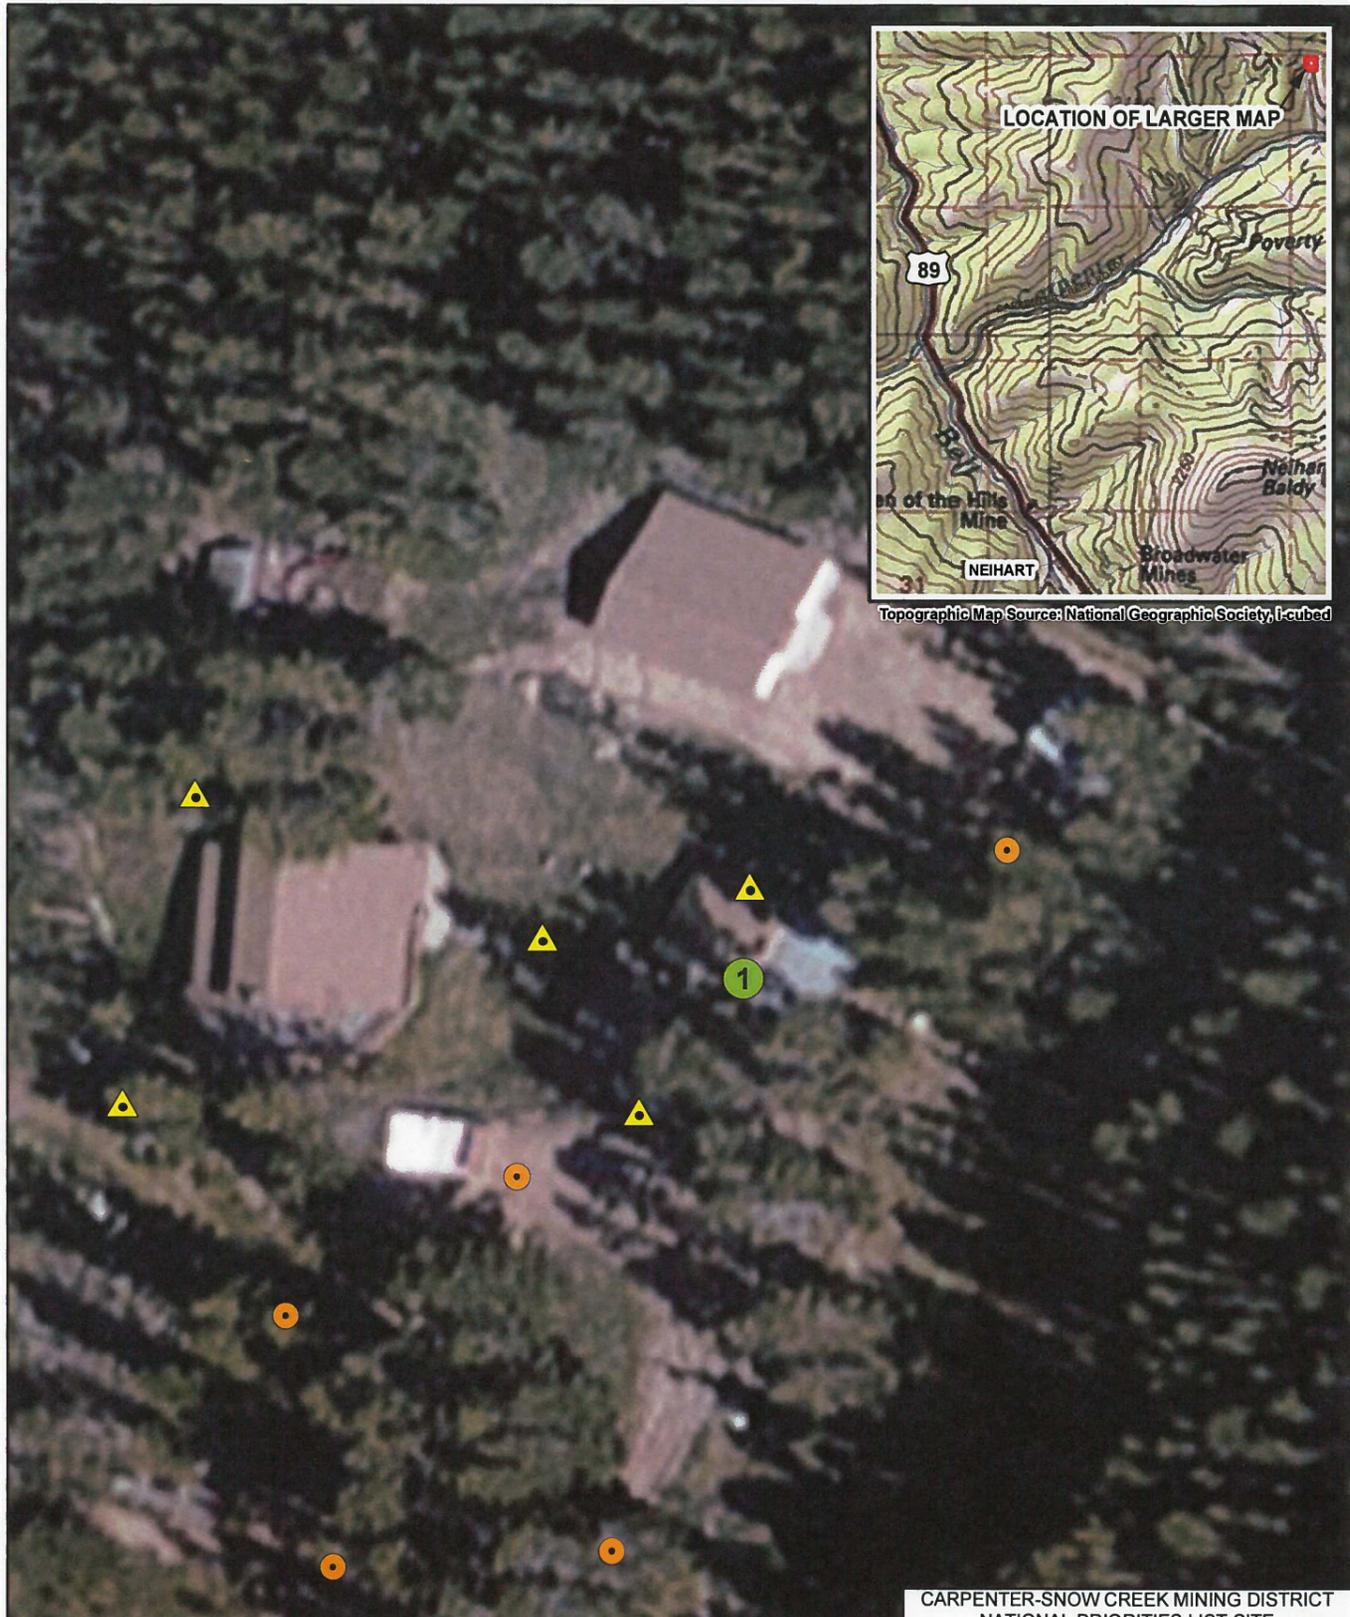
FIGURE 4.5-2A
2011
SUPPLEMENTAL RESIDENTIAL INVESTIGATION
RESIDENCE 1 - SOIL SAMPLE LOCATIONS

- RESIDENCE
- DRIVEWAY SAMPLE POINT - RS01-SS-2
- ▲ YARD SAMPLE POINT - RS01-SS-1

In 2011, soil samples were evaluated for lead and other metals by both laboratory and XRF analysis. Two 5-point composite soil samples were collected from two depths, 0-2" and 6-12", including both yard and driveway areas of the property. Consistent with OSWER 9285.7-50, only the 0-2" surface soil data will be considered for the purposes of evaluating potential human health risk to residents. The soil lead concentrations reported by laboratory analysis from the surface composite samples were 3,930 and 6,280 mg/kg (average = 5,105 mg/kg), which were consistent with reported field XRF results of four samples (range 2,455 – 5,592 mg/kg).

In 2011, this property was investigated as part of the remedial investigation and soil samples were collected and analyzed. Four samples were analyzed using XRF from the residential property. The XRF concentrations were:
