Red and Bonita Mine Bulkhead Test Closure Analytical Report

June 2021

Prepared For:
U.S. Environmental Protection Agency
Region 8
1595 Wynkoop Street
Denver, CO 80202

Prepared By:
Mountain Studies Institute
116 E. 12th St
P.O. Box 426
Silverton, CO 81433

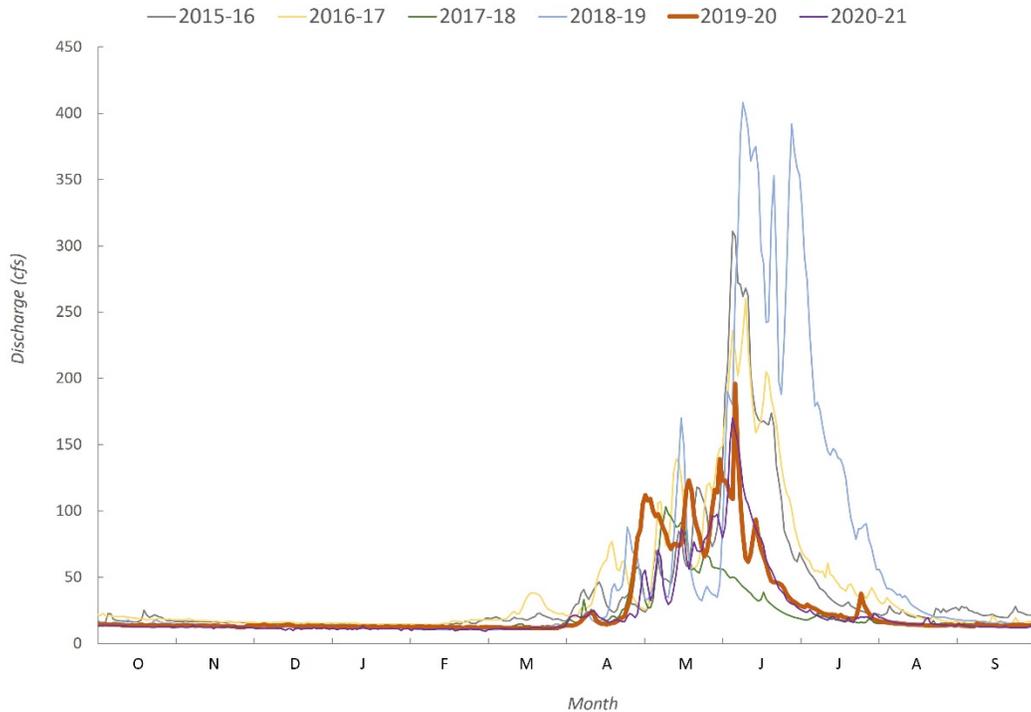
Figure 1: Streamflow at Cement Creek USGS gage (CC48) from 2015-16 water year to 2020-21 water year. 2019-20 water year of R&B bulkhead test emphasized in red.

The primary challenge in evaluating a potential response from the bulkhead test closure is whether or not we can definitively isolate the influence of the bulkhead closure from unrelated watershed wide phenomena. For example, if we were to assess whether a reduction in zinc load downstream of R&B during the closure could be solely attributable to the R&B closure, we could look at whether a similar reduction occurred in other drainages that are not influenced by R&B. Additionally, we could examine whether the observed reduction was typical for the observation period based on data from previous years when the bulkhead test closure did not occur. Fortunately, there are several data sources that allow for a baseline understanding of pre-closure conditions. Notably, a hydrologic water balance report was completed in 2021, which describes the seasonality of metal loadings from draining mines in the R&B vicinity (Cowie and Rock 2021). In 2019, high frequency monthly water quality sampling was conducted at surface water and draining mine sites within the Cement Creek watershed. This 2019 dataset is valuable for interpreting whether conditions observed during the 2020 test closure were a departure from pre-closure conditions. It is important to note that hydrologic conditions in 2020 differed greatly from 2019. The winter of 2018/19 delivered above average snow accumulations to the San Juan Mountains and subsequent high river flows in the spring of 2019. Conversely, 2020 was characterized by drought conditions and low river levels exacerbated by a weak monsoon season. Annual average streamflow at the Cement Creek USGS gage (CC48) was more than twice as high in the 2018-19 water year (54.6 cfs) compared to 2019-20 water year (26.9 cfs). This pattern persisted into the late summer and fall, when during the R&B bulkhead test closure (July 15-October 22), average streamflow at CC48 was still more than twice as high in 2019 (33.7 cfs) than in 2020 (15.2 cfs). Therefore, comparisons of water quality data from 2019 to 2020 should be interpreted within the context of these contrasting hydrologic regimes (Figure 1; Table 4).

- Hydrologic and climatic conditions preceding the test closure strongly influenced water quality trends observed during the test closure. For example, metal concentrations were elevated and metal loads were reduced in 2020 at many sites compared to 2019; a reflection of an average snowpack in the winter of 2019/20 and subsequent average stream flows compared to an above average snowpack in the winter of 2018/19 and subsequent above average stream flows (Figure 1; Table 4).

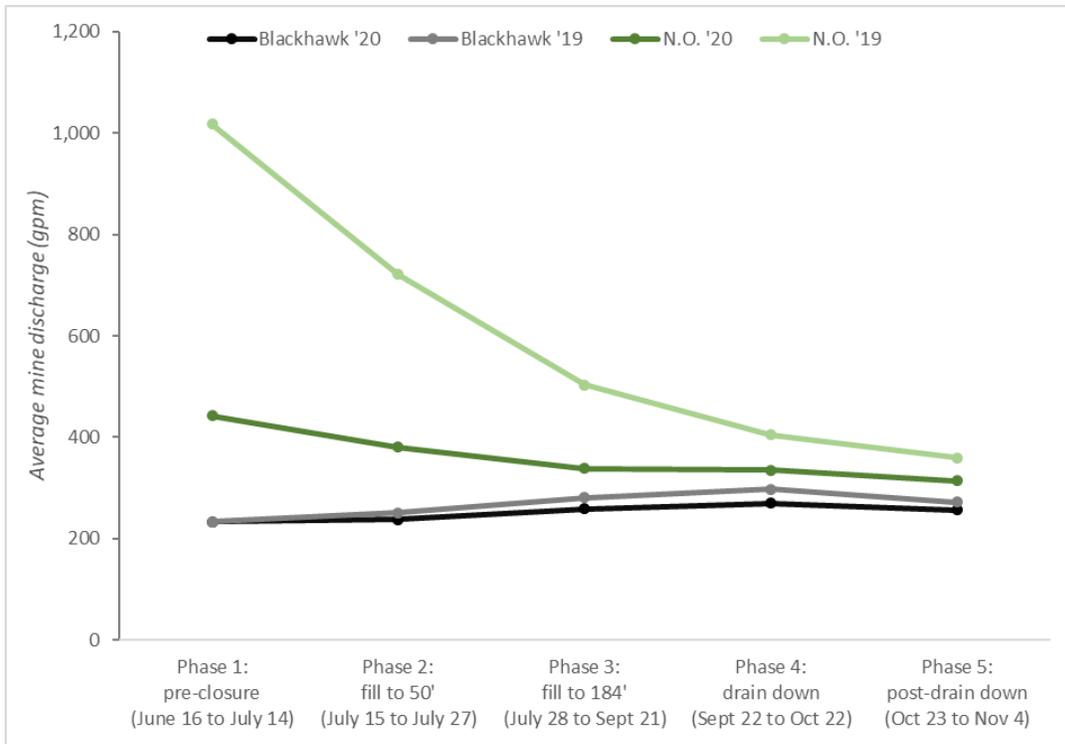
Figure 2: Discharge of Blackhawk Mine and Natalie Occidental Mine in 2019 and 2020.

As described by Deere and Ault (2020), data from deployed instruments in neighboring draining mines during the closure demonstrated very little change in mine discharge rates that could be attributable to the closure. The closure effectively reduced R&B discharge from about 228 gpm prior to the closure to approximately 0.3 gpm during the closure. The trends in mine discharge from other monitored mines varied over the closure period but were markedly similar to seasonal trends in discharge observed from the same time period in 2019 (Figures 2-4). There was a slight increase in average discharge at Mogul from July to November during the closure period, but this pattern generally mimicked the 2019 pattern in discharge over the same time period. In both 2019 and 2020, discharge at Blackhawk gradually increased from June to October, but began decreasing in November. Discharge from Natalie/Occidental decreased over the closure period in 2020 and 2019. Flows from Gold King and American Tunnel varied over the closure period, but generally decreased. In 2019, flows from Gold King and American Tunnel increased from June to July and then decreased from July to November. This difference in the trend in discharge of Gold King and American Tunnel from 2019 to 2020 reflects the greater snowpack and later runoff period that occurred in 2019 as compared to 2020 (Figure 1).

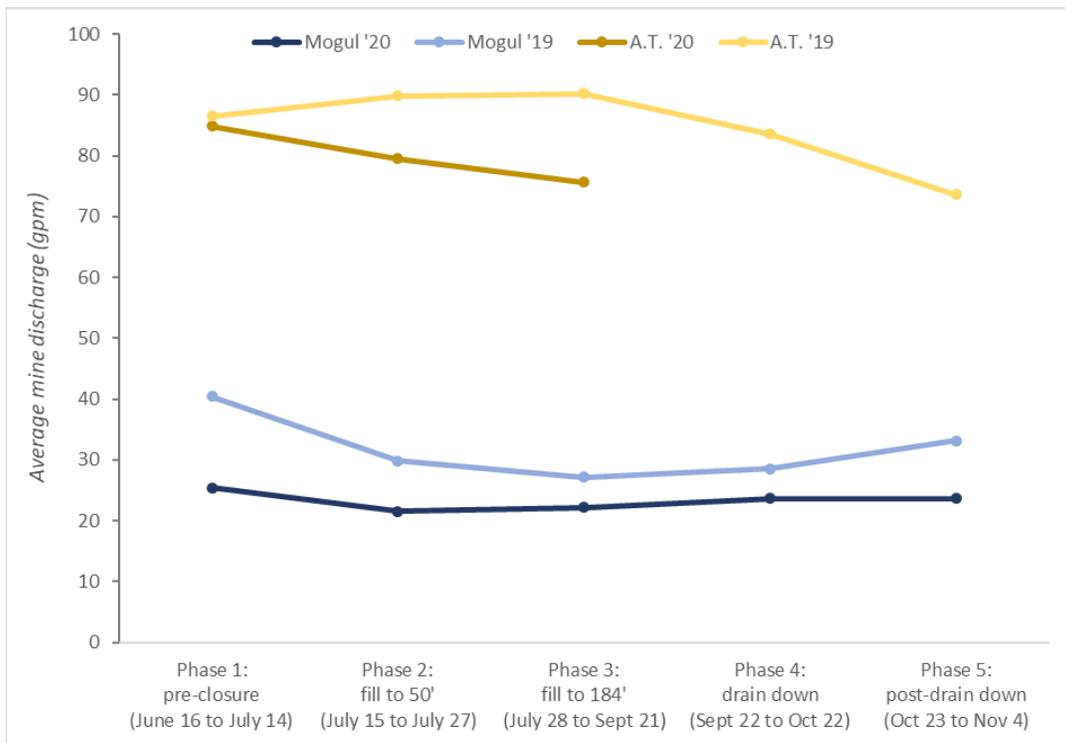
Figure 3: Discharge of Mogul Mine and American Tunnel in 2019 and 2020.

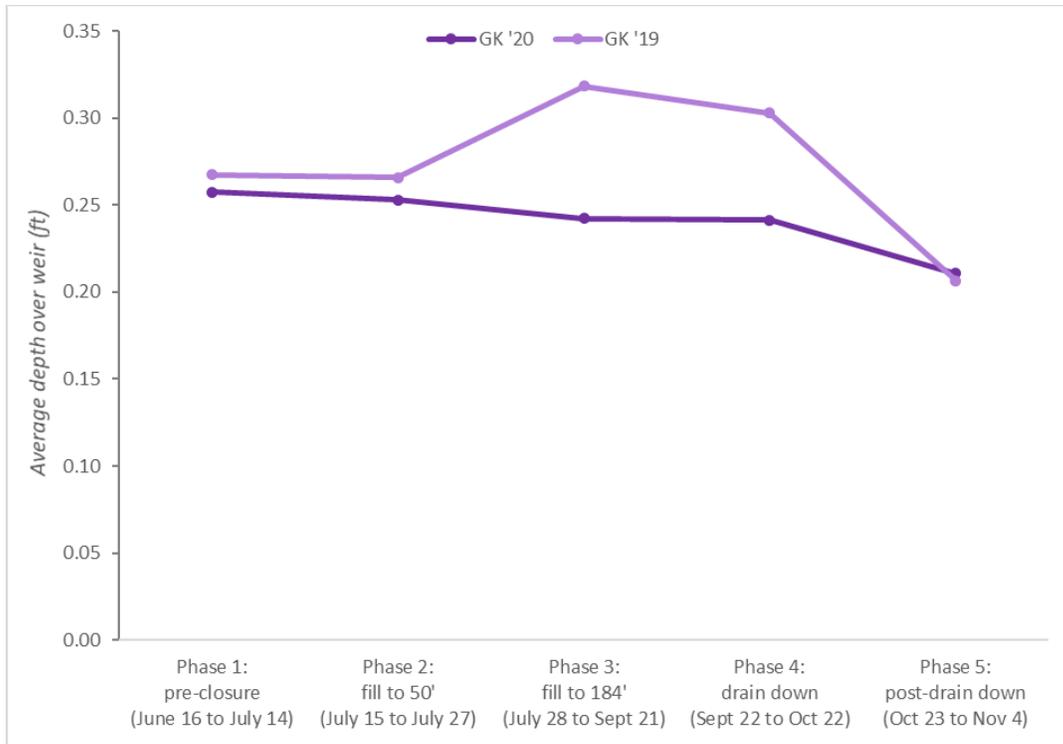
Figure 4: Discharge of Gold King Mine in 2019 and 2020.

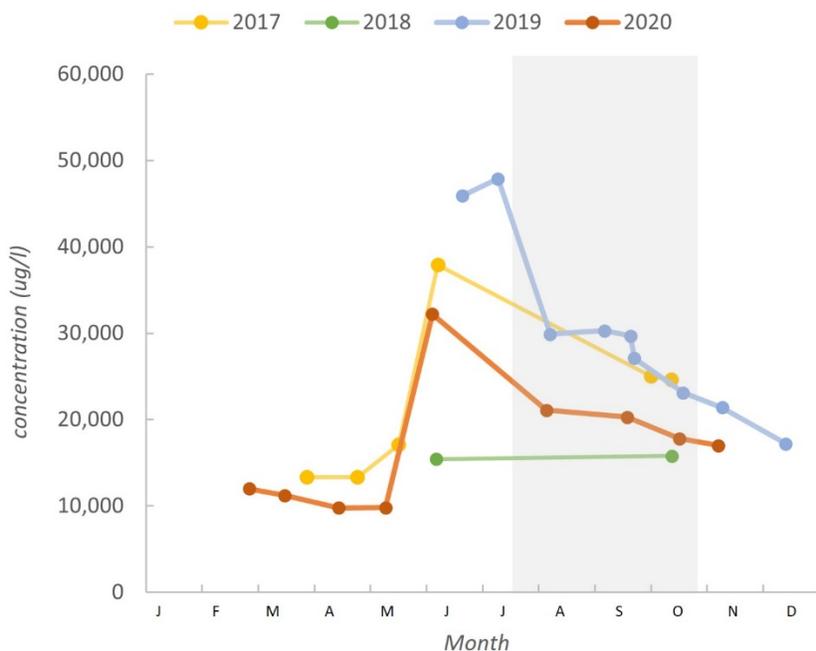
Figure 5: Total zinc concentration of Gold King Mine (CC06) from 2017-2020.
Gray shading represents timeframe of 2020 R&B bulkhead test closure.
See Appendix A for trend plots from all sites.

We also focused on the August to September time period when pressure was building behind the bulkhead to examine whether there were increases in metal concentrations or loads at draining mines that could be attributable to the closure. We found that mine drainage loads of several metals did increase from August to September of 2020 during the closure but loads increased similarly during the same time period in 2019. This illustrates the value of robust pre-test data. Without the availability of pre-test data for comparison, one may incorrectly conclude that all metal load increases from draining mines during the closure period in 2020 were directly attributable to the test closure.

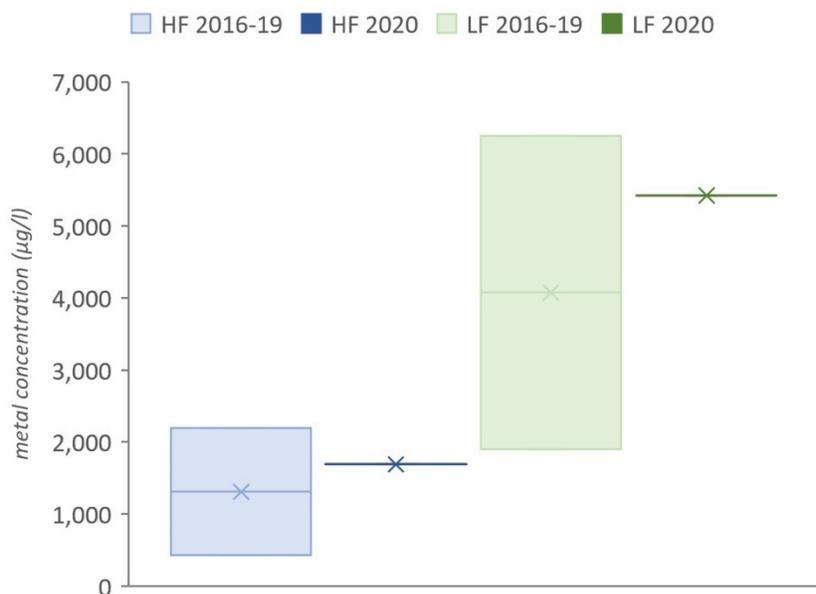
Figure 6: Total zinc concentration of SS084 during high-flow (HF) and low-flow (LF) of 2020 compared to HF and LF observations from 2016-2019.

One hypothesis was that metal concentrations and/or loads may increase at draining mines in the R&B vicinity during the closure. Of the handful of instances where low-flow 2020 concentrations or loads were higher than the median of previous years, they were preceded by high-flow conditions that demonstrated

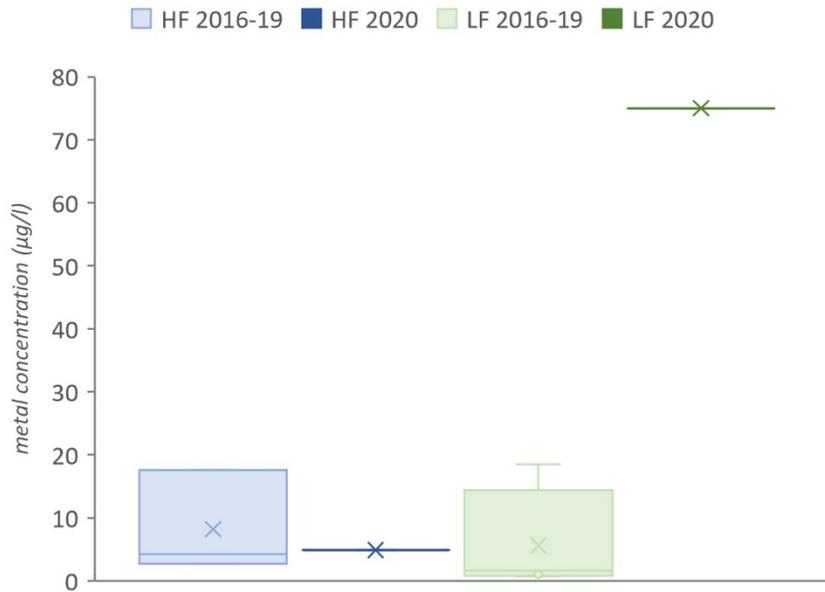
Figure 8: Total lead concentration of SS062 during high-flow (HF) and low-flow (LF) of 2020 compared to HF and LF observations from 2016-2019.
See Appendix B for box plots from all sites.

- SS062 and SS236 had higher low-flow concentrations of total iron and total lead that were not preceded by the same condition during the pre-test high-flow period.

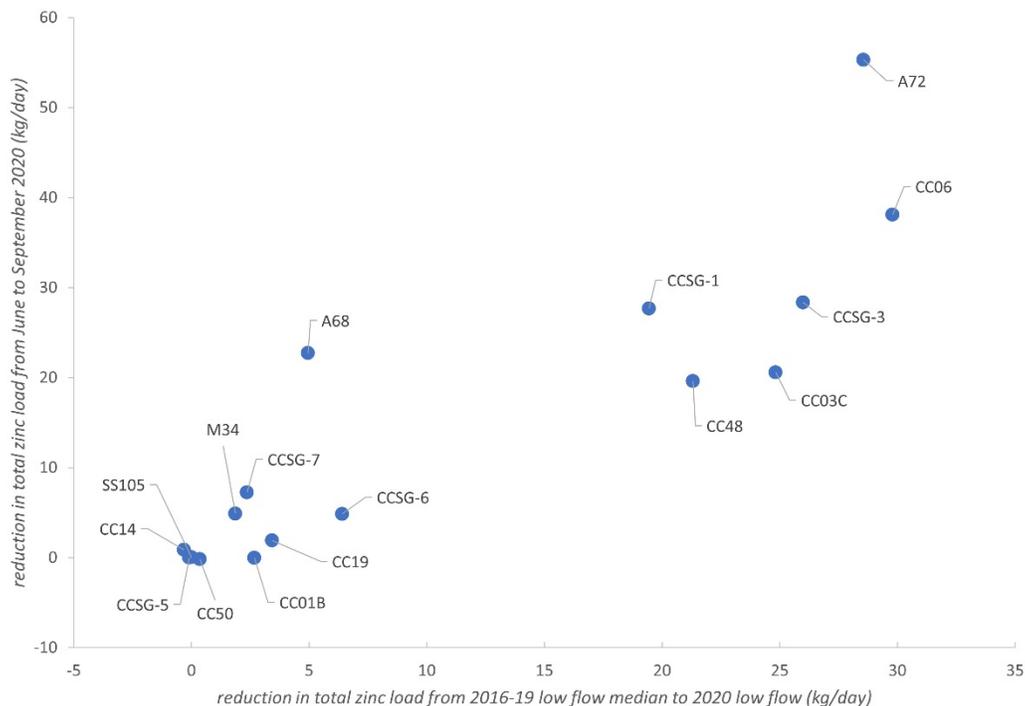
Figure 9: Reduction in total zinc load from 2016-19 low flow median to 2020 low flow; and reduction in total zinc load from June to September 2020.

In an attempt to differentiate load reductions that may be related to the test closure from broader watershed-wide reductions related to drought conditions, we combined two different metrics that assess how 2020 conditions differed from previously documented conditions. We chose to focus this analysis on potential changes in total zinc load since R&B is known to discharge high total zinc loads (Cowie and Roberts 2019; 2020) and due to the strong influence of zinc toxicity on aquatic life downstream of R&B (Roberts 2016). Plotting the numerical reduction (kg/day) of zinc load from July 2020 (just prior to test closure) to September 2020 (at the height of the test closure), and from the 2016-19 low-flow median to the measured 2020 low-flow load further differentiates the response of surface water sites and draining mine sites along a gradient of zinc load reduction (Figure 9). It is clear from both metrics of change that surface water locations in closest downstream proximity to R&B (CCSG-3; CCSG-1) had greater numeric reductions of total zinc load than surface water locations upstream of R&B (CCSG-6; CCSG-7), or those locations not influenced by R&B (A68; M34). Surface water sites CCSG-3, CCSG-1, CC48, and A72, all located downstream of R&B, had greater than about a 20 kg/day reduction in total zinc load in low-flow 2020 regardless of whether you used the comparison to the 2016-19 low-flow median or to the July 2020 load. All other surface water sites had zinc load reductions less than 7 kg/day from 2016-19 low-flow median. The large total zinc load reduction at A72 (28.6 kg/day reduction from 2016-19 low-flow

median) reflects the load reductions of the three major upstream tributaries that contribute flow to A72: A68 (Animas River upstream of Silverton), CC48 (Cement Creek upstream of Silverton), and M34 (Mineral Creek at Silverton) had reductions, respectively, of 5.0, 21.3, and 1.9 kg/day, from the 2016-19 low flow median. We discussed previously that Gold King (CC06) had large reductions in the loads of several metals during 2020 low-flow conditions. Figure 9 illustrates that total zinc load of Gold King in low flow 2020 was 29.8 kg/day lower than the 2016-19 median.

So far, we've compared low-flow zinc loads from 2020 to aggregated median low-flow zinc loads from previous years (e.g., Figure 9). This approach effectively compares samples collected during a similar hydrologic period (low flow to low flow) but does not specifically address the variability in flows that can occur during low flow conditions. Another method to differentiate load reductions that may be related to the test closure from broader watershed-wide hydrologic conditions is to compare loads not as aggregate medians, but rather on a sample by sample basis. This analysis necessitates water quality and flow data collected at a high enough temporal frequency (e.g., monthly) to obtain samples to compare with similar flow levels regardless of calendar date. For each sample collected from surface water sites during the 2020 test closure, we compared zinc loads to samples collected in previous years that met the following criteria: a) samples from previous years must be from the same hydrologic regime (low-flow; Aug-Nov); b) samples from previous years must have been collected when flows were within 10% of the flow level recorded at the time of the 2020 sample (*in the absence of available samples within the 10% threshold, we compared 2020 samples to the sample from previous years with the closest flow numerically*).

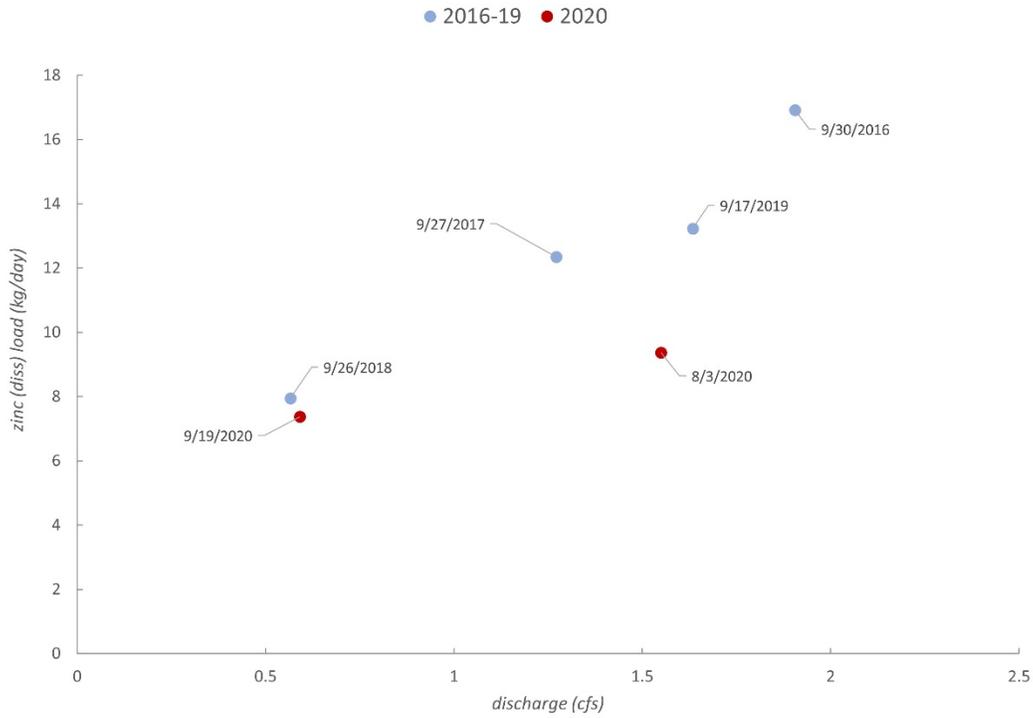
Figure 10: CCSG-6 zinc loads during 2020 bulkhead test compared to 2016-19 zinc loads recorded during similar flows.

Using this refined approach, we found that zinc loads were reduced across all surface water sites in 2020 low-flow compared to samples from previous years, but the magnitude of load reduction differed among surface water sites. Samples from reference sites that are not downstream of R&B (CCSG-6, A68, and M34) had zinc load reductions during the test closure calculated on a sample-by sample basis that ranged from 0.57 kg/day to 19.28 kg/day, with a median of 3.06 kg/day (Figures 10, 14, and 15). Sites downstream of R&B had reductions that ranged from 4.06 kg/day to 37.45 kg/day, with a median of 15.35 kg/day (Figures 11, 12, 13, 16, and 17). By comparing the load reductions of reference surface water sites to load reductions of surface water sites downstream of R&B, it is clear that samples collected downstream of R&B had greater zinc load reductions than would be expected based on the reference sites. Zinc load reductions related to R&B become more difficult to discern with increasing downstream distance from R&B. For example, the zinc load reduction among samples collected during the test closure at A72 (median zinc load reduction of 30.3 kg/day) reflects reductions originating from the Upper Animas (A68, median zinc load reduction of 9.0), Cement Creek (CC48, median zinc load reduction of 14.0), and Mineral Creek (M34, median load reduction of 2.6 kg/day). Further downstream on the Animas River below Cascade Creek (A75B), using data collected by EPA and the Bonita Peak Community Advisory Group, zinc load reductions among samples collected during the test closure range from 4.1 kg/day to 23.2 kg/day, with a median of 12.8 kg/day (Figure 17). It is possible that some of the zinc load reduction this far downstream was related to the R&B test closure but would also be reflective of zinc load reductions that occurred in the Upper Animas, Mineral Creek, and other tributaries un-related to the R&B closure.

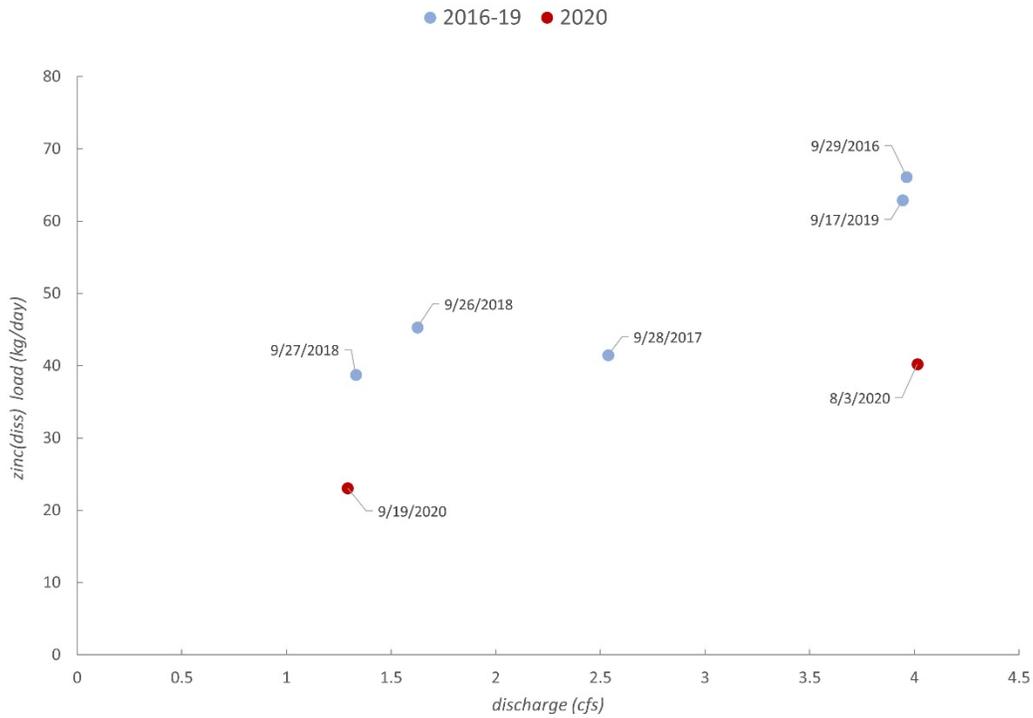
Figure 11: CCSG-3 zinc loads during 2020 bulkhead test compared to 2016-19 zinc loads recorded during similar flows.

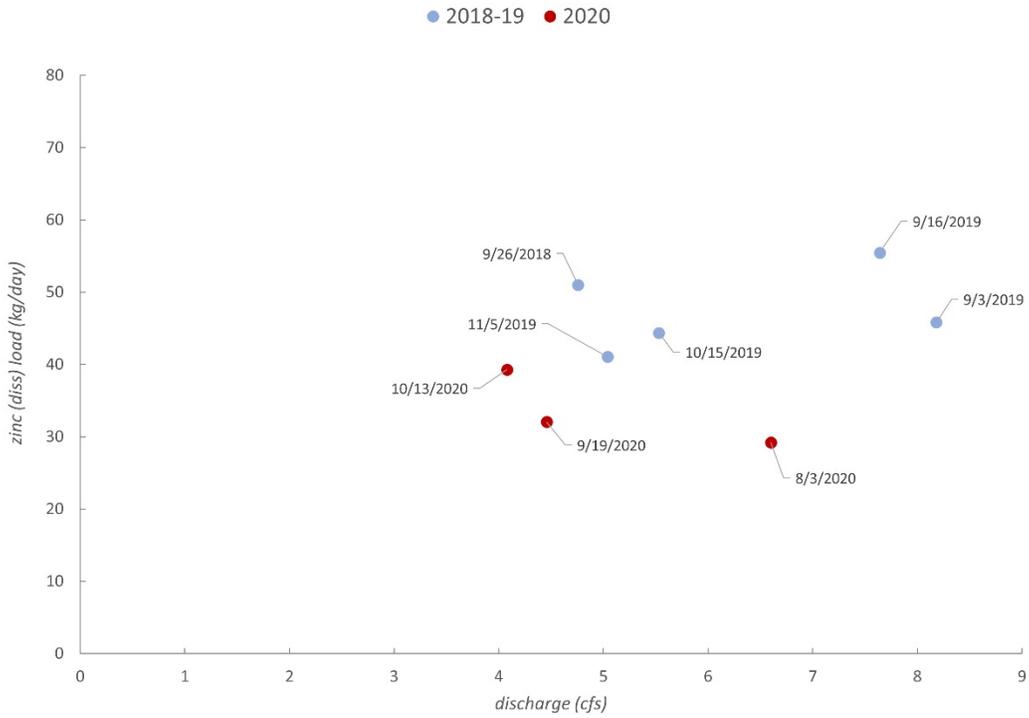
Figure 12: CCSG-1 zinc loads during 2020 bulkhead test compared to 2016-19 zinc loads recorded during similar flows.

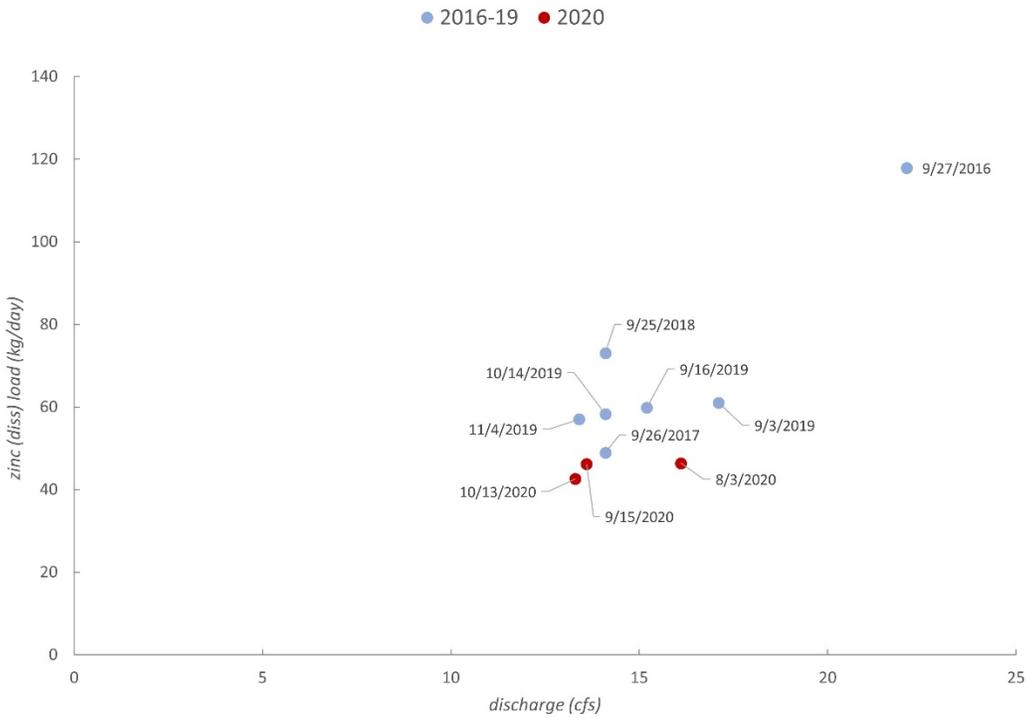
Figure 13: CC48 zinc loads during 2020 bulkhead test compared to 2016-19 zinc loads recorded during similar flows.

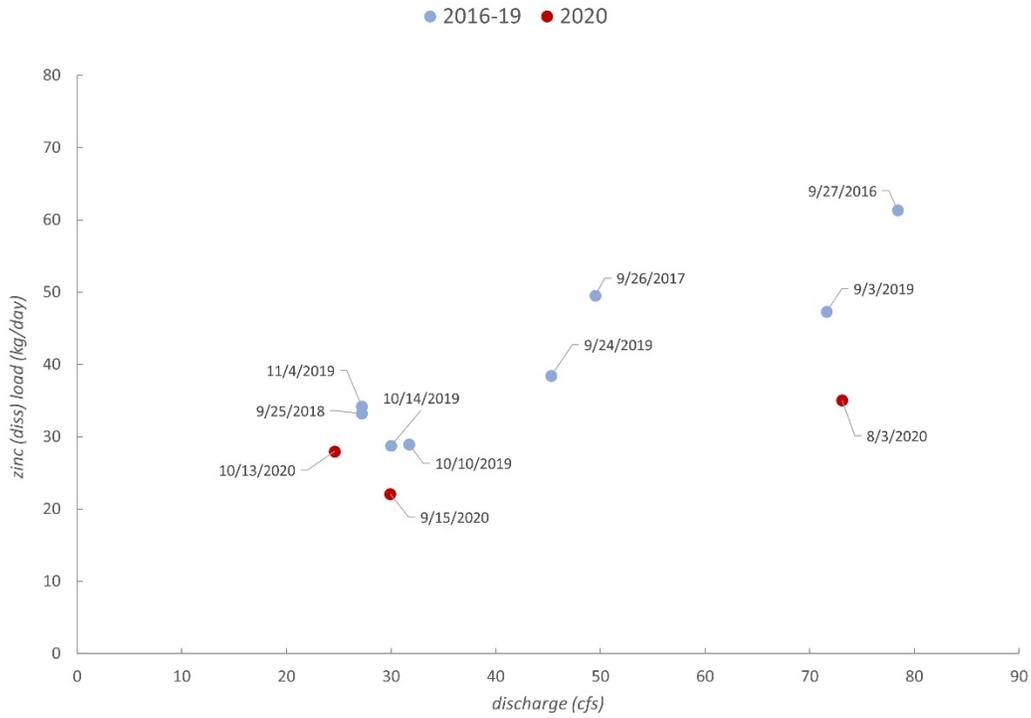
Figure 14: A68 zinc loads during 2020 bulkhead test compared to 2016-19 zinc loads recorded during similar flows.

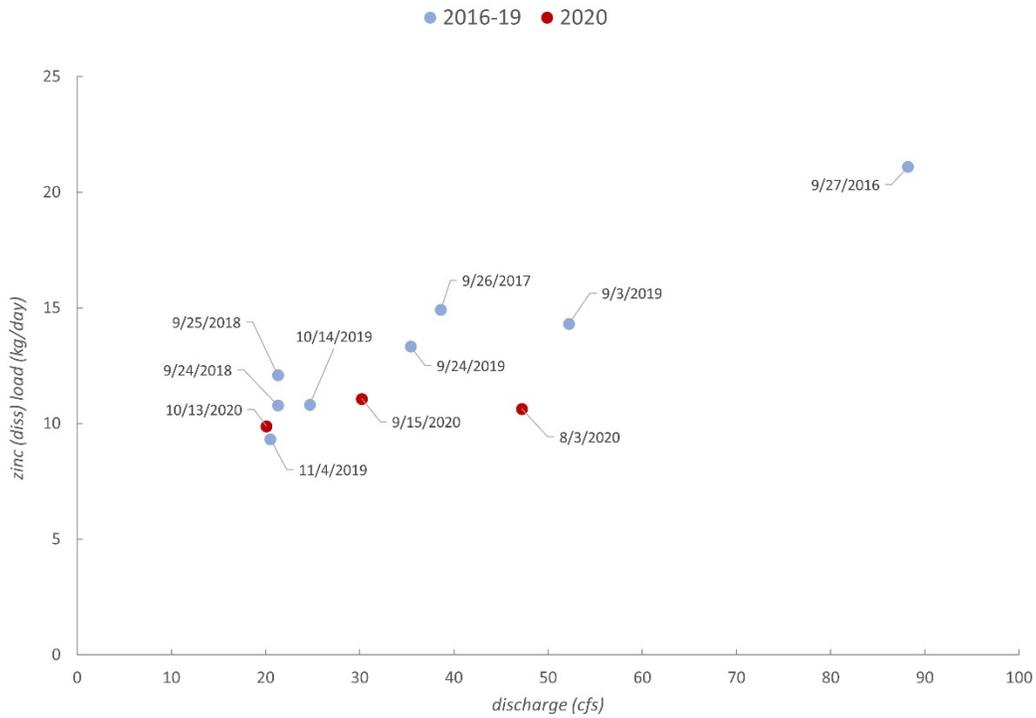
Figure 15: M34 zinc loads during 2020 bulkhead test compared to 2016-19 zinc loads recorded during similar flows.

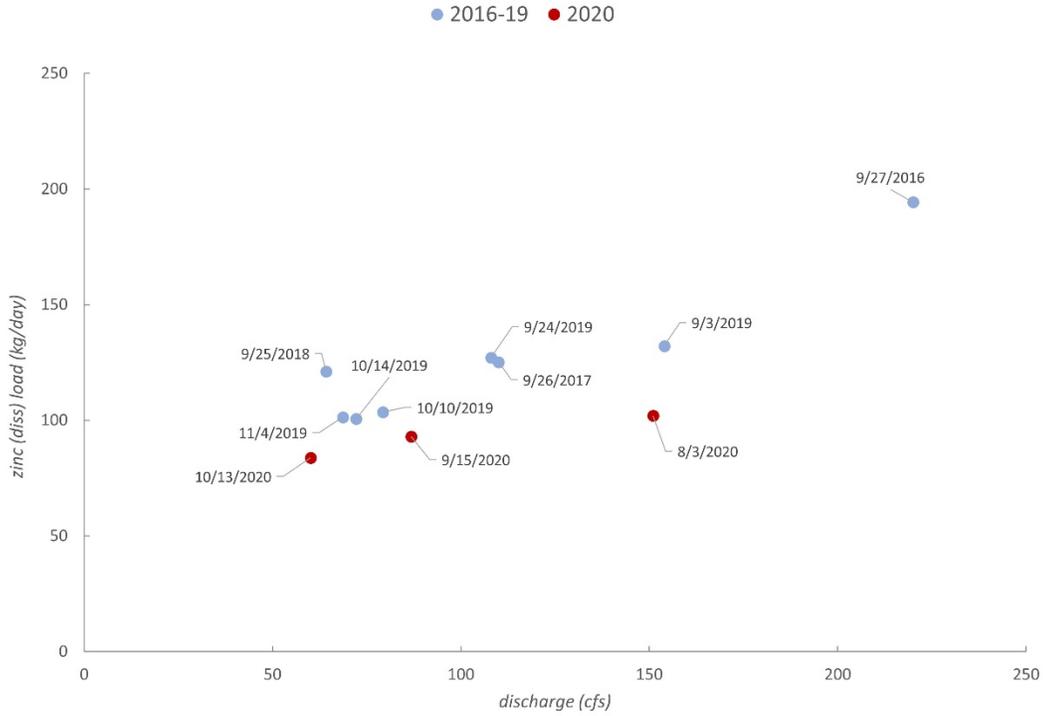
Figure 16: A72 zinc loads during 2020 bulkhead test compared to 2016-19 zinc loads recorded during similar flows.

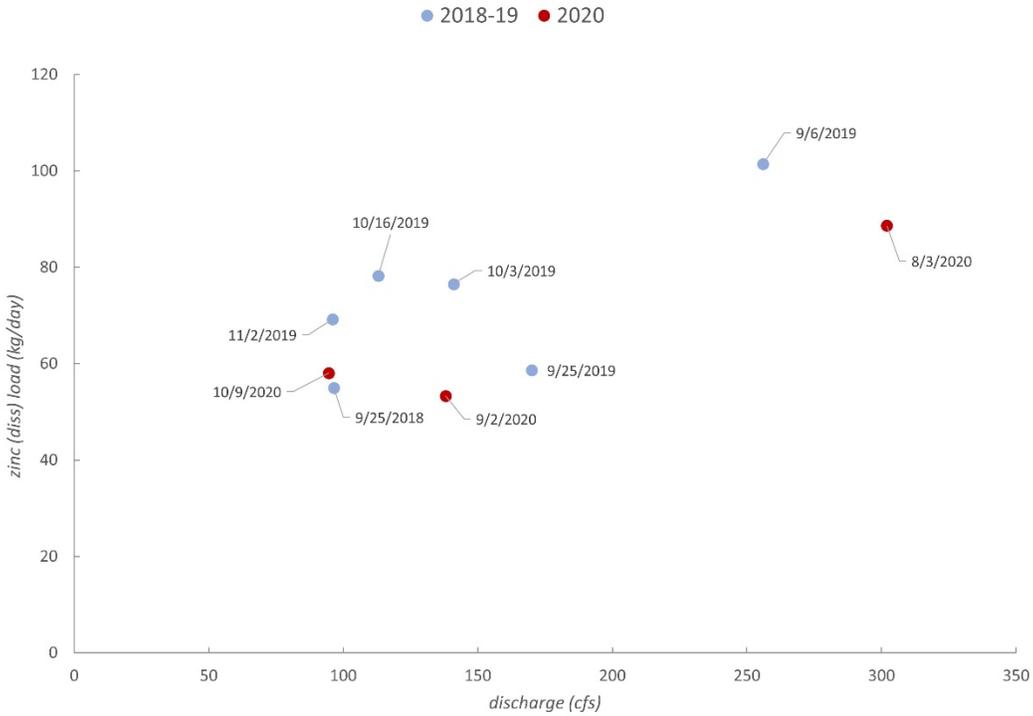
Figure 17: A75B zinc loads during 2020 bulkhead test compared to 2016-19 zinc loads recorded during similar flows.

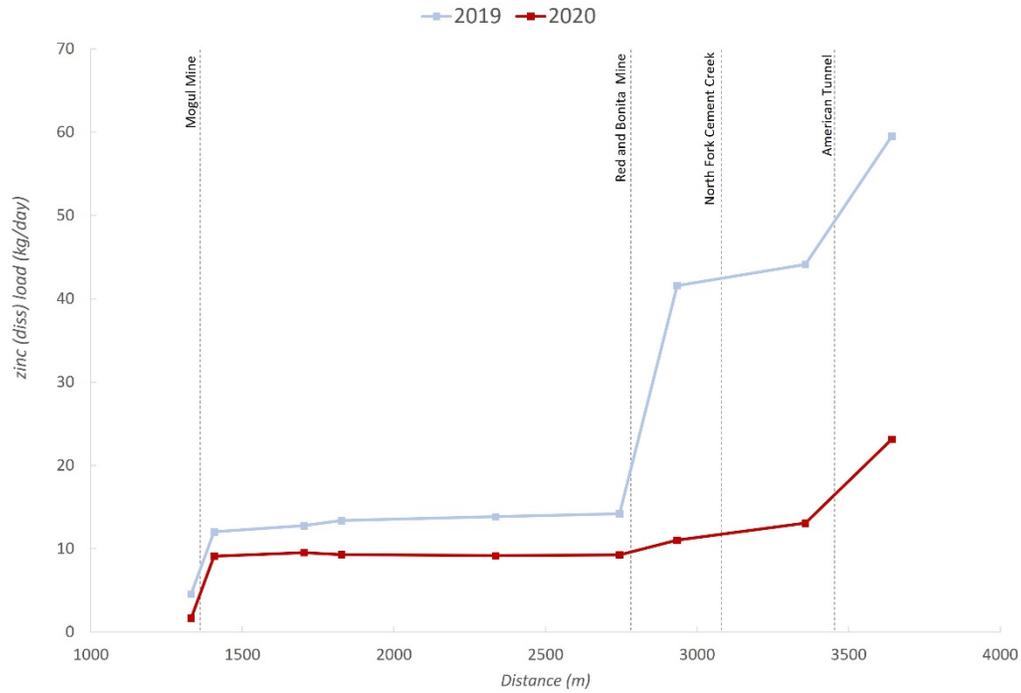
Figure 18: Cement Creek zinc load profile – low flow 2020 compared to 2019.

To further examine possible load reductions along Cement Creek, we used synoptic USGS data to compare zinc loads measured during low-flow conditions in 2019 and 2020 at surface water sampling locations along Cement Creek (Figures 18-19; Runkel in review). This Cement Creek profile reveals a) at the upper sites (UC-1331 and CCSG-7), zinc loads were higher in 2019 than in 2020, possibly due to a higher water table associated with 2019 being a wetter year than 2020 (Runkel, personal communication); b) a divergence in how zinc loads respond downstream of Red and Bonita Mine in 2019 vs. 2020. The

zinc load increased in 2019 from UC-2744 (upstream of R&B) to UC-2934 (downstream of R&B) by 27.3 kg/day, but only increased by 1.8 kg/day in this same segment in 2020. Differences in zinc load between 2019 and 2020 in other Cement Creek segments were much more muted, suggesting that the large downstream increase in zinc load below the segment of Cement Creek that brackets Red and Bonita Mine is likely attributable to the test closure. USGS synoptic data from 2019 and 2020 allowed for an examination of zinc loads at a high spatial resolution along Cement Creek. Previous synoptic sampling events have occurred along Cement Creek in the past decade, but at a lower spatial resolution than the USGS dataset. We compared zinc loads during synoptic sampling events across hydrologic periods from 2010 to 2020 from three locations: CCSG-6, CCSG-3, and CC48 (Figures 20 and 21). All synoptic sampling events recorded a varied, but notably sharp increase in zinc load from CCSG-6 (upstream of R&B) to CCSG-3 (downstream of R&B) whereas the zinc load increase recorded in this segment during the test closure in September 2020 was much reduced; an increase of 15.7 kg/day compared to the 2010-2019 median of 56.1 kg/day. When examining the most recent synoptic sampling events, the zinc load increases from CCSG-6 to CCSG-3 in August 2020 (30.9 kg/day; beginning of test closure), November 2020 (51.2 kg/day) after the test closure was complete), and September 2019 (46.8 kg/day; 1 year prior to the test closure) were all substantially higher than the zinc load increase observed during the test closure in September 2020 (15.7 kg/day). Of note, is that the highest increase in zinc load from CCSG-6 to CCSG-3, 122.6 kg/day, was recorded in September 2015 following the Gold King Mine release and prior to the implementation of the Gladstone treatment plant.

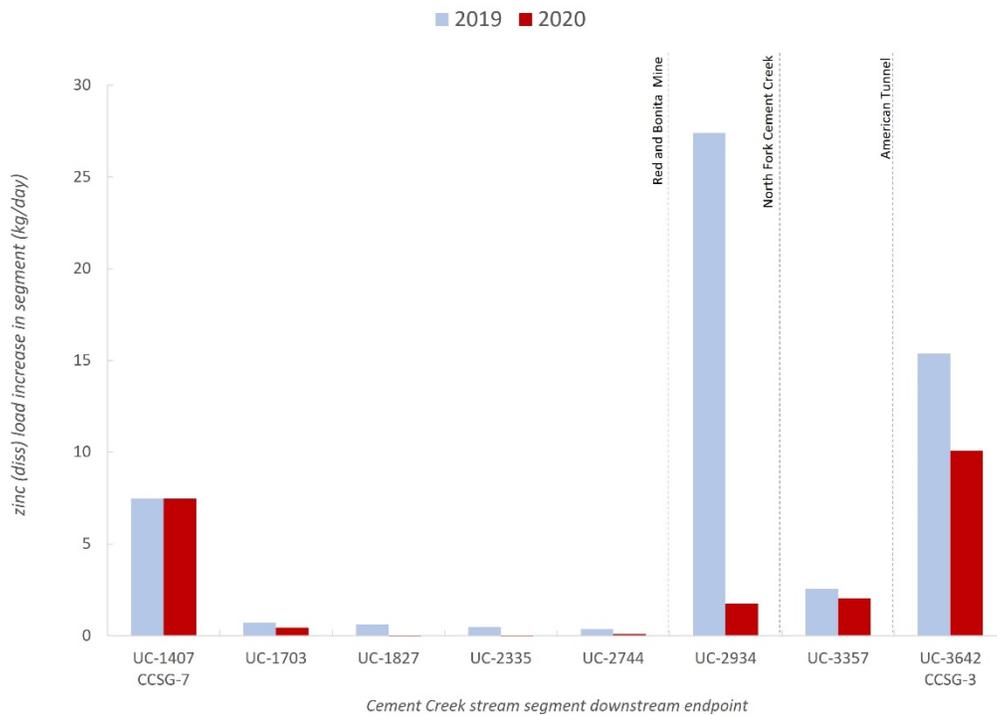
Figure 19: Cement Creek zinc load by segment during low flow 2019 and 2020.

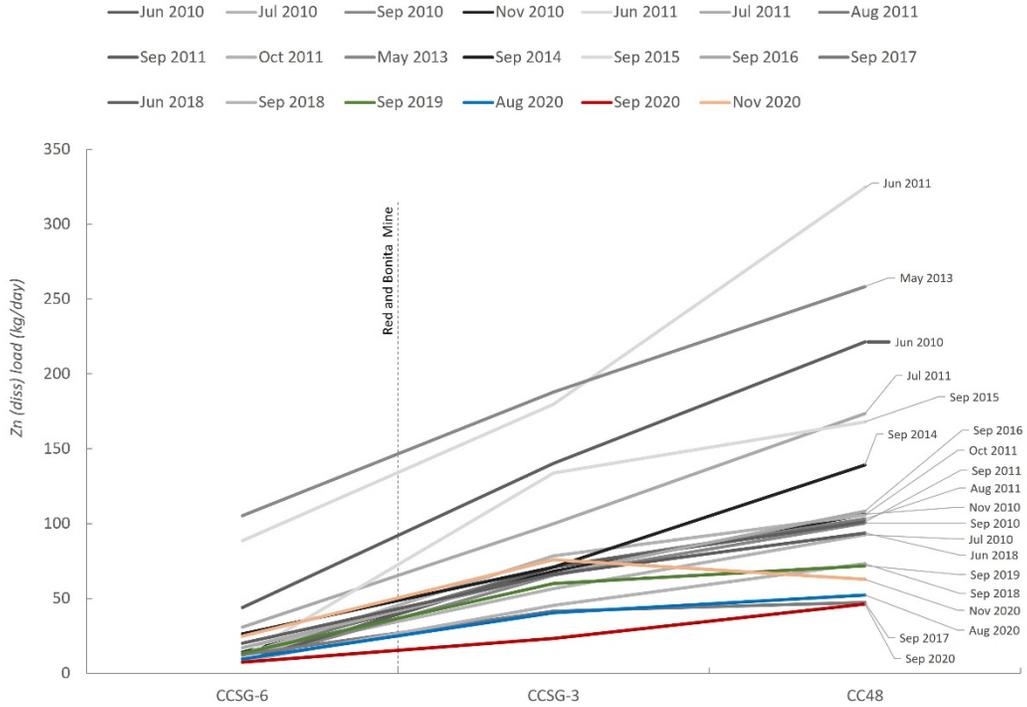
Figure 20: Cement Creek zinc load profile across synoptic sampling events from 2010 to 2020.

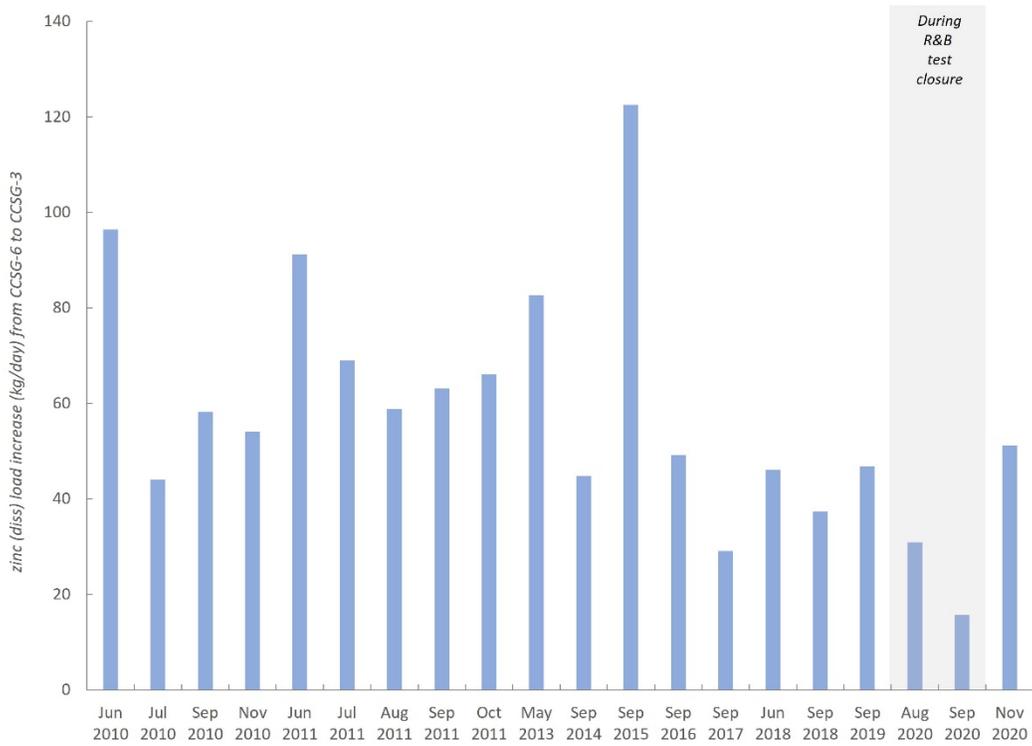
Figure 21: Cement Creek zinc load increase from CCSG-6 (upstream of R&B) to CCSG-3 (downstream of R&B) across synoptic sampling events from 2019 to 2020.

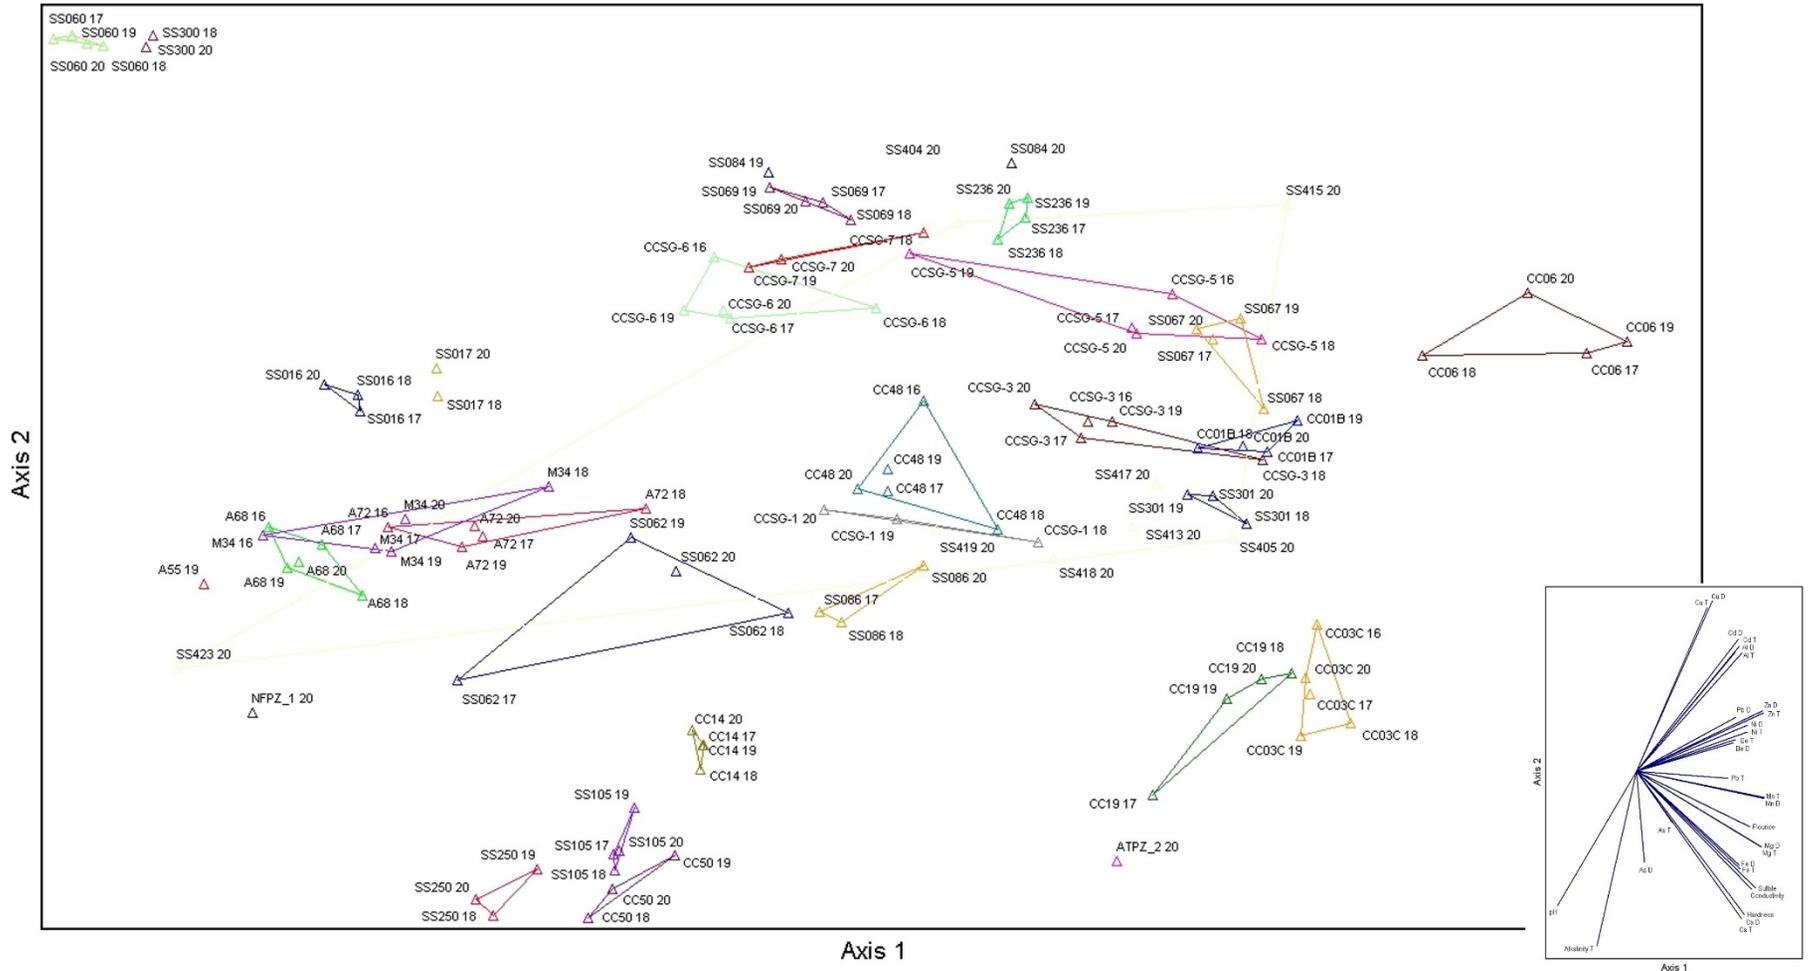
Figure 22: Principal Component Analysis (PCA) plot reflecting analytical results of samples collected during low flow 2016-2020.

In order to assess how 2020 low-flow water quality conditions compared to previous years across multiple analytes, we employed PCA. PCA reflects water quality results for samples where low-flow water quality data was collected during 2016-2020 and includes analytes that were consistently collected across samples and were not highly skewed (<3) after log transformation (Figures 22-23). Axis 1 accounted for 75% of the plotted variation in water quality among samples and has a strong negative correlation with numerous parameters including total manganese, dissolved manganese, total zinc, dissolved zinc, total magnesium, dissolved magnesium, total sulfate, conductivity, total fluoride, total nickel, and dissolved nickel ($r^2 > 0.6$). Axis 2 accounted for an additional 12% of the plotted variation in water quality and is positively correlated with total and dissolved copper and negatively correlated with total alkalinity ($r^2 > 0.4$) (Table 5). PCA resulted in a distinct separation in ordination space among most locations. Among draining mines, Gold King occurs on the upper right-hand side of the PCA plot, distinct from other locations, perhaps indicating a unique water quality signal that PCA loading vectors suggest could be related to elevated copper concentrations. R&B, American Tunnel, and ATPZ occur on the lower right-hand side of the PCA plot. Mogul occurs in the center-right in close proximity to CCSG-3, SS067, CCSG-5, and SS301, indicating a similarity in water quality among those sites. Cement Creek surface water locations were distributed generally in the middle of the plot while stream gauge sites on the Animas and Mineral Creek occur on the left-hand side of the plot. The variability in water quality in seeps and springs sites is evident as those sites are distributed throughout the PCA plot. In addition to illuminating differences in water quality among locations, PCA also depicts differences in water quality among years for the same location. This allows us to further assess whether low-flow water quality in 2020 differed from previous years. Another utility of PCA is to assess whether 2020 low-flow water quality conditions moved toward (i.e., became more similar to) or away from (i.e., became less similar to) typical R&B water quality. We calculated the two-dimensional distance in ordination space from 2020 low-flow samples to the R&B centroid (Tables 6-7). The vast majority of sites had samples in the 2016-19 period that were closer in ordination space to the R&B centroid than 2020 samples were. Of locations with at least two pre-2020 samples, only SS086 was closer in two-dimensional ordination space to the

R&B centroid in 2020 compared to previous years. Interestingly, SS086 had greater concentrations of Al, Mn, Pb, Zn, and SO_4^{2-} in both high-flow and low-flow conditions of 2020 compared to previous years, indicating that water quality conditions in 2020 were already different from previous years even before the bulkhead test closure began. SS084 also moved closer to the R&B centroid in 2020, reflecting an increase in the concentration of several metals in both high-flow and low-flow conditions, but interpretation is limited by only having one pre-2020 sample with complete analytical records for comparison. As evidenced by PCA plots and distances from the R&B centroid, metal concentrations at many sites, including all surface water sites, were highest in the 2018 drought year; 2018 samples trend toward the right-hand side of the PCA plot, the same direction that vectors indicate increasing concentrations of several metals. For several surface water sites, the distance from 2020 samples to the R&B centroid was greater than the average distance of 2016-19 samples to the R&B centroid. This pattern is most evident at CCSG-1, CCSG-3, and CC48, indicating that during the test closure, low-flow water quality at these sites was less similar to R&B water quality than previous years.
