Red and Bonita Mine Bulkhead Test Closure Analytical Report

June 2021

Prepared For:
U.S. Environmental Protection Agency
Region 8
1595 Wynkoop Street
Denver, CO 80202

Prepared By:
Mountain Studies Institute
116 E. 12th St
P.O. Box 426
Silverton, CO 81433

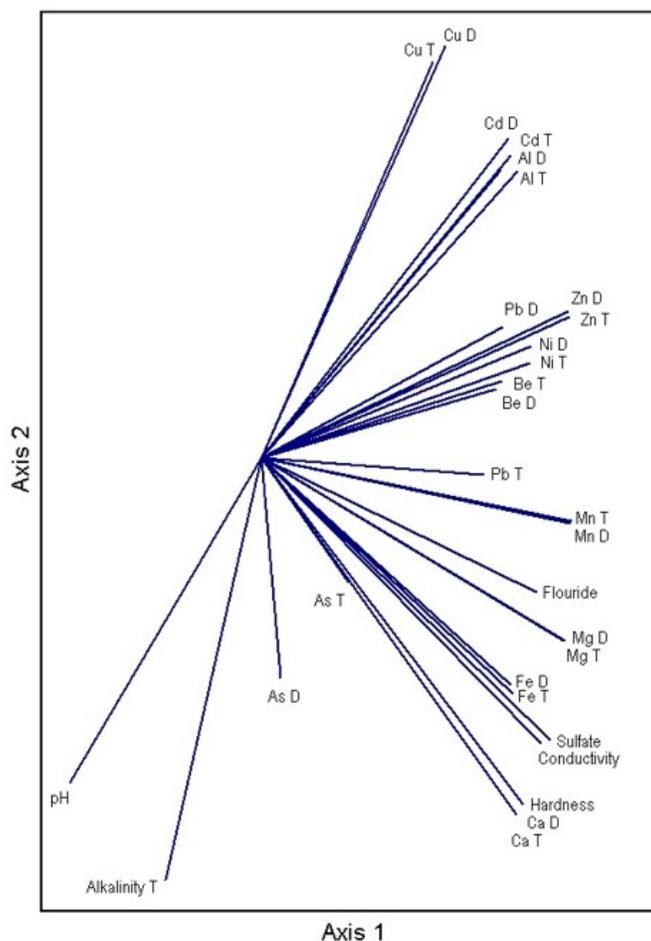
Figure 23: Principal Component Analysis (PCA) loading vectors indicating the strength and direction of how strongly each water quality parameter influenced the plotted variability among samples depicted in PCA plots.

In order to assess how 2020 low-flow water quality conditions compared to previous years across multiple analytes, we employed PCA. PCA reflects water quality results for samples where low-flow water quality data was collected during 2016-2020 and includes analytes that were consistently collected across samples and were not highly skewed (<3) after log transformation (Figures 22-23). Axis 1 accounted for 75% of the plotted variation in water quality among samples and has a strong negative correlation with numerous parameters including total manganese, dissolved manganese, total zinc, dissolved zinc, total magnesium, dissolved magnesium, total sulfate, conductivity, total fluoride, total nickel, and dissolved nickel ($r^2 > 0.6$). Axis 2 accounted for an additional 12% of the plotted variation in water quality and is positively correlated with total and dissolved copper and negatively correlated with total alkalinity ($r^2 > 0.4$) (Table 5). PCA resulted in a distinct separation in ordination space among most locations. Among draining mines, Gold King occurs on the upper right-hand side of the PCA plot, distinct from other locations, perhaps indicating a unique water quality signal that PCA loading vectors suggest could be related to elevated copper concentrations. R&B, American Tunnel, and ATPZ occur on the lower right-hand side of the PCA plot. Mogul occurs in the center-right in close proximity to CCSG-3, SS067, CCSG-5, and SS301, indicating a similarity in water quality among those sites. Cement Creek surface water locations were distributed generally in the middle of the plot while stream gauge sites on the Animas and Mineral Creek occur on the left-hand side of the plot. The variability in water quality in seeps and springs sites is evident as those sites are distributed throughout the PCA plot. In addition to illuminating differences in water quality among locations, PCA also depicts differences in water quality among years for the same location. This allows us to further assess whether low-flow water quality in 2020 differed from previous years. Another utility of PCA is to assess whether 2020 low-flow water quality conditions moved toward (i.e., became more similar to) or away from (i.e., became less similar to) typical R&B water quality. We calculated the two-dimensional distance in ordination space from 2020 low-flow samples to the R&B centroid (Tables 6-7). The vast majority of sites had samples in the 2016-19 period that were closer in ordination space to the R&B centroid than 2020 samples were. Of locations with at least two pre-2020 samples, only SS086 was closer in two-dimensional ordination space to the

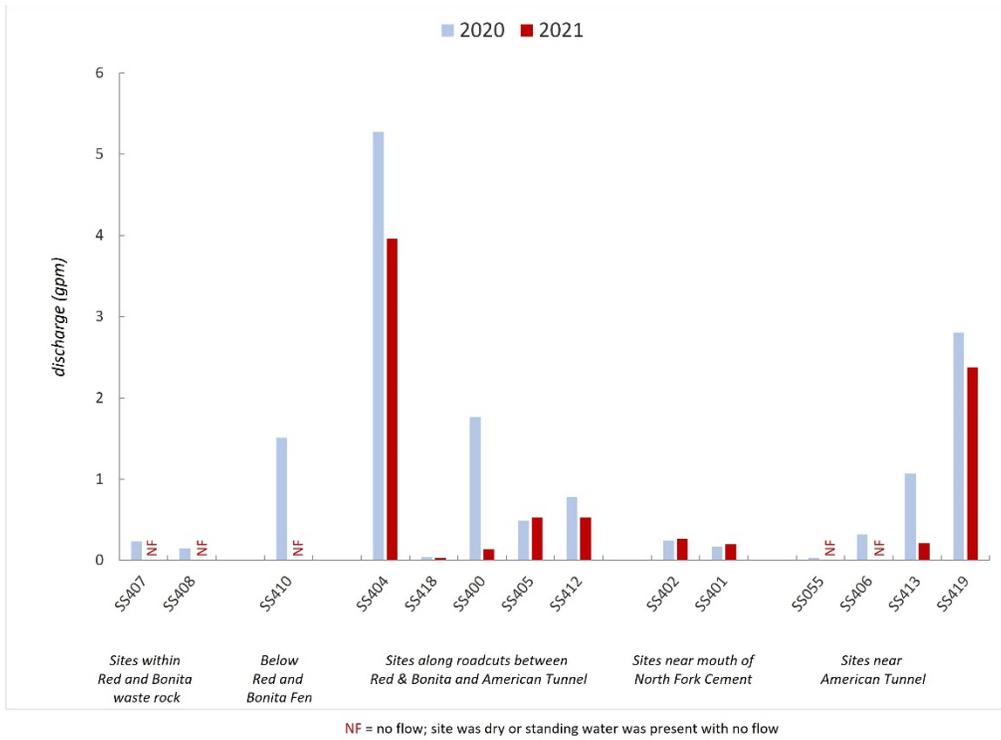
Figure 24: Discharge of new surface water expressions in 2020 and 2021.

The 2021 condition of new surface water expressions documented during the R&B test closure can be categorized as a) site was dry or standing water was present but not enough to measure flow; b) reduced flow from 2020 to 2021; or c) slight increase in flow from 2020 to 2021 (Figure 24; Map 5). Several surface water expressions documented as new during the test closure were located in the R&B fen and were found to be indiscernible from R&B drainage in 2021 (i.e., water draining the R&B flows across the fen and thus it is not possible to differentiate R&B drainage water from any water that may be associated with surface water expressions documented during the test closure when R&B drainage water was not flowing across the fen). There appears to be a spatial pattern in the 2021 condition of new surface water expressions compared to 2020 observations. Sites that were flowing in 2020 during the test closure that were located within the R&B waste rock and/or below the Red and Bonita Fen were found to be dry in 2021. Of the five new surface water expressions documented during the test closure along roadcuts

between R&B and AT, four of the sites had reductions in flow from 2020 to 2021 and one site had a slight increase in flow from 2020 to 2021. Both new surface water expression sites near the mouth of the North Fork of Cement Creek had slight increases (<0.005 gpm) in flow from 2020 to 2021. New surface water expressions near the American Tunnel were either dry in 2021 or had reduced flow from 2020 to 2021. Most new surface water expression sites did not have substantial changes in pH from 2020 to 2021 (Figure 25). Exceptions include SS401 which had a pH of 4.39 during low flow of 2020 and 3.48 during low flow of 2021, and SS419 which had a pH of 4.42 during low flow of 2020 and 3.57 during low flow of 2021. When evaluating these data, one could hypothesize that the greatest change in the condition of surface water expressions between the test closure period and the non-test closure period would occur at sites that were found to have water quality most similar to R&B drainage according to PCA and K-means cluster analysis (SS405, SS413, SS415, SS417, SS418). SS415 and SS417 are located within the R&B fen and were obscured in 2021 by R&B drainage. SS405 and SS418 are located along roadcuts between R&B and AT and changed very little from 2020 low flow to 2021 low flow. SS413 is located near the AT and did have reduced flow from 2020 to 2021. Our ability to draw assured conclusions as to whether new surface water expressions changed from 2020 to 2021 is limited by only one site visit in 2021 and the compounding influence of different meteorological and hydrological conditions between 2020 and 2021 (see Figure 1).

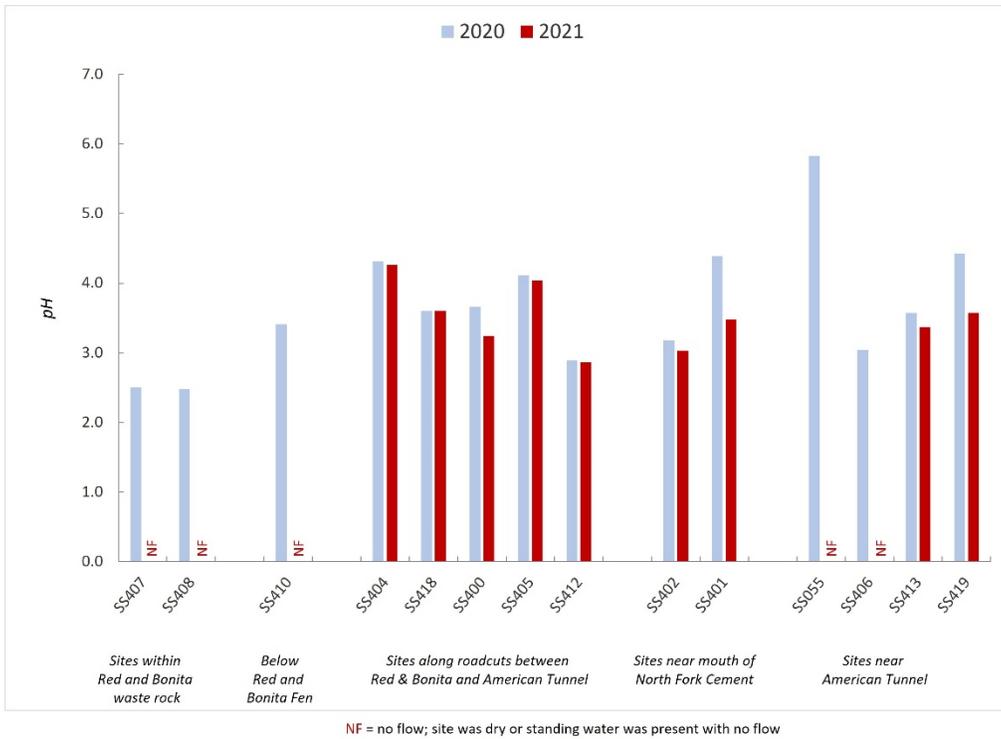
Figure 25: pH of new surface water expressions in 2020 and 2021.

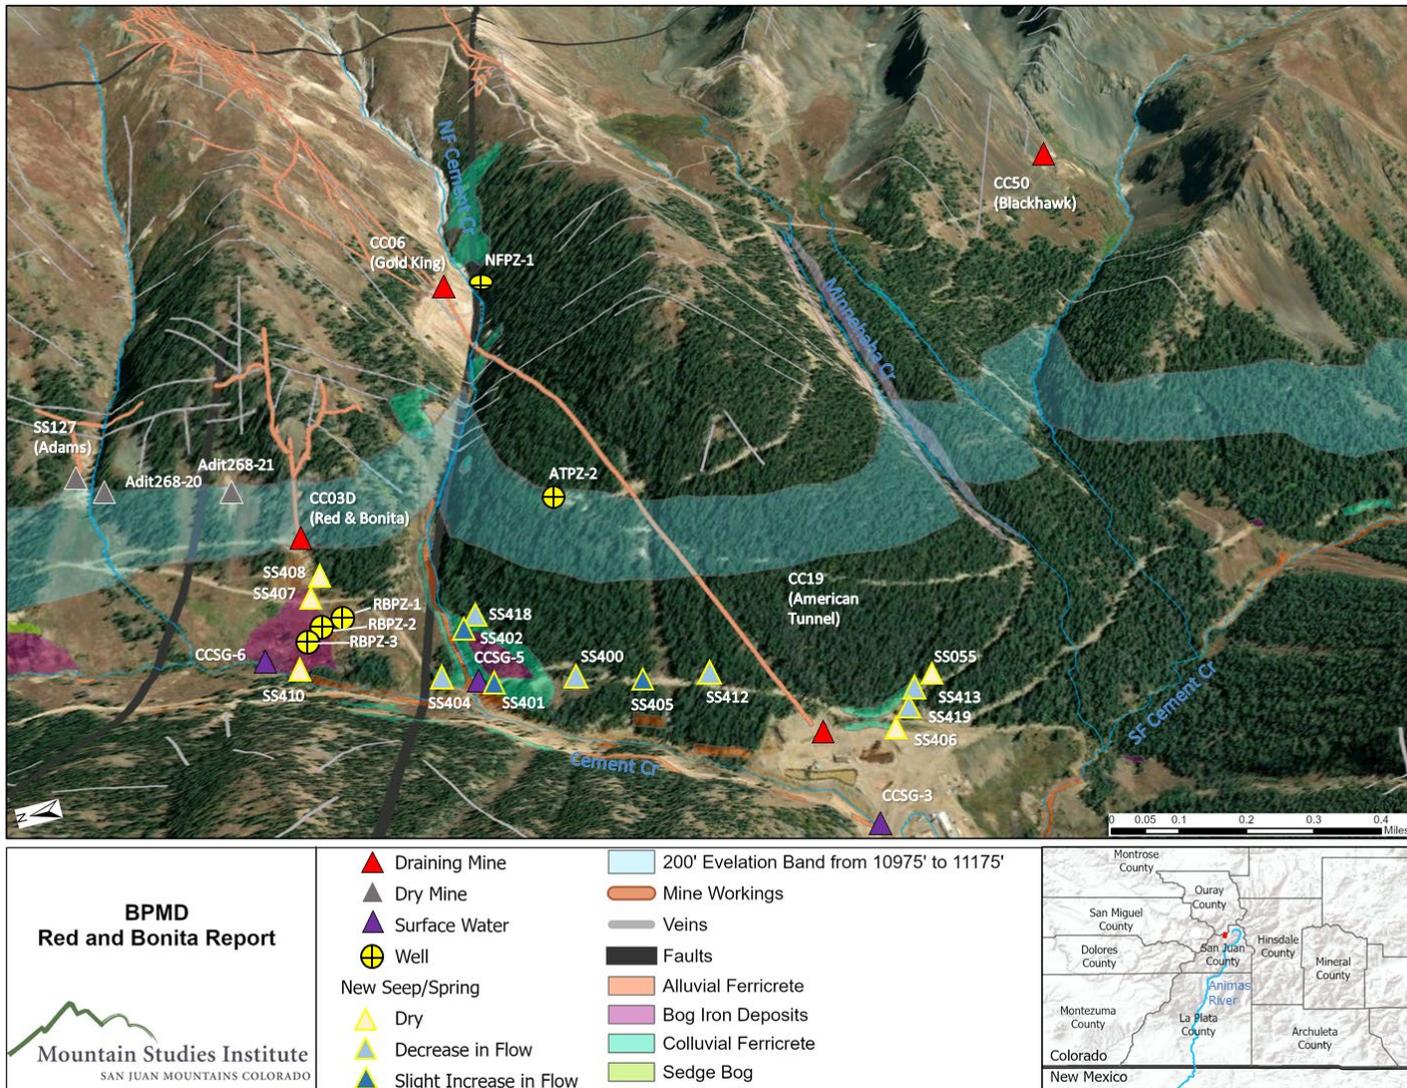
Map 5: Fall 2021 hydrologic condition of new surface water emergences compared to Fall 2020 during test closure
 Elevation band extends 200' above R&B portal elevation; source of ferricrete deposit spatial data: Yager et al. 2007.

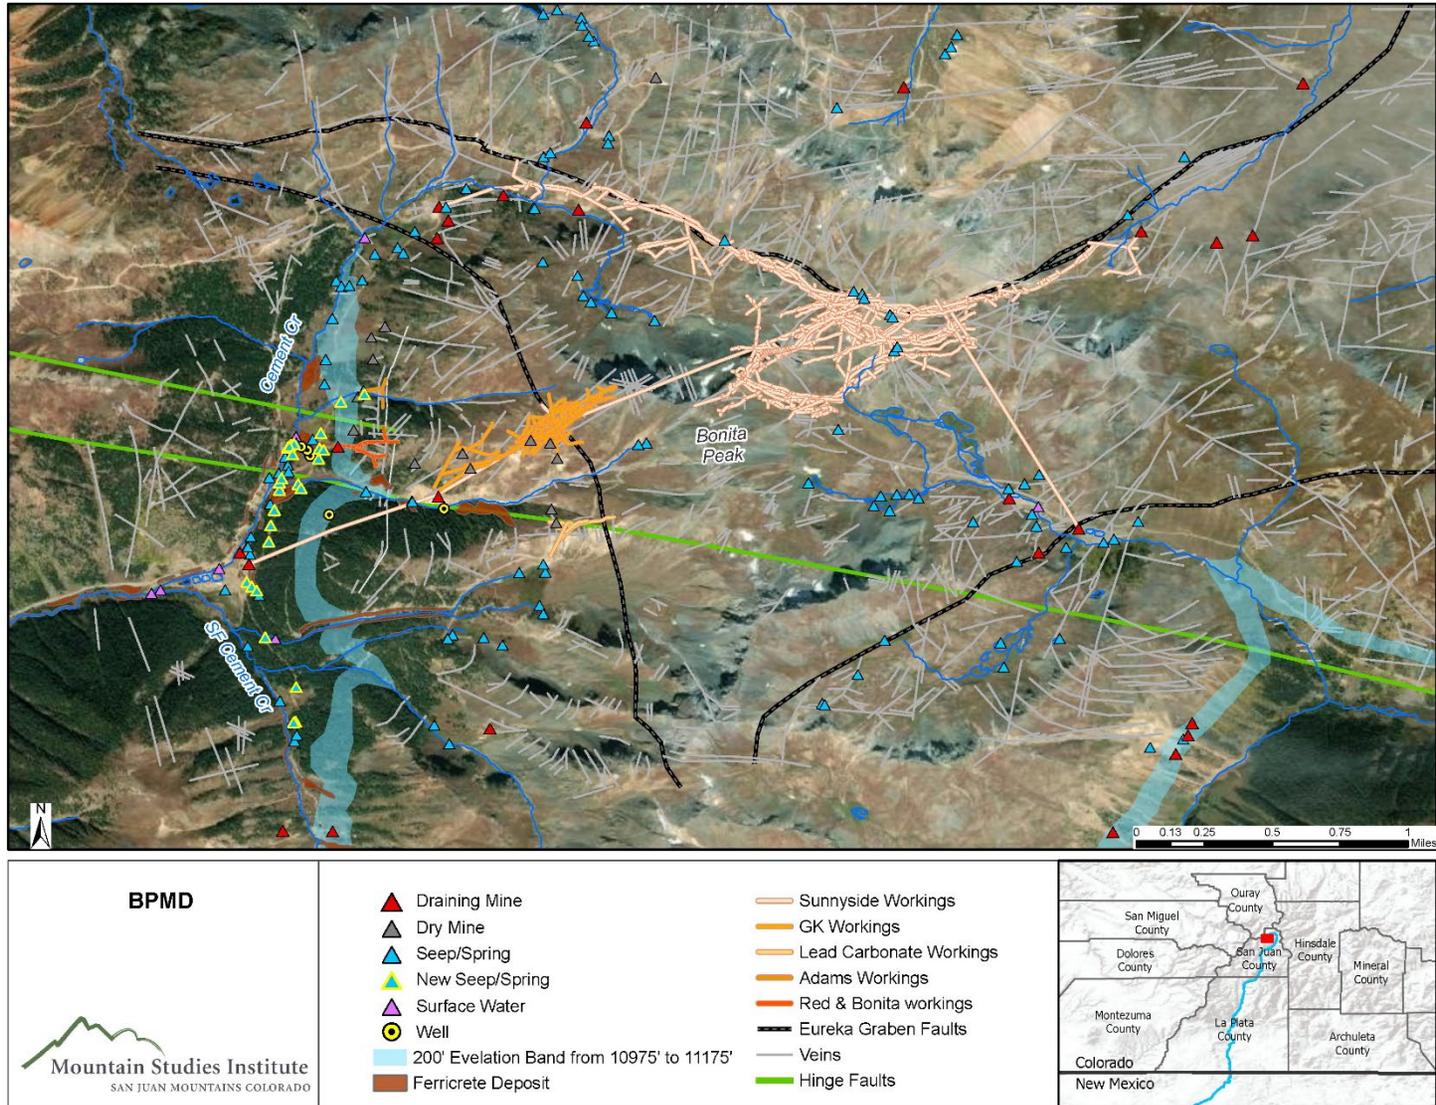
Map 6: Bonita Peak complex with monitoring locations, mine workings, faults, and veins.

- Draining mines and seeps along the South Fork of the Animas that could be connected to Bonita Peak groundwater via faults and fractures extending from the Hinge Fault (Map 6).

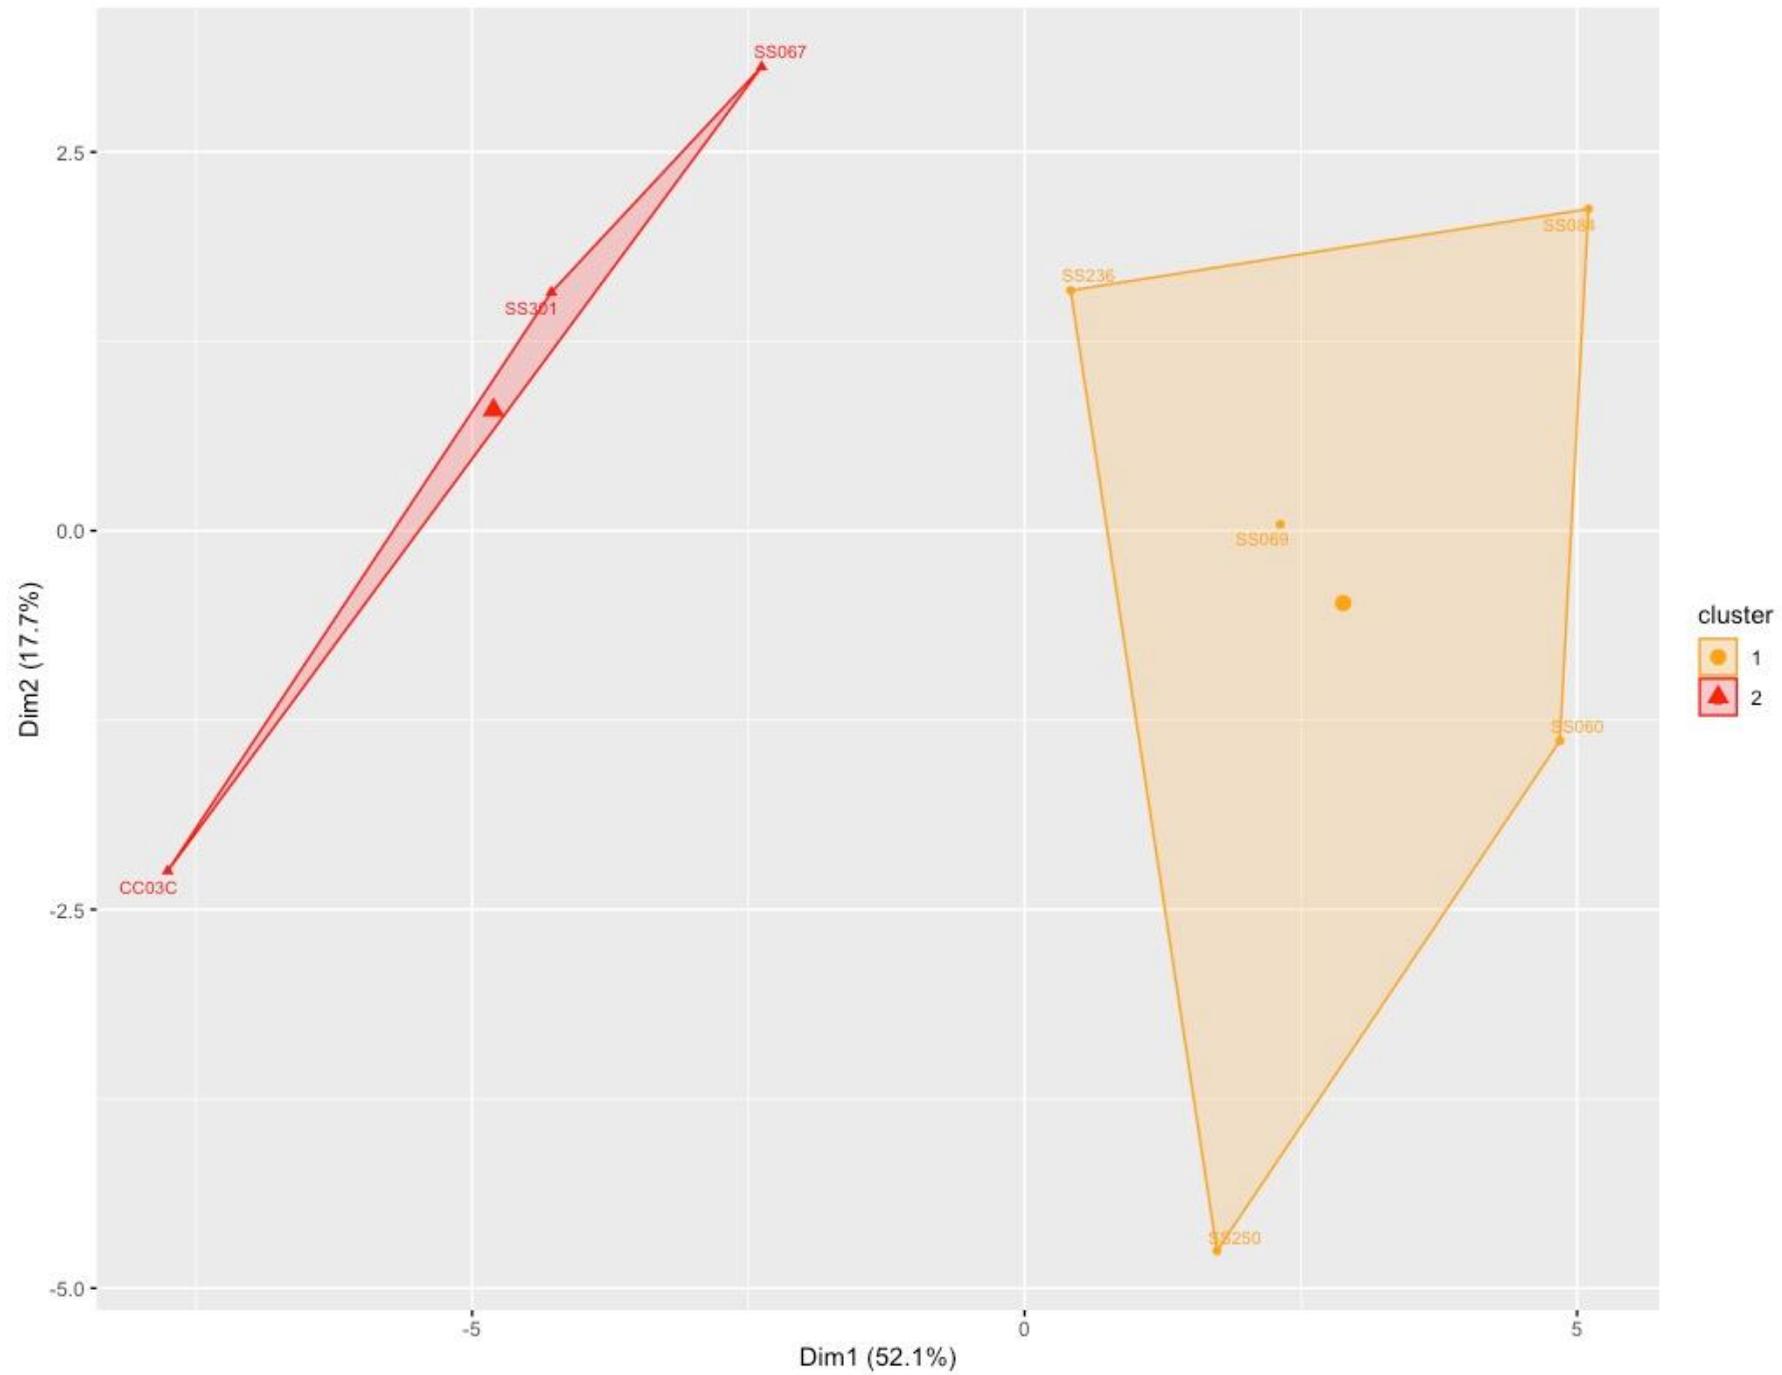
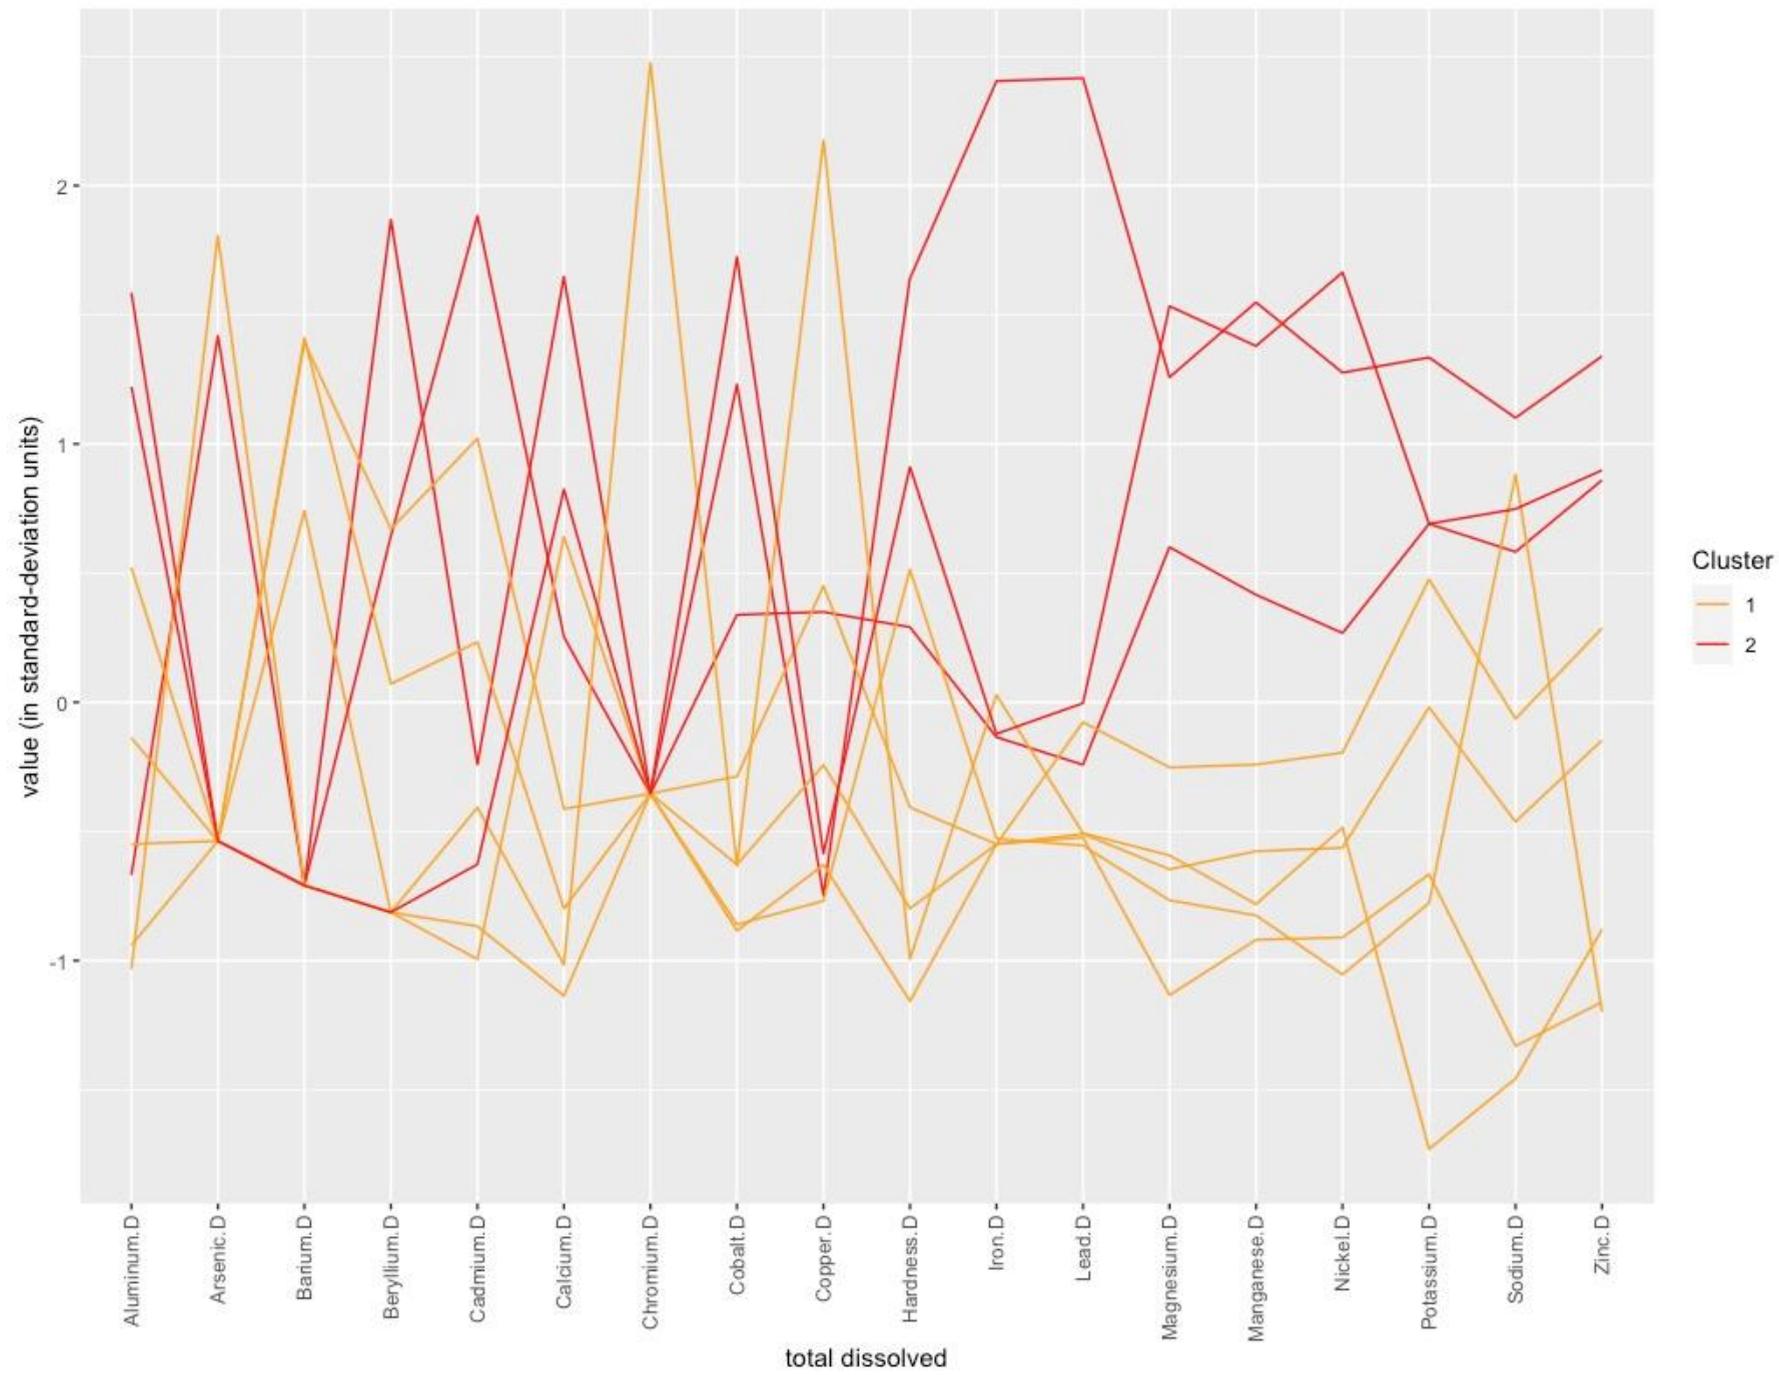
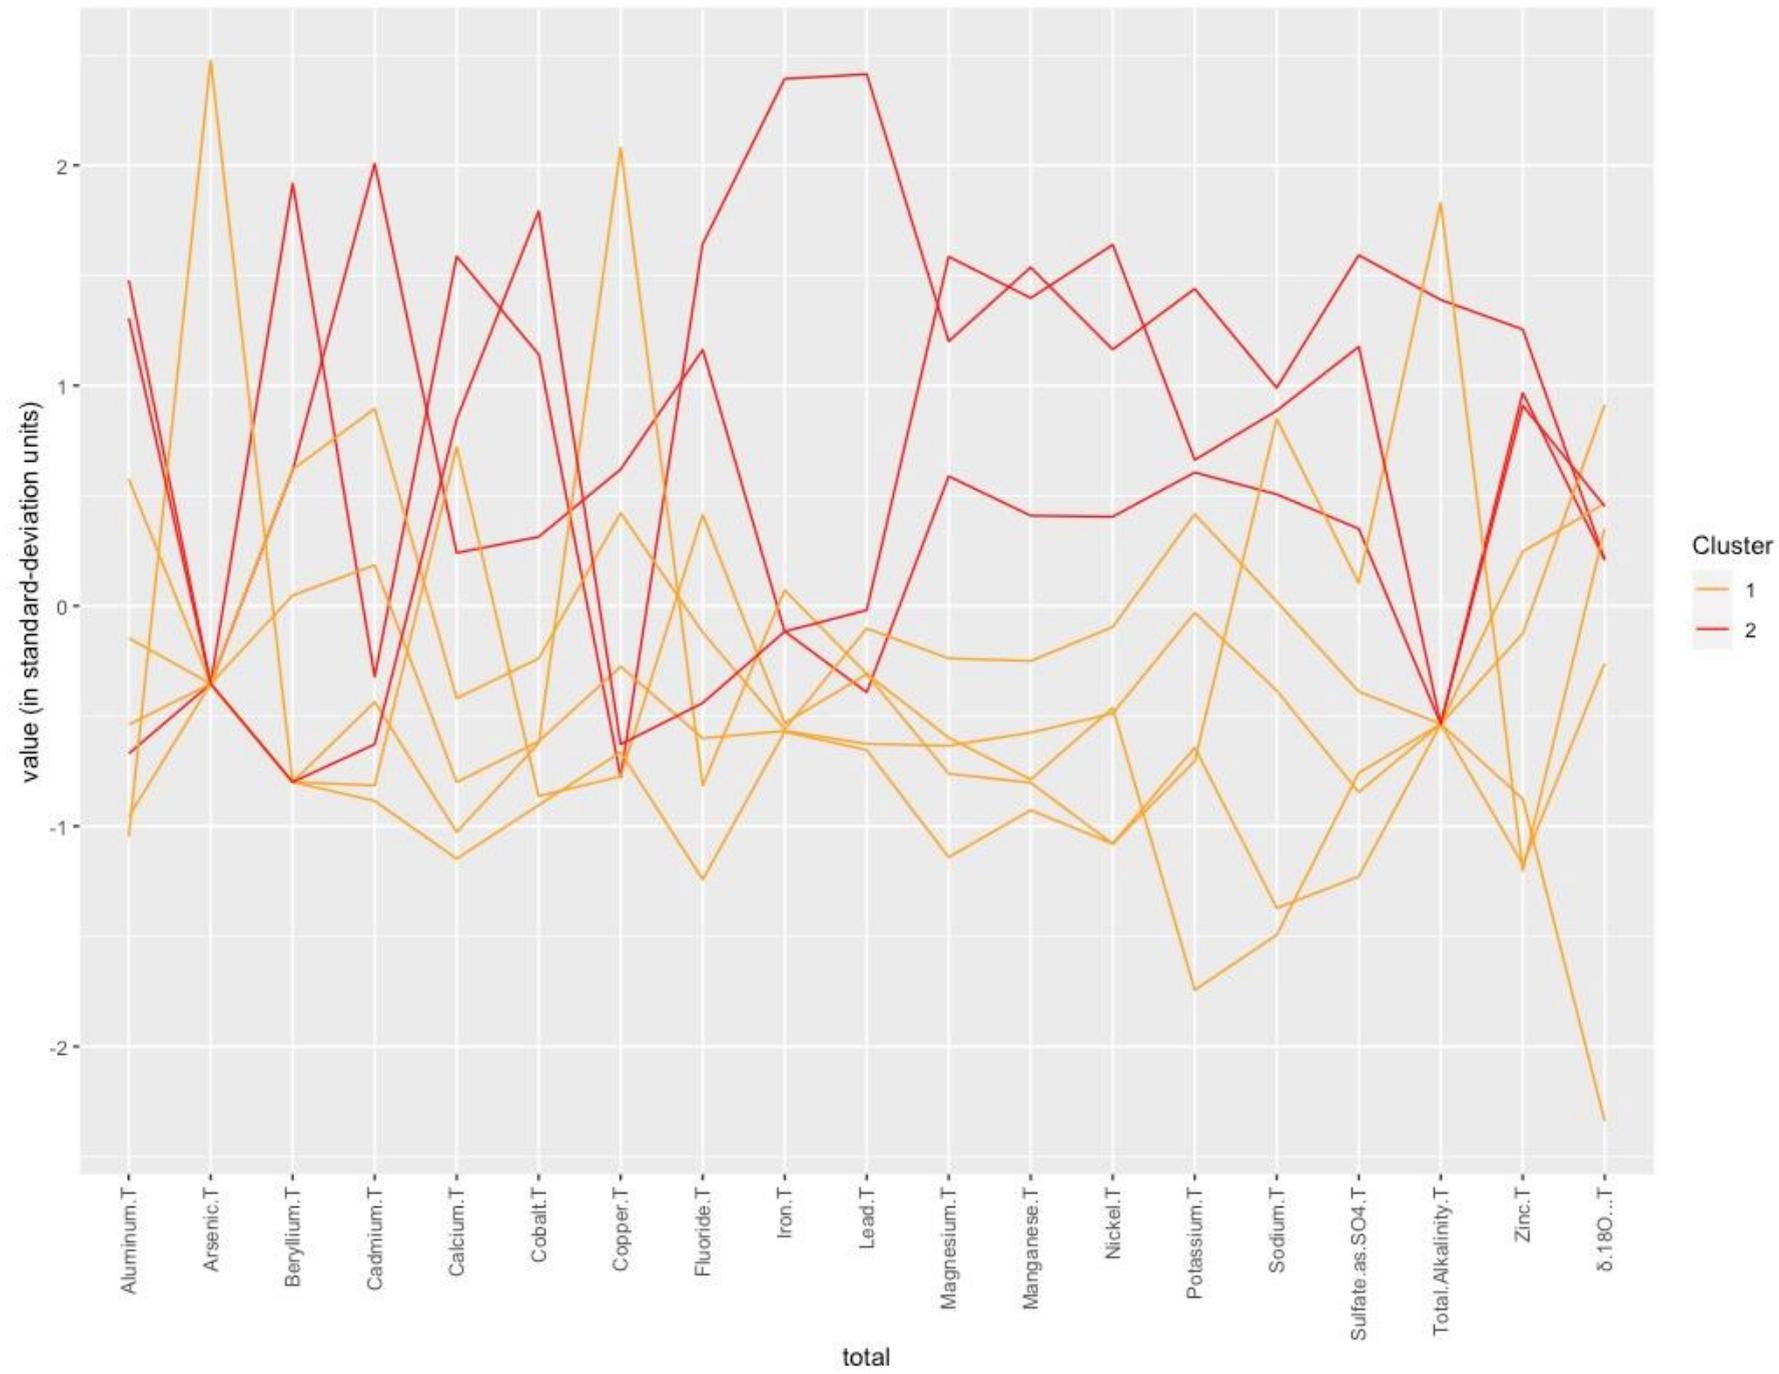
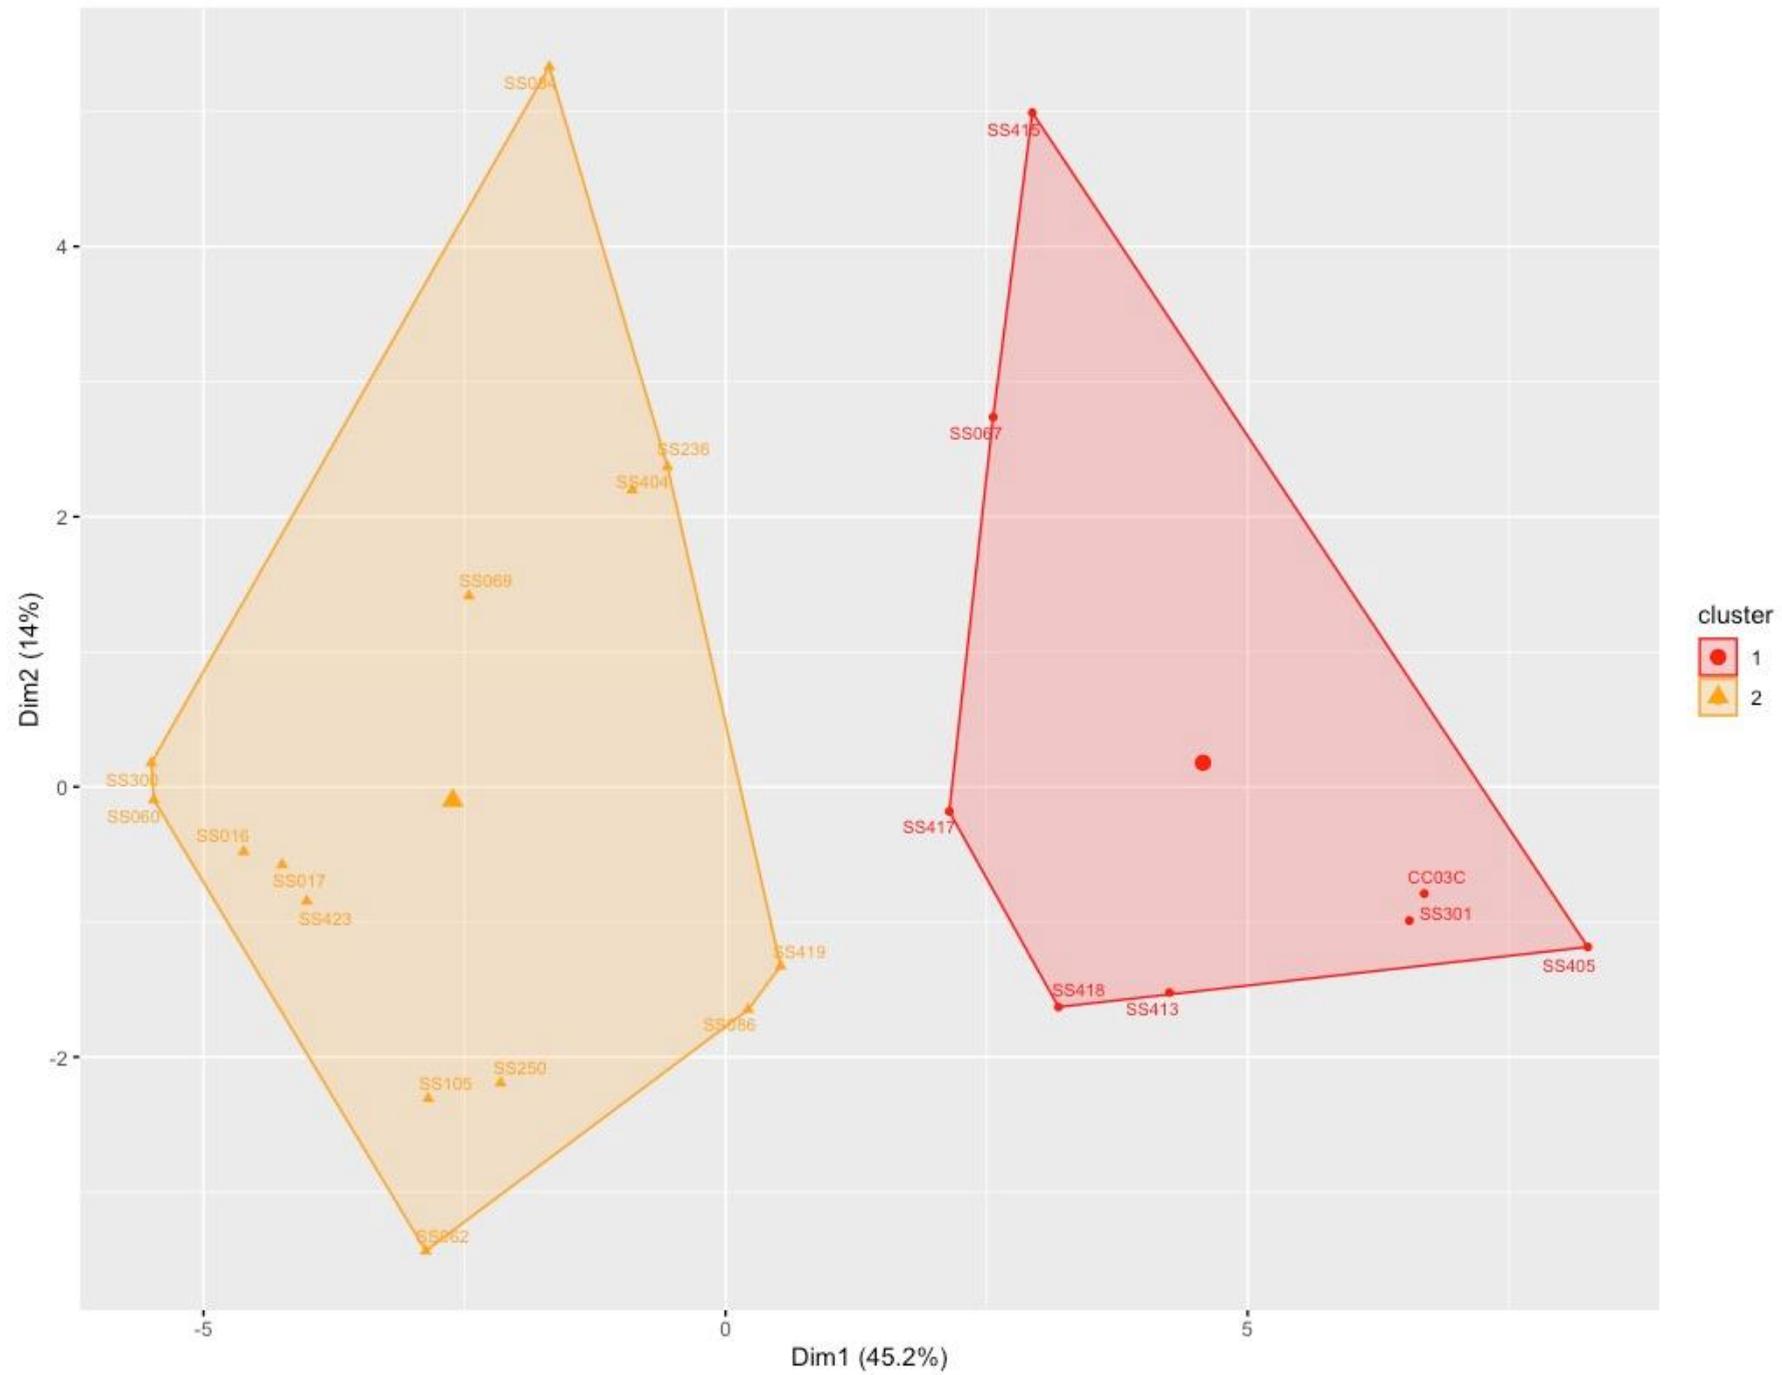
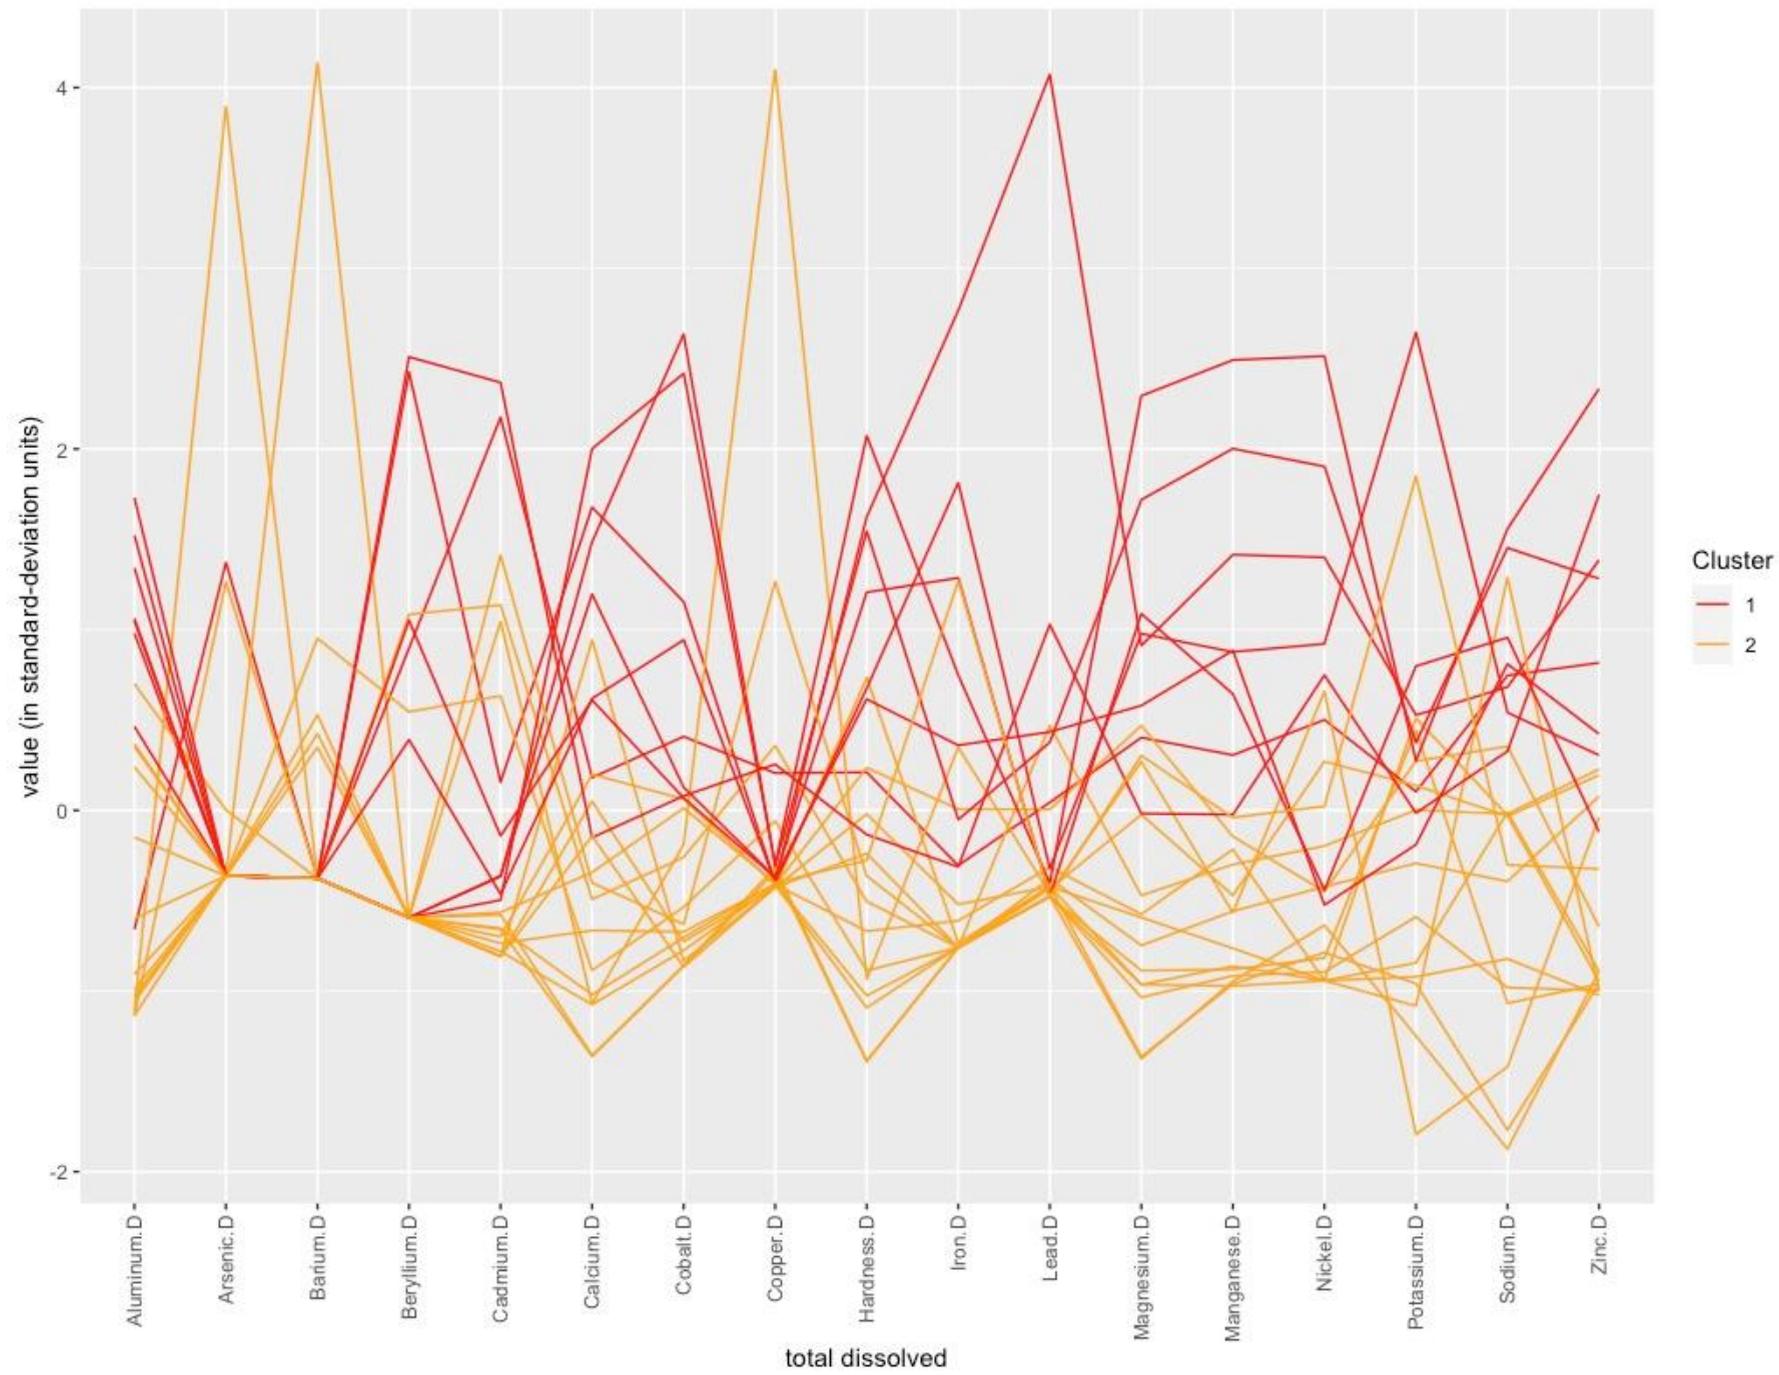
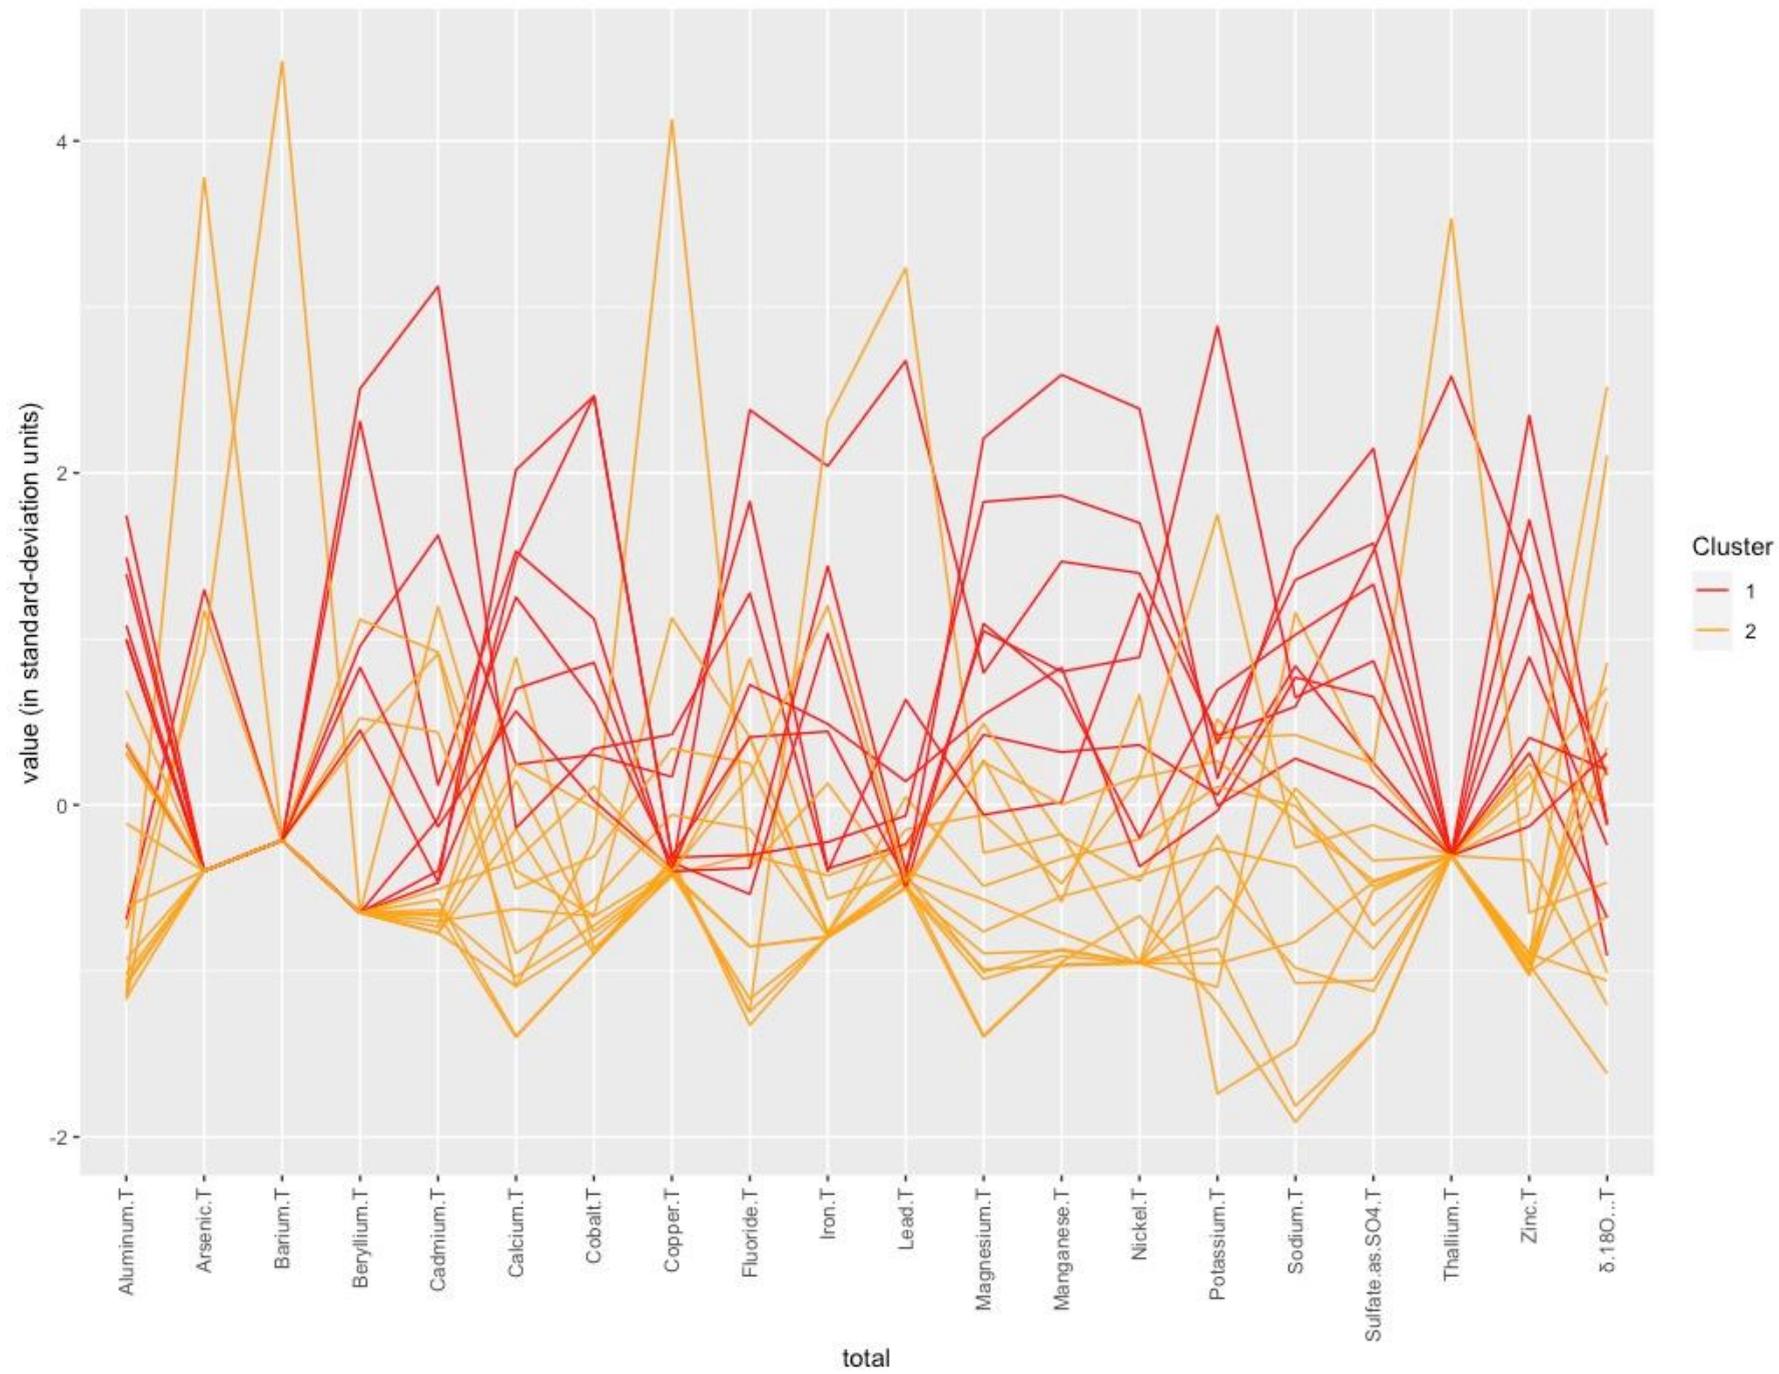
D. Statistical Analysis Plots: Cluster Analysis

addition to PCA, we employed K-means cluster analysis to further explore water quality similarities and differences between seeps and springs, new surface water expressions, and R&B drainage (Appendix D). K-means cluster plots represent 2019-20 low-flow water quality samples from the R&B and new surface water expressions. Samples are grouped into clusters based on similarity of water quality. The first cluster plot reflects groups of sites based on 2019 low-flow water quality conditions. SS067 and SS301 were assigned to Cluster 2 due to their similarity in water quality to R&B. The second cluster plot reflects groups of sites based on 2020 low-flow water quality conditions. SS067 and SS301 remained in a cluster with R&B, indicating that their water quality did not change enough from 2019 to 2020 to warrant separation to a different cluster assignment. Of the sampled new surface water expressions, SS405, SS413, SS415, SS417, SS418 were grouped with R&B indicating similarity in water quality. While the purpose of cluster analysis is to identify patterns in the data and group observations into clusters based on the similarity of these patterns, there is not much interpretation of the variables that are driving the similarity and dissimilarity of the clusters. We plotted the standard deviations of each of the scaled analytes in order to understand what analytes were driving the clusters. The sites clustered with R&B generally had higher levels of sulfate and total and dissolved cobalt, manganese, magnesium, nickel, and zinc (Appendix D). There was broad agreement between PCA and K-means cluster analysis as to which locations of new surface water expression were most similar to R&B drainage.
