SUPERFUND TECHNICAL ASSESSMENT RESPONSE TEAM STANDARD OPERATING PROCEDURE FOR REMOVAL OF LITHIUM-ION AND NICKEL METAL HYDRIDE BATTERIES FROM ELECTRIC VEHICLES 2023 MAUI WILDFIRE RESPONSE

October 27, 2023

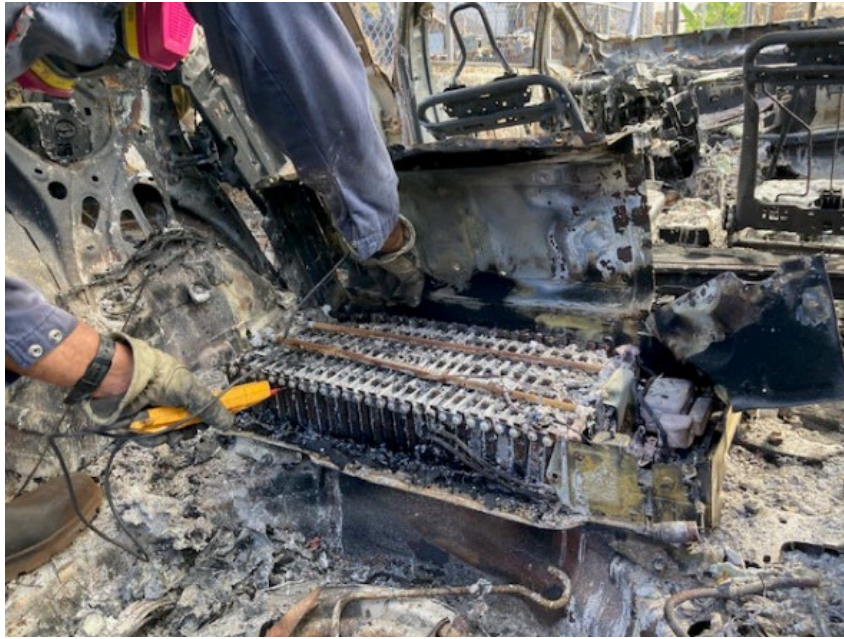
Certified electrician testing Ni-MH battery pack for remaining battery charge prior to removal

Batteries may continue to hold a charge or be energized even after being thermally impacted. It is extremely important to ensure that batteries are de-energized prior to removal of any component of the vehicle, particularly the battery. A certified electrician will determine whether any stored energy remains in the battery pack before field personnel proceed to the removal step. If a charge is remaining, additional tactics such as physical separation or sever of the main power cable may be necessary. A review of the technical specifications of the specific make and model of the vehicle prior to such event to ensure appropriate and safe separation is essential. The vehicle should not be touched or disturbed until de-energizing of the battery is performed. An infrared thermometer or thermal imaging should also be used to ensure the temperature of the battery is not elevated or increasing. Once it has been shown that there is no risk of electrocution or fire to personnel, the team may proceed with the physical removal of the battery.

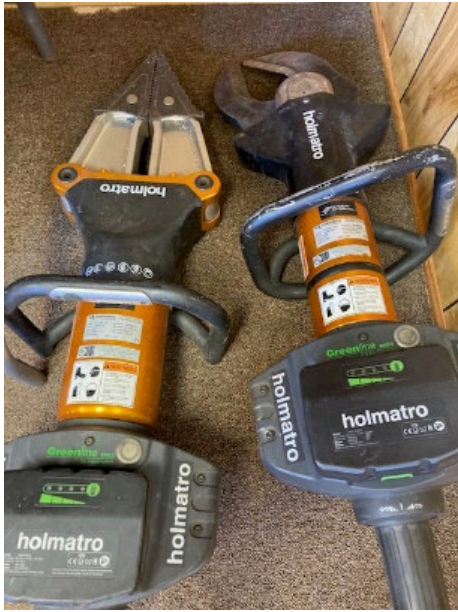
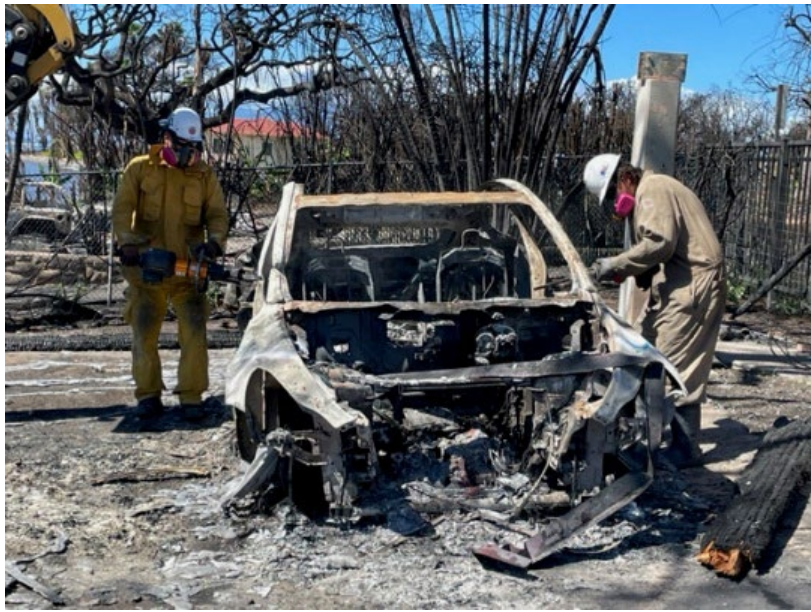
(Left) Rescue spreader and cutter. (Right) Cutting roofing support beams (A, B, C pillars) prior to flipping vehicle for battery pack access on some vehicles.

A combination of power tools and hand tools will be used to remove batteries from EVs. Fire responder tools (spreader and cutter) are also utilized for accessing damaged vehicles and rendering the vehicle structurally safe for battery access. Doors and/or the roof of the vehicle may be removed for easier battery access or to safely flip the vehicle to access undercarriage batteries. A mini excavator with thumb attachment is also used for repositioning vehicles as well as assisting with access by removing seats or other obstructions. Dust suppression is provided prior to and during vehicle repositioning by a support vehicle with water buffalo trailer, however the batteries are not to be oversaturated with water.

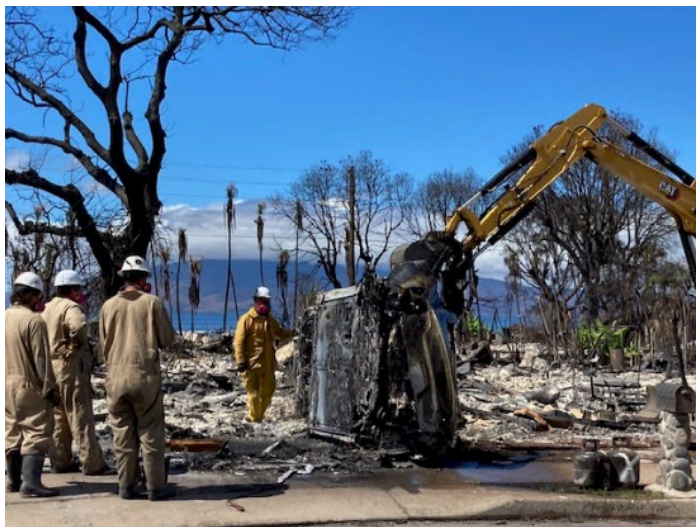
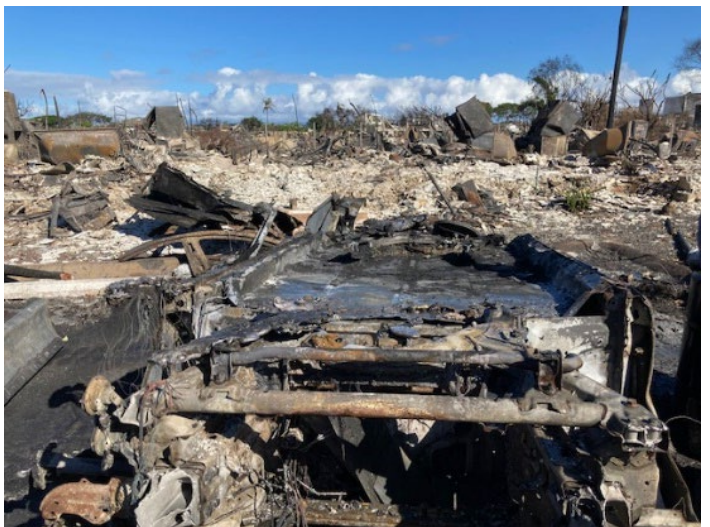
Flipping Tesla Model S to access batteries in undercarriage.

Access to the batteries will depend on the type and condition of the vehicle. Most EV battery compartments will be found intact or partially intact. Location of each battery will be dependent on the year, make, and model of the EV. Some battery packs are located on the bottom of the vehicle and will require the EV to be placed on its side or have its roof removed (for stability) and rolled on its top. Others have batteries located under the back seat and may require the roof to be peeled back to access the battery. Each EV will be assessed to determine the most appropriate method to access and recover the battery.

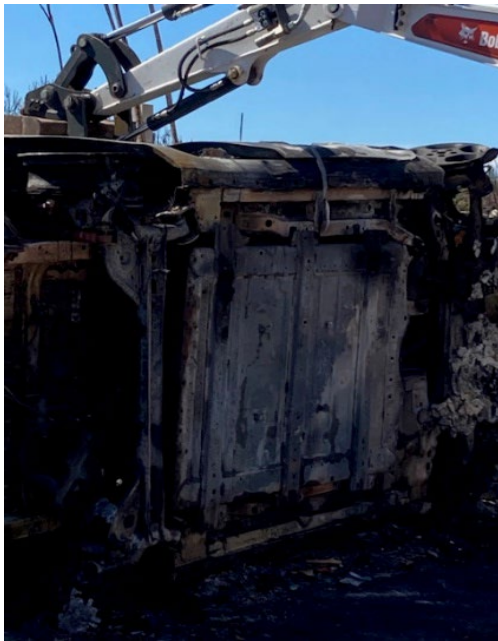
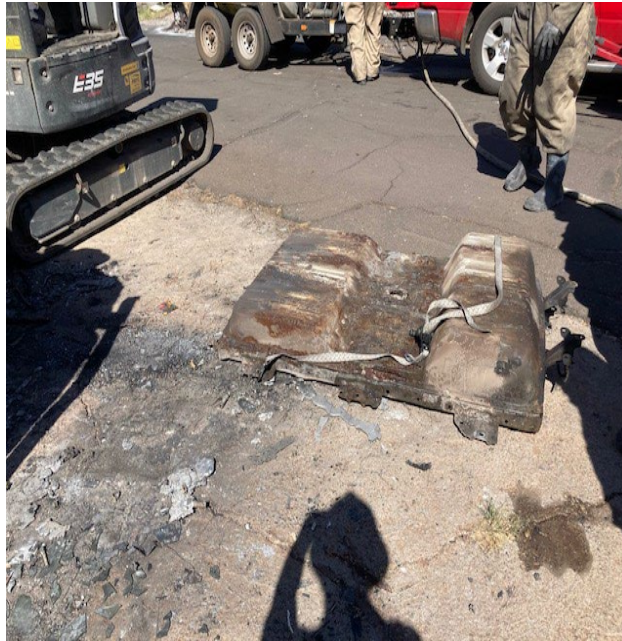
(Left) Nissan Leaf li-ion battery pack in undercarriage. (Right) Nissan Leaf battery pack after removal.

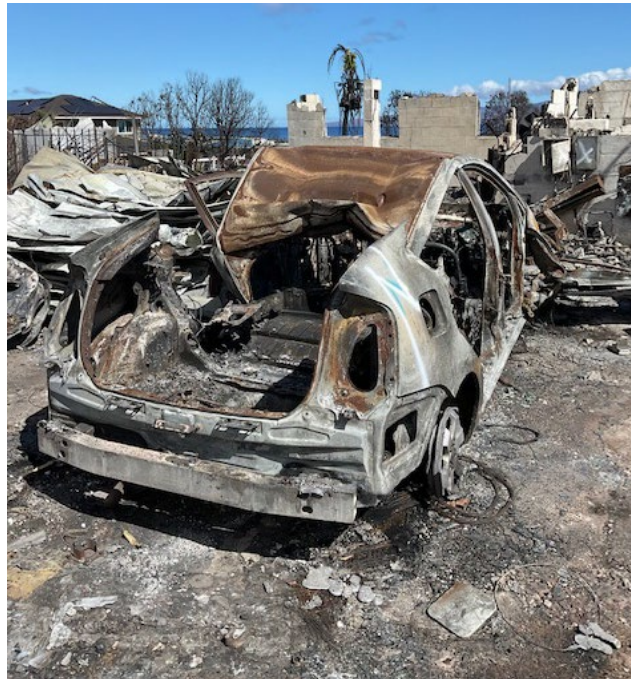
White lightning bolt painted over blue lightning bolt indicating that battery has been removed.

Once battery removal is complete, a white lightning bolt is painted over the blue lightning bolt and a post removal photo is collected. The data point is updated to “Complete” in QuickCapture via Field Maps, and additional information is placed in the database. If the
