**REMOVAL PROGRAM  
AFTER ACTION REPORT  
FOR THE  
LEWIS CHEMICAL SITE  
HYDE PARK, SUFFOLK COUNTY, MASSACHUSETTS  
27 MARCH 2023 THROUGH 22 OCTOBER 2024**

U.S. Environmental Protection Agency  
Region I  
Emergency Planning and Response Branch  
5 Post Office Square, Suite 100  
Boston, Massachusetts 02109-3912

Weston Solutions, Inc.  
Region I  
Superfund Technical Assessment and Response Team  
101 Billerica Avenue, Building 5  
North Billerica, Massachusetts 01862

April 2025

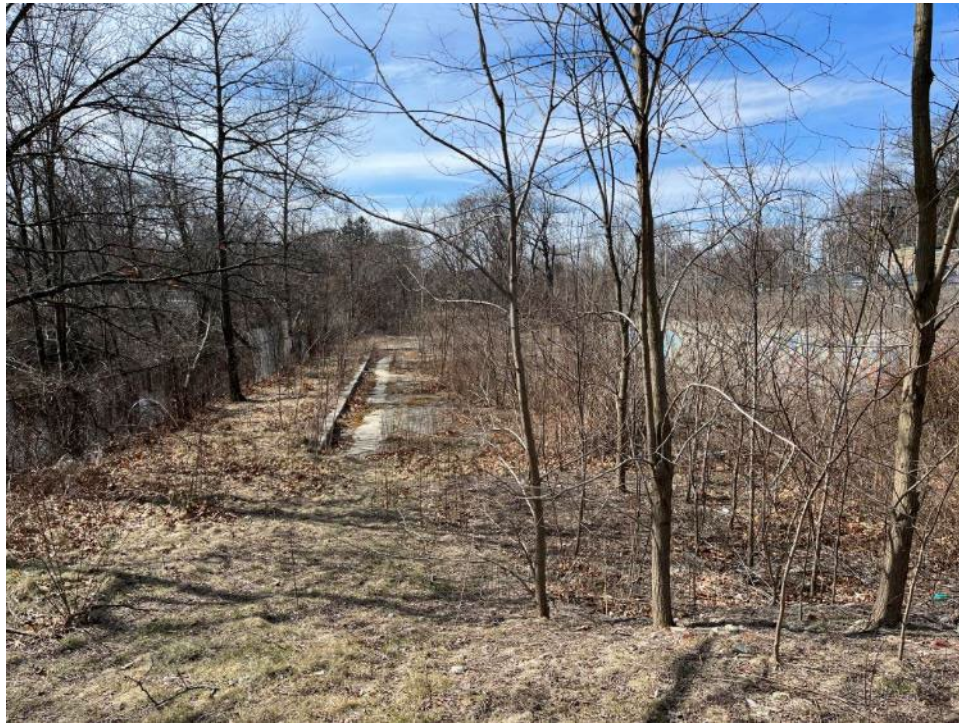
**SCENE:** View of the former Lewis Chemical building concrete pad prior to the start of removal activities. The concrete pad is in the central area of the Site. Photograph taken facing southwest.

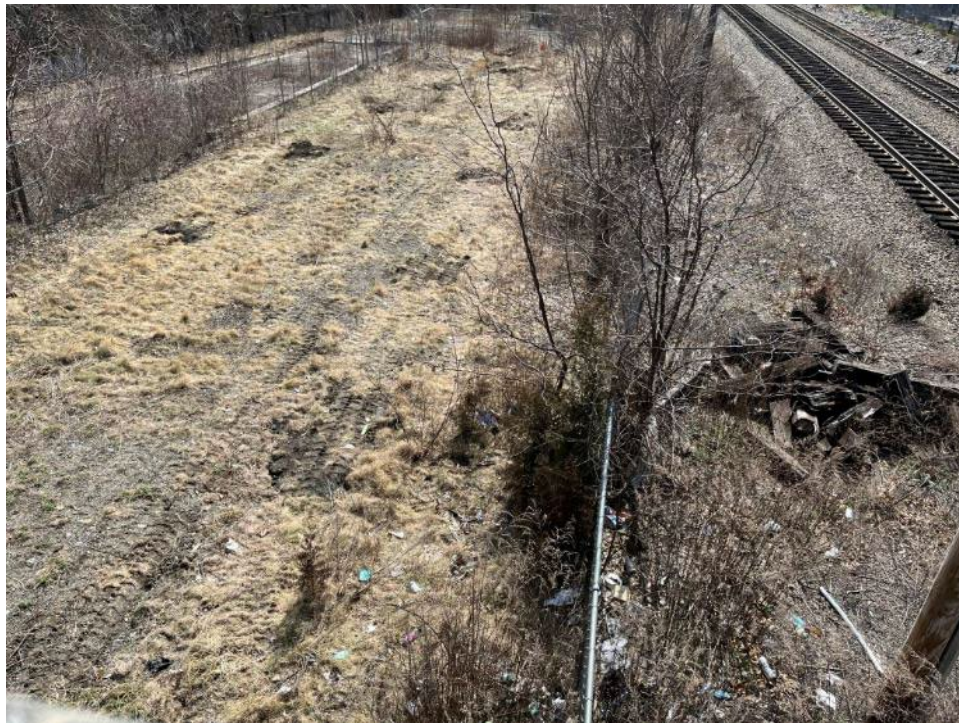
**SCENE:** View of the Site prior to the start of removal activities. The land to the north of the concrete pad is referred to as the upland road. Photograph taken facing southwest.

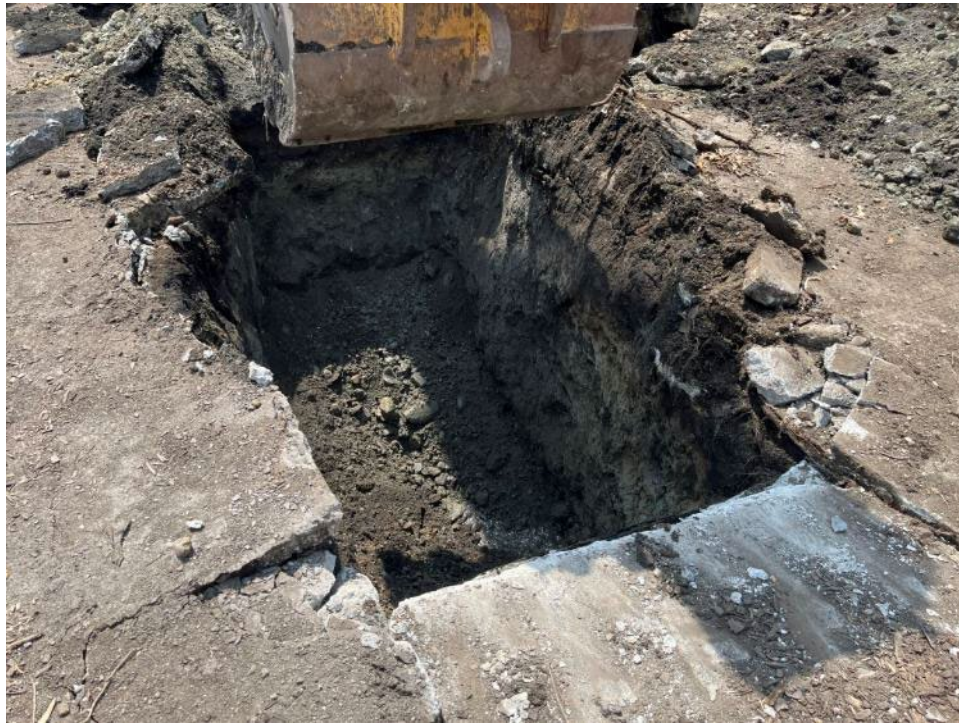
**SCENE:** View of one of the test pits that were excavated to conduct extent-of-contamination (EOC) sampling and determine if volatile organic compound (VOC) suppressant foam would be utilized throughout the removal action.

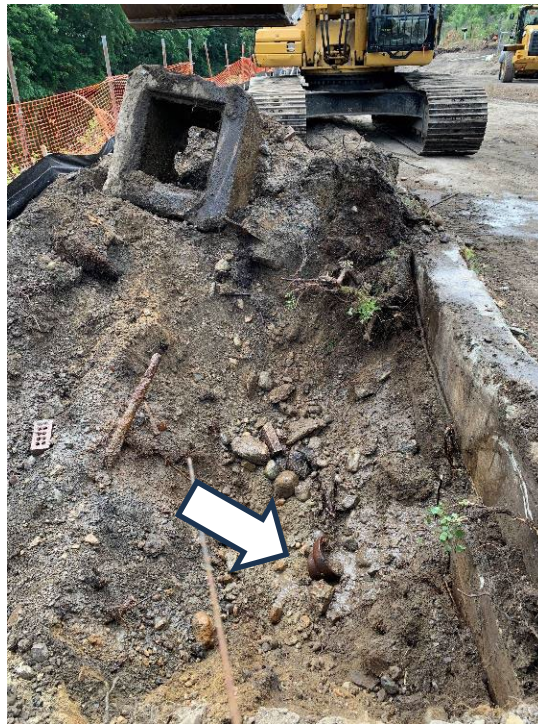
**SCENE:** View of the bottomless concrete rectangular structure found during test pitting activities between the edge of the concrete pad and the riverbank. The bell end of an 8-inch clay pipe was discovered at the base of the rectangular structure.

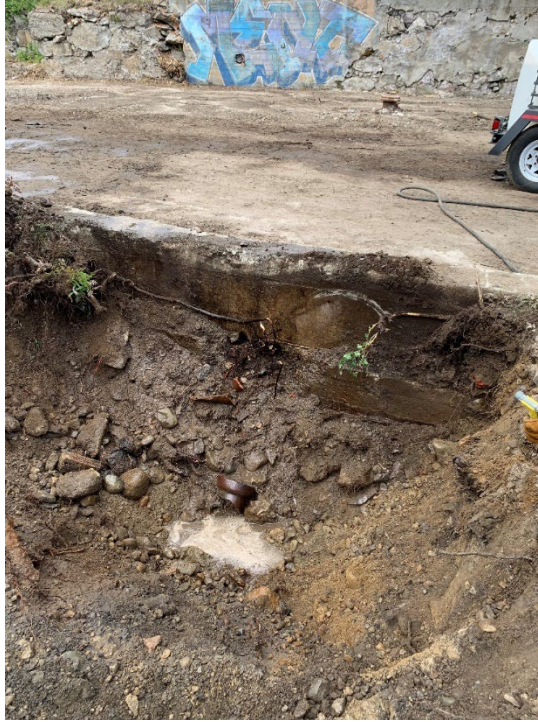
**SCENE:** View of the edge of the concrete pad where the bottomless concrete rectangular structure and the bell end of an 8-inch clay pipe was discovered during test pitting activities. Photograph taken facing northwest.

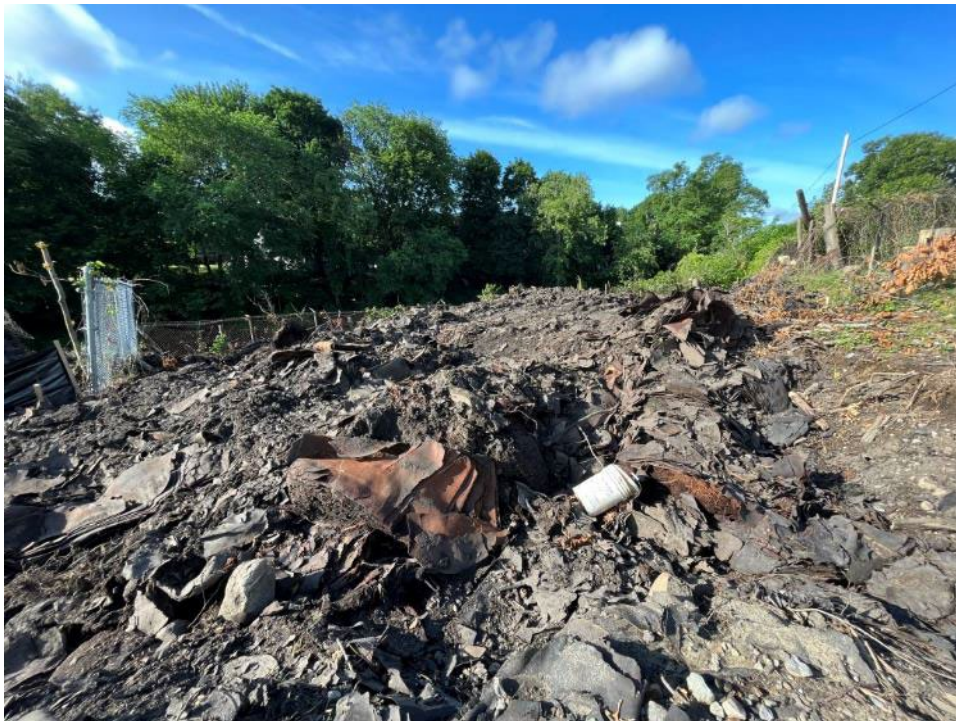
**SCENE:** View of the extent of the “pleather” material at the southwest portion of the Site. This portion of the Site is referred to as the pleather area. Photograph taken facing southwest.

- Continued excavation of the pleather area at the southwest portion of the Site and stockpiled the material at the east end of the concrete slab.
- Reduced the volume of the stockpile by compacting the pleather material utilizing the excavator.
- Conducted dust suppression with copious amounts of water.
- Repaired and re-installed silt fence along the riverbank.
- Modified the Aspen Consulting fence gate to facilitate loadout activities.
- Conducted brush clearing along the riverbank and the northern fence line.
- Secured stockpiled material with polyethylene sheeting at the end of each day.
- Conducted particulate air monitoring using TSI DustTraks DRX2s.

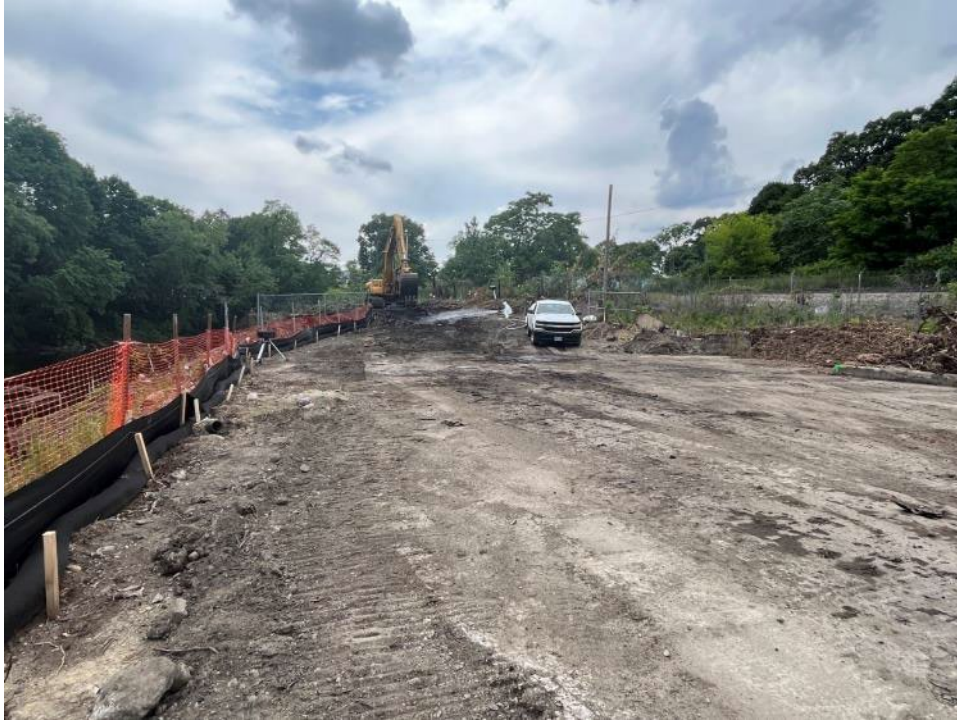
**SCENE:** View of air monitoring and dust/odor suppression being utilized at the southwest portion of the Site during excavation of pleather material.

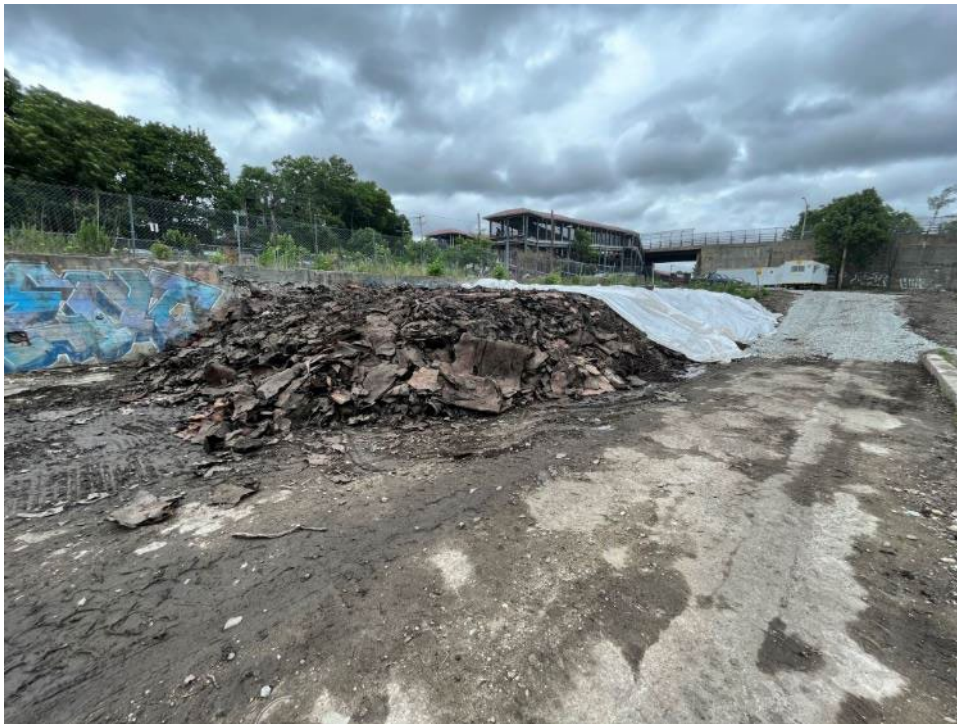
**SCENE:** View of the stockpile of pleather material removed from the southwest portion of the Site, staged in preparation for disposal. Photograph taken facing north.

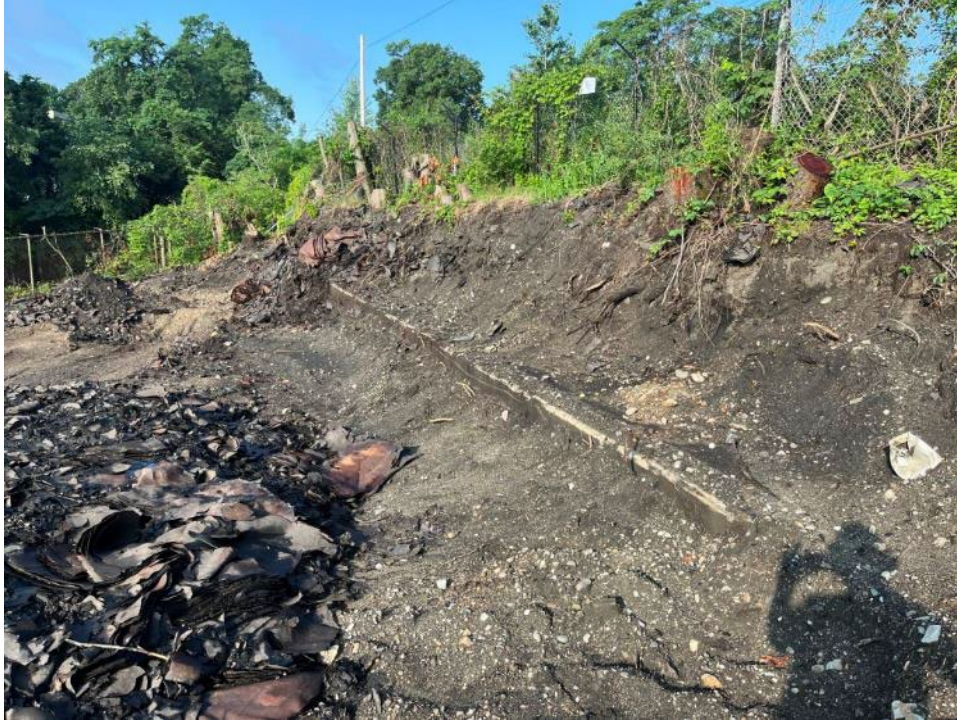
**SCENE:** View of the retaining wall unearthed during excavation activities in the southwest portion of the Site. Photograph taken facing north.

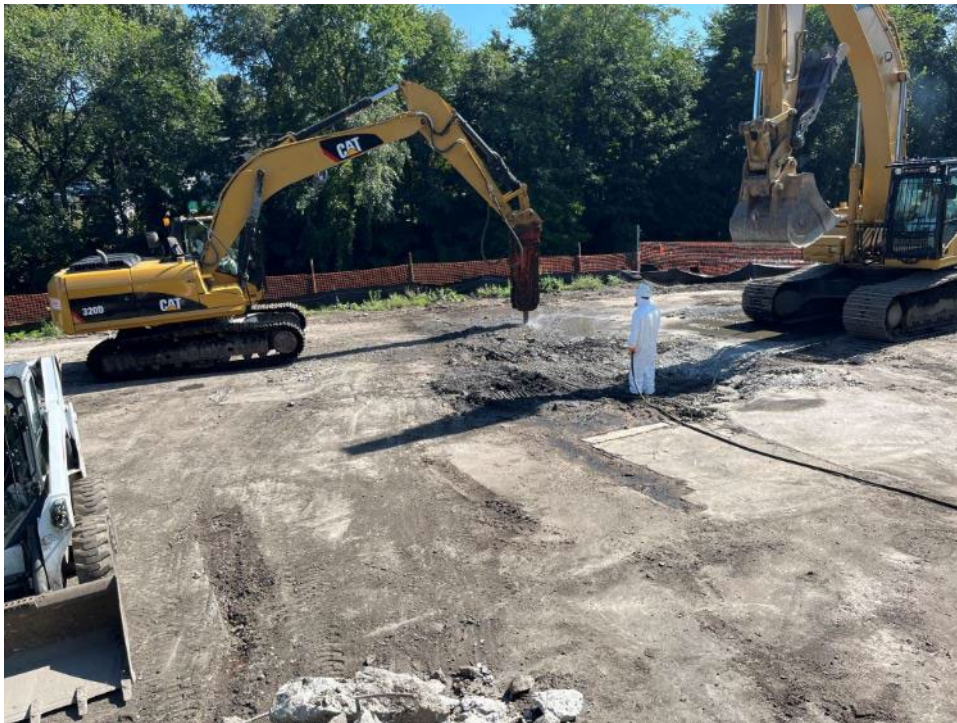
**SCENE:** View of the concrete slab being broken up into pieces, including utilization of dust suppression methods. Photograph taken facing east.

On 21 September 2023, personnel observed a strong chemical-like odor during breaking of the concrete pad in the central area of the concrete pad. The area was sprayed with water and covered with polyethylene sheeting to suppress the VOC odors pending determination of modifications to work and safety procedures.

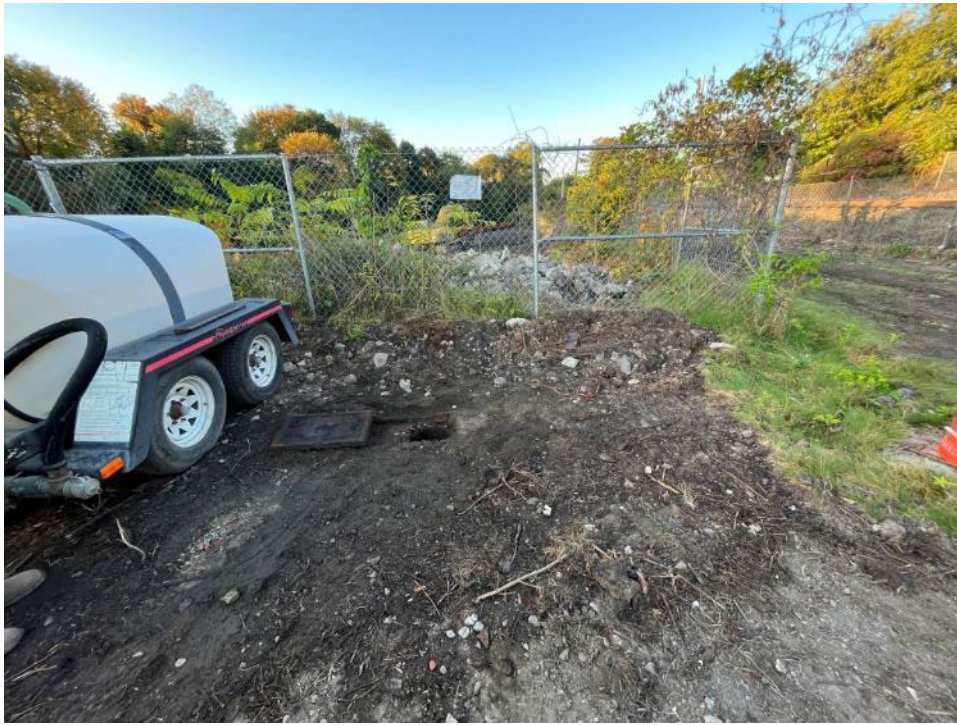
**SCENE:** View of the Boston Water and Sewer Department (BWS) pipe located on the upland road between the railroad tracks and the retaining wall. Photograph taken facing southwest.

On 19 October 2023, personnel discovered a BWSO manhole cover on the northern earthen road in the area where the original loading dock was located during excavation beneath the removed concrete pad. Underneath the cover, an 8-inch waterline with a gate valve at the end was observed. It was unknown if this waterline had been capped by the building demolition contractor.

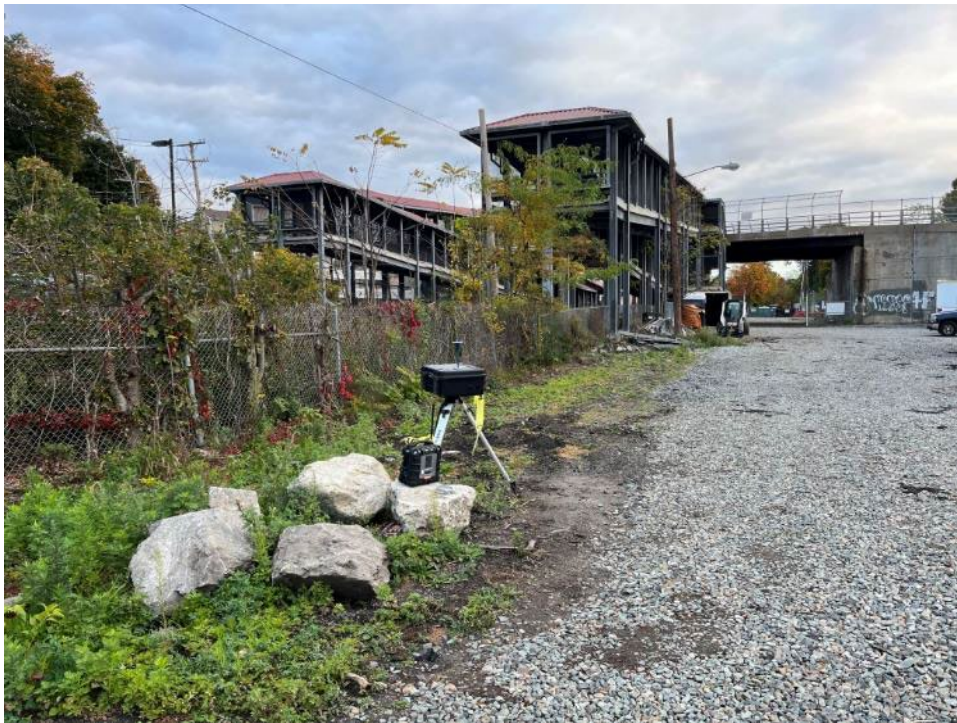
**SCENE:** View of air monitoring station, including a DustTrak and an AreaRAE, deployed at the Site between the railroad station and the work area. Photograph taken facing north.

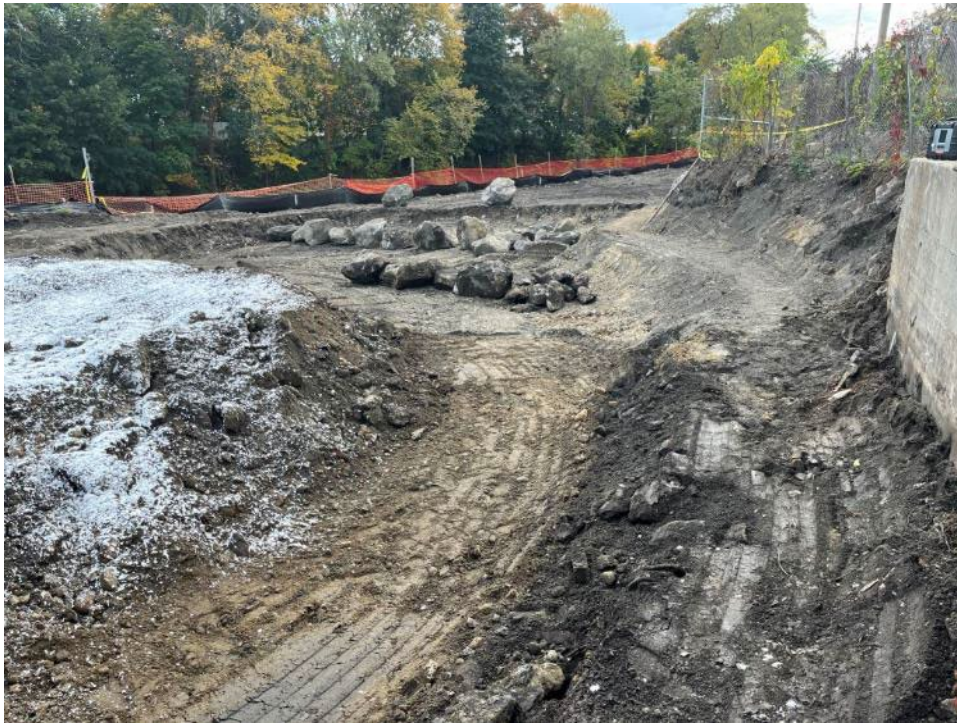
**SCENE:** View of excavation progress in the central area. Large rocks were placed at the edges of the excavation pit to prevent vehicles from entering. The white material visible on the left side is VOC suppressant foam. Photograph taken facing southwest.

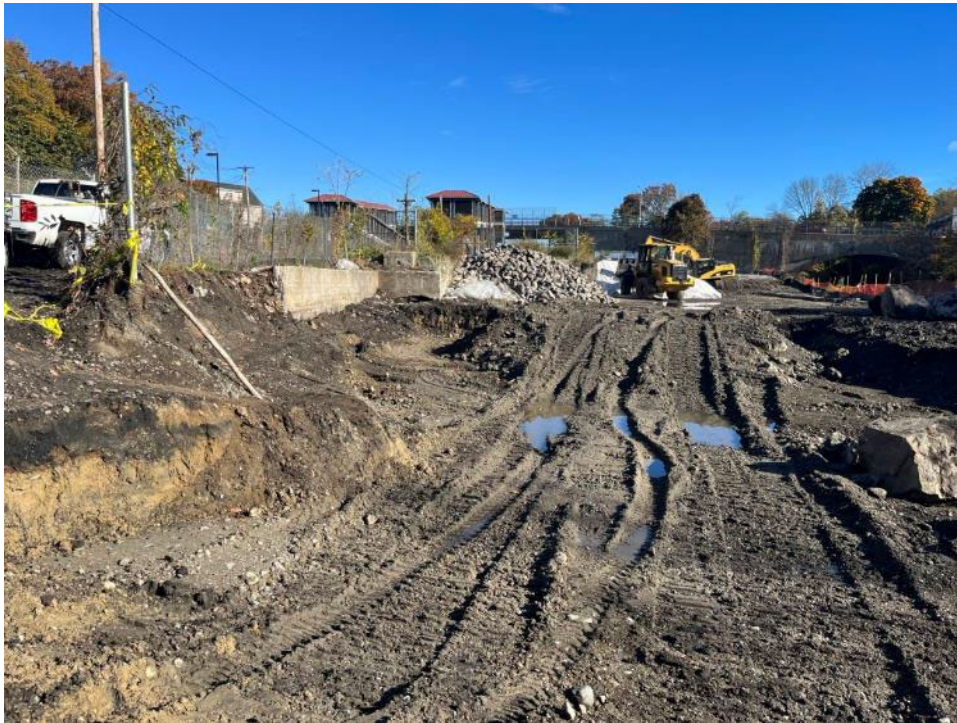
**SCENE:** View of the central area after the excavation of contaminated soil. The central area was located at the former Lewis Chemical loading dock. Photograph taken facing north.

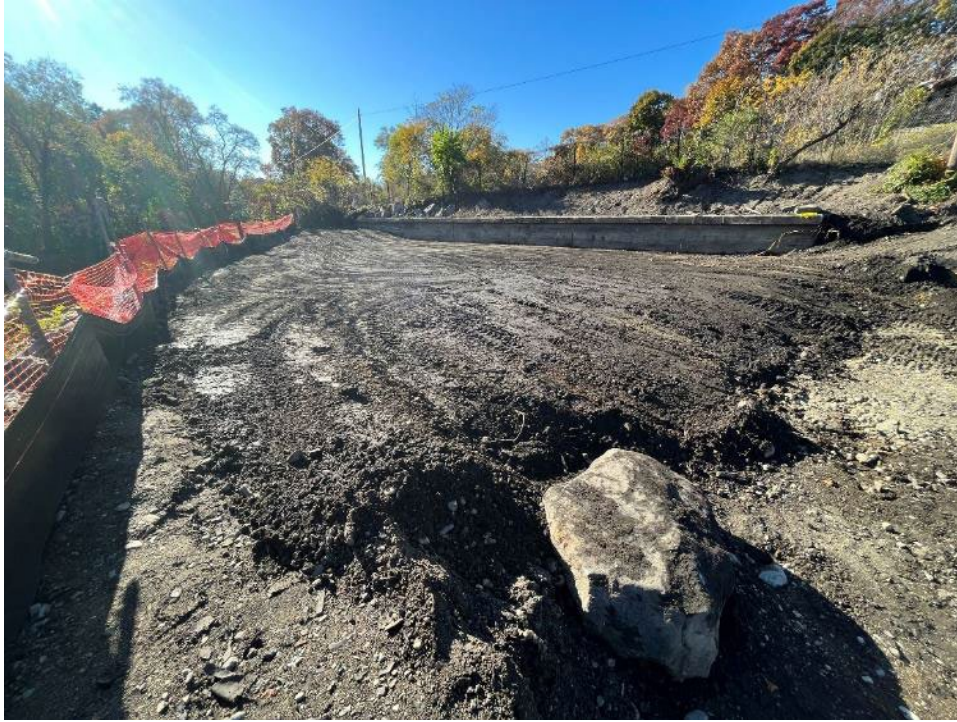
**SCENE:** View of the southwest area of the Site after the excavation of the pleather material and contaminated soil. Photograph taken facing southwest.

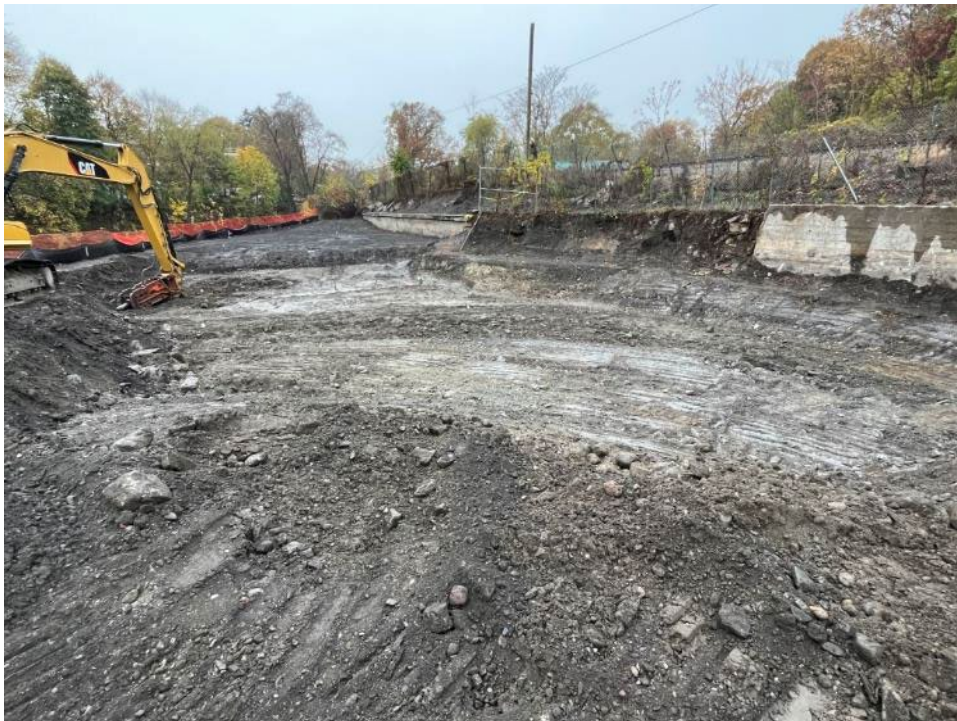
**SCENE:** View of the central area of the Site after excavation of polychlorinated biphenyl (PCB)-contaminated soil. Photograph taken facing southwest.

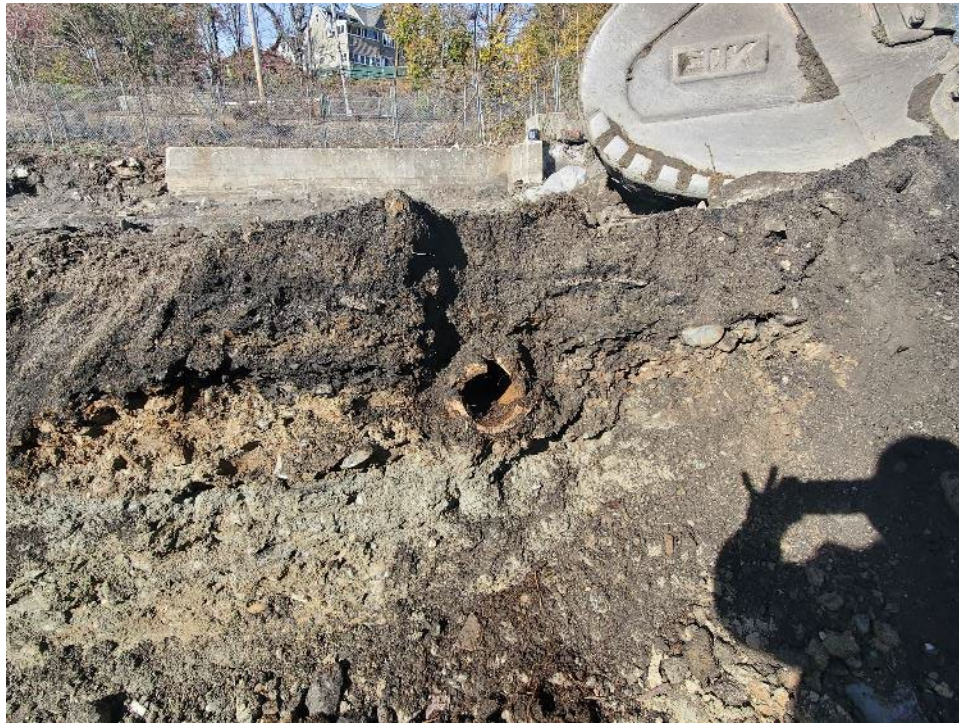
**SCENE:** View of the excavation of the 8-inch clay pipe discovered during test pitting activities the week of 12 June 2023. The pipe extended under the former concrete pad and ran toward the Neponset River. Photograph taken facing northwest.

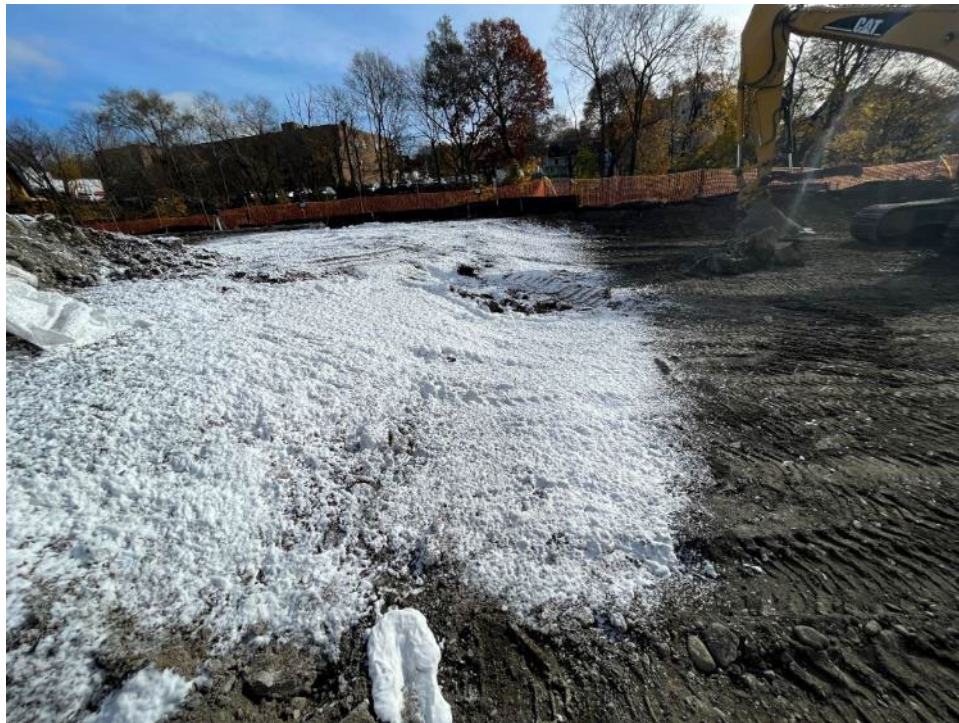
**SCENE:** View of the utilization of VOC suppressant foam to minimize vapors of soil underneath the concrete pad. Photograph taken facing northeast.

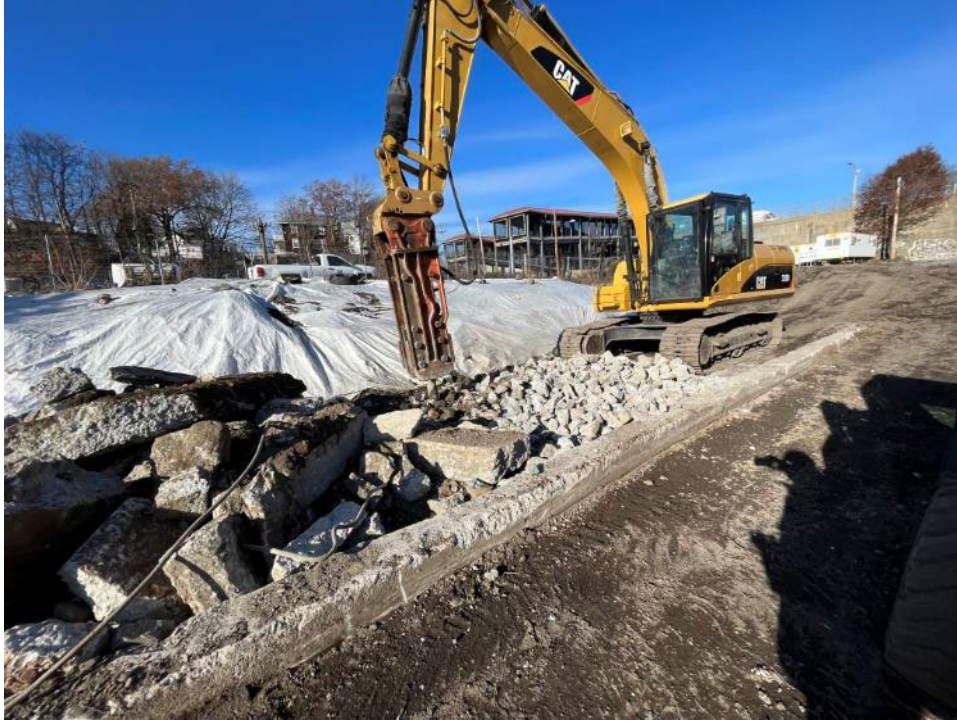
**SCENE:** View of the concrete foundation of Lewis Chemical broken up to allow for removal of PCB-contaminated soil underneath. Photograph taken facing north.

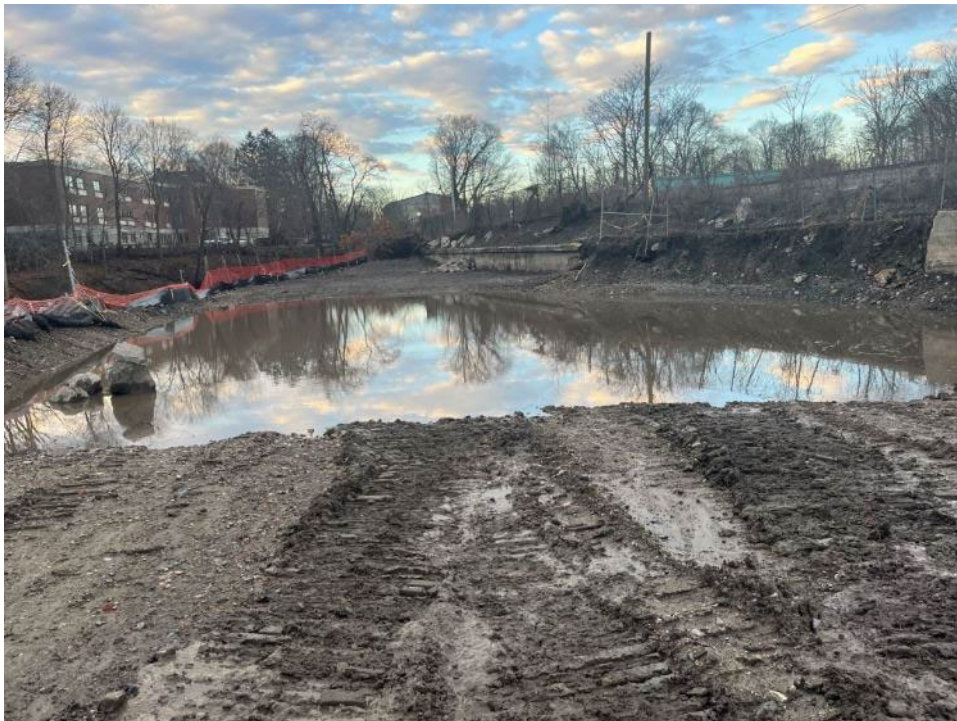
**SCENE:** View of the central area flooded with water following heavy rains. The central area was located by the former loading dock of Lewis Chemical. Photograph taken facing southwest.

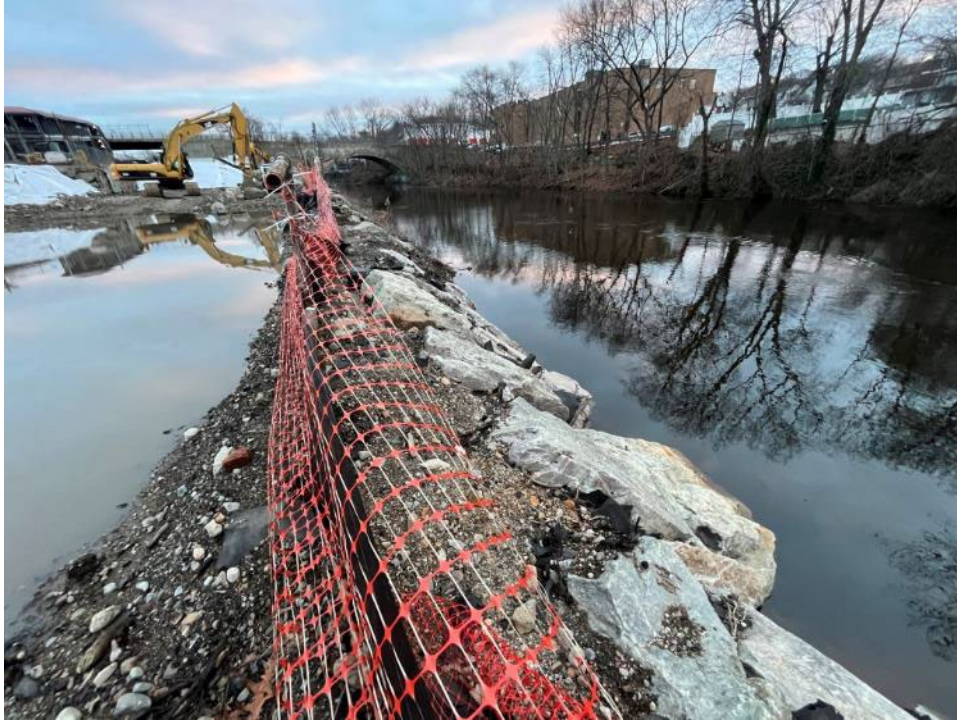
**SCENE:** View of the riverbank during excavation activities and removal of armor stones. Photograph taken facing northeast.

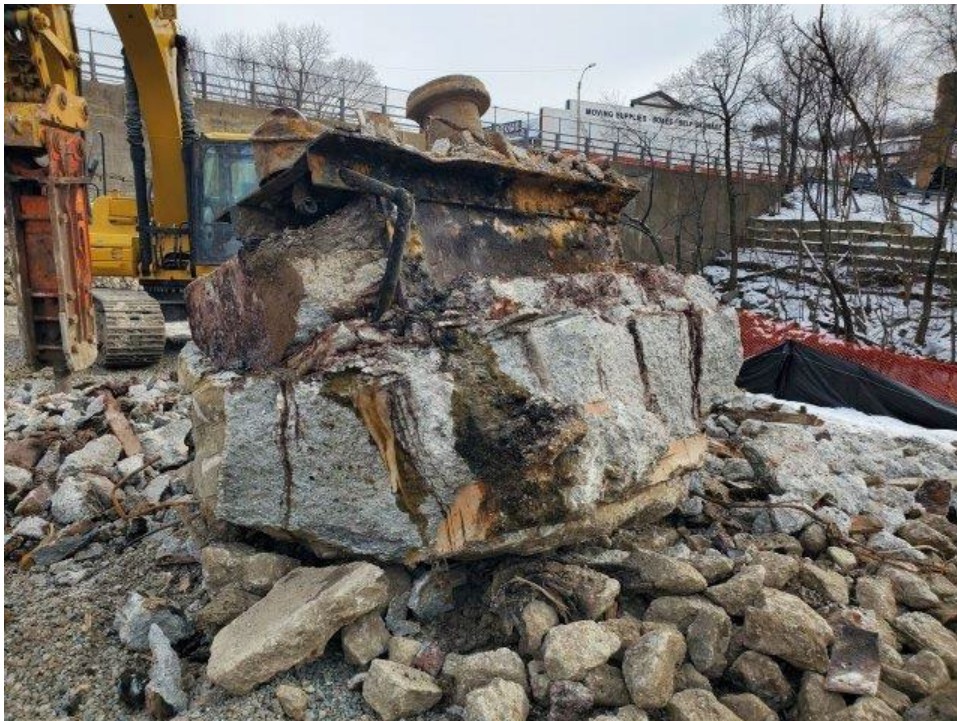
**SCENE:** View of the large concrete block with oil-like staining that was approximately 8 feet by 7 feet by 5 feet, with broken, deteriorated pipes and a large metal piston-type device protruding from the block. Photograph taken facing northeast.

On 11 January 2024, during excavation at the northern portion of the concrete pad, an additional large concrete block was encountered approximately 45 feet from the riverbank. The block had oil-like staining, was approximately 8 ft by 7 ft by 5 ft, and had attached broken, deteriorated pipes and a large metal piston-type device sticking out of it (see Appendix B - Photo-documentation Log).

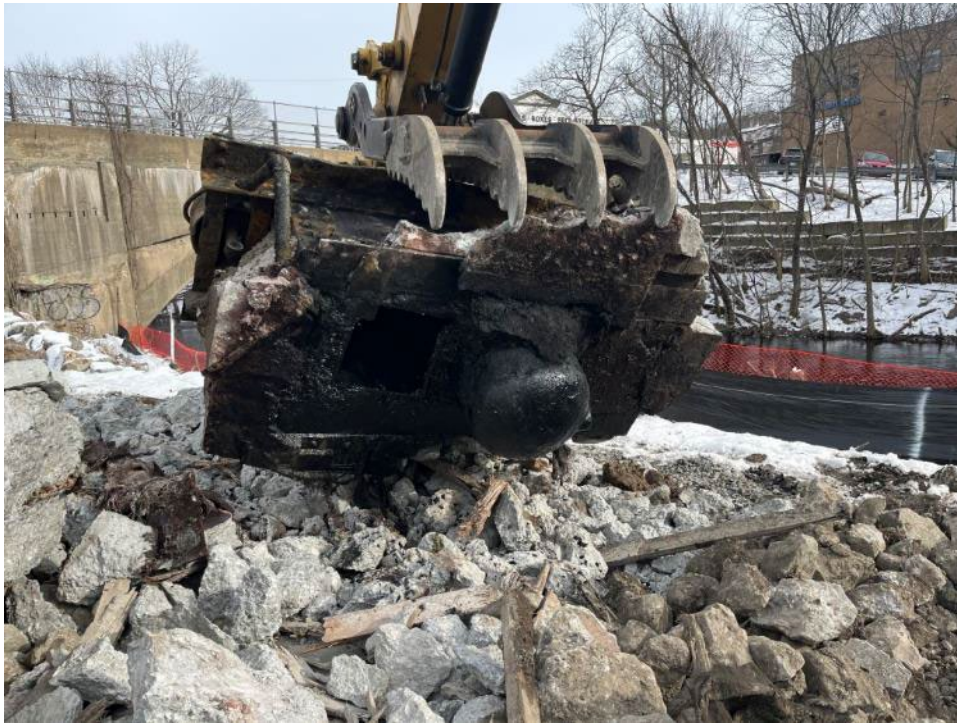
**SCENE:** View of the metal removed from the large concrete block with oil-like staining and the large protruding metal piston-type device. Photograph taken facing northeast.

- Continued breaking up and stockpiling the concrete pad, using the excavator with the hammer attachment, and separating steel rebar.
- Removed the steel rebar from the large concrete block with the large metal piston-type device sticking out of it from the previous week.
- Broke up stained concrete from the large concrete block and added it to the contaminated soil stockpile.
- Removed and staged a steel riveted box approximately 3 ft by 2 ft that was imbedded into the large concrete block along with the piston.
- Conducted dust suppression with copious amounts of water.
- Graded the pile and upper loading areas to prepare for loadout.
- Secured stockpiled material with polyethylene sheeting at the end of each day.
- Conducted air monitoring using combinations of DustTraks, AreaRAEs, and a MultiRAE.

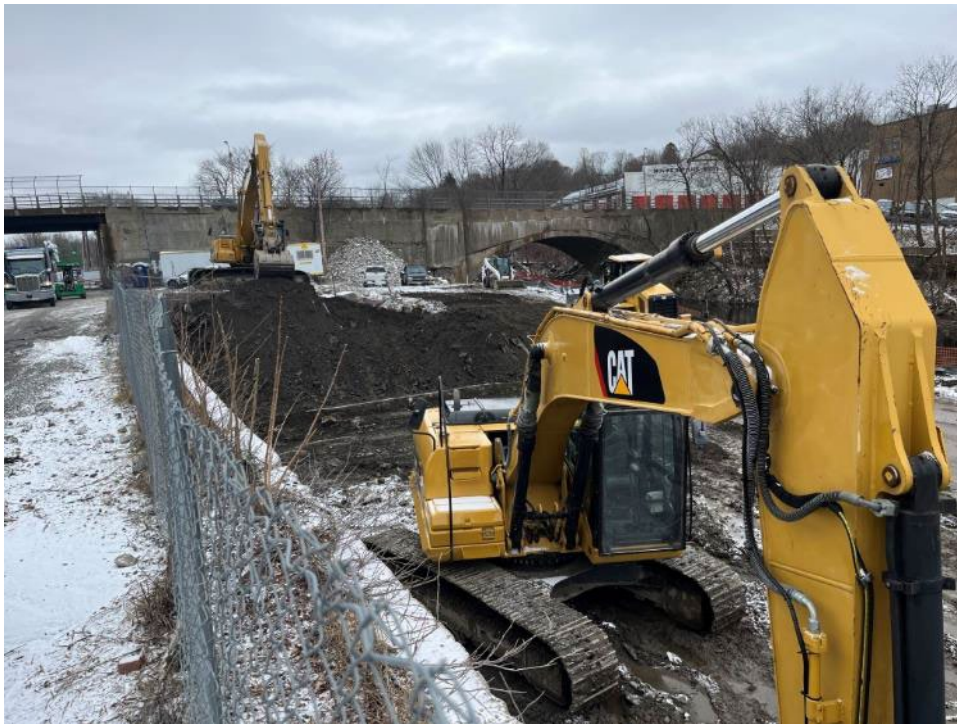
**SCENE:** View of loadout of stockpiled PCB-contaminated soil into trucks for transport to the disposal facility. Photograph taken facing northeast.

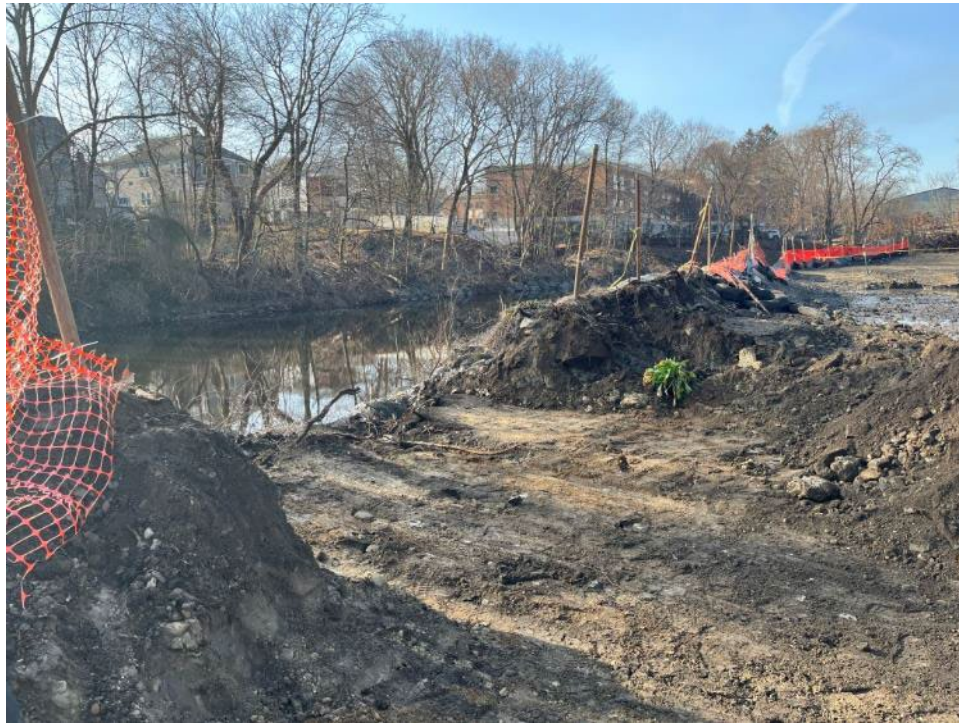
**SCENE:** View of the depth of excavation on the riverbank after the armor stones were removed. Photograph taken facing south.

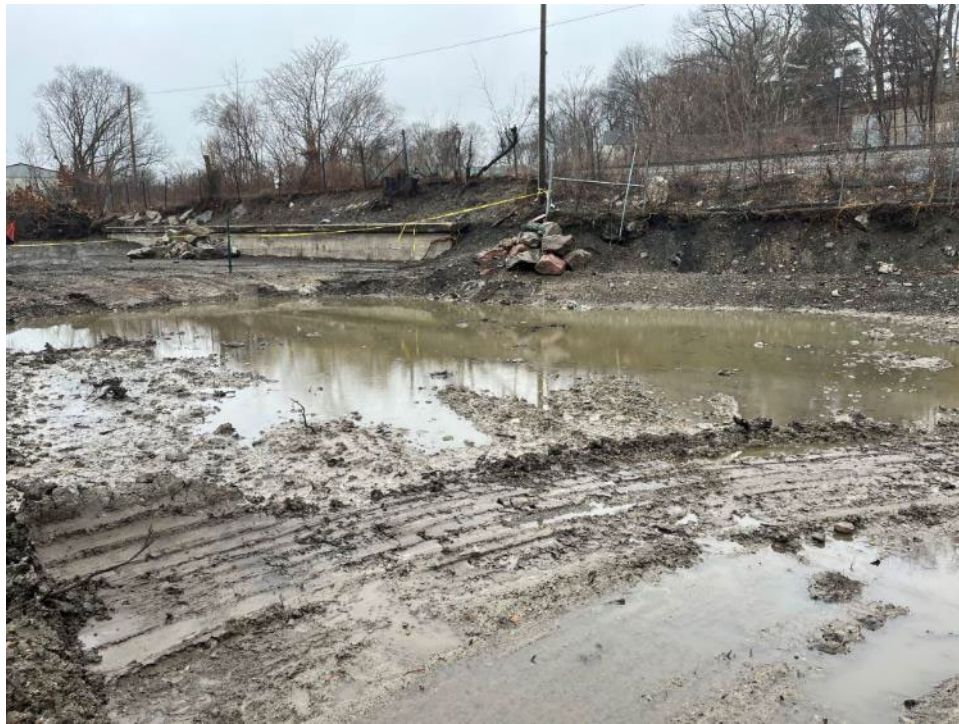
**SCENE:** View of the flooding in the main excavation area. Photograph taken facing south.

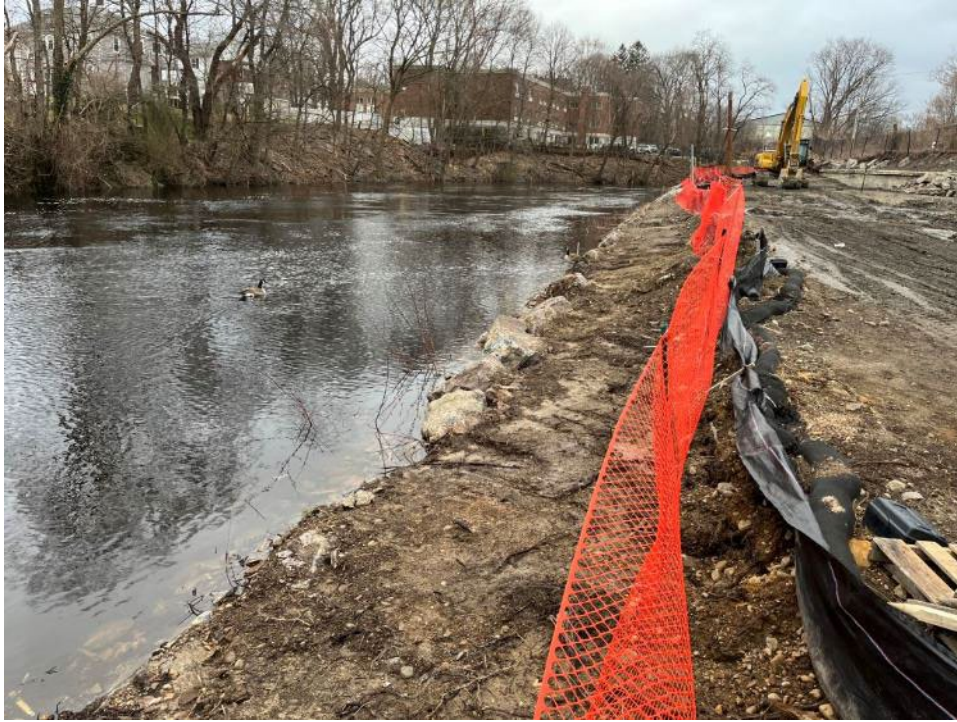
**SCENE:** View of the riverbank after removal of armor stones and subsequent excavation. Photograph taken facing southwest.

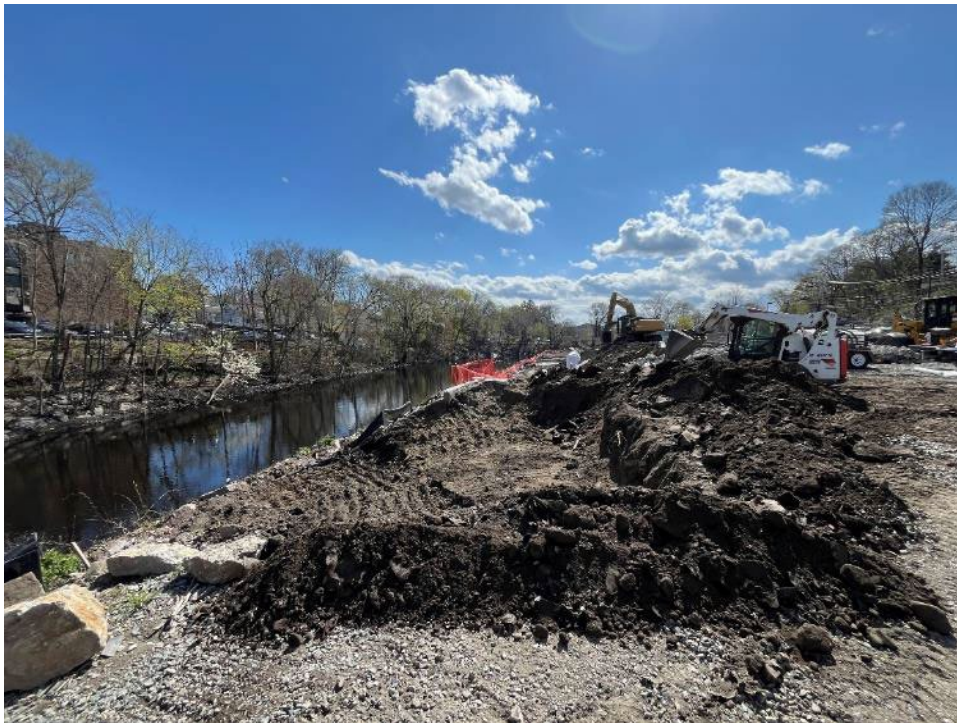
**SCENE:** View of the northern end of the riverbank after excavation and removal of pleather material (sample locations B-110 and BKP-041). Photograph taken facing south.

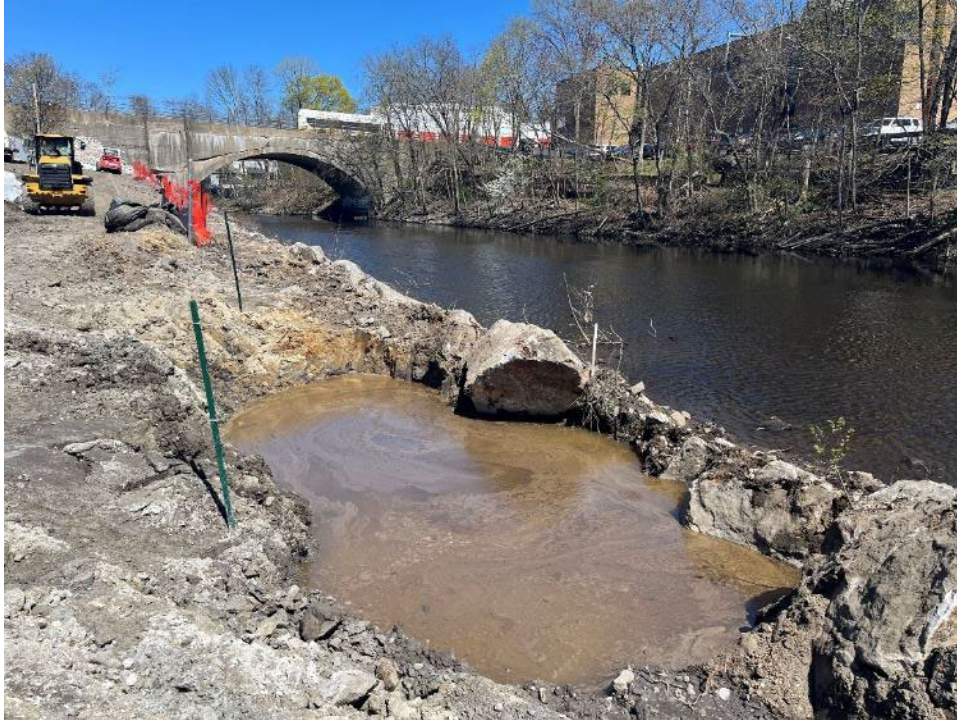
**SCENE:** View of the riverbank after re-excavation at sample locations BKP-029, BKP-030, and BKP-031. Photograph taken facing northeast.

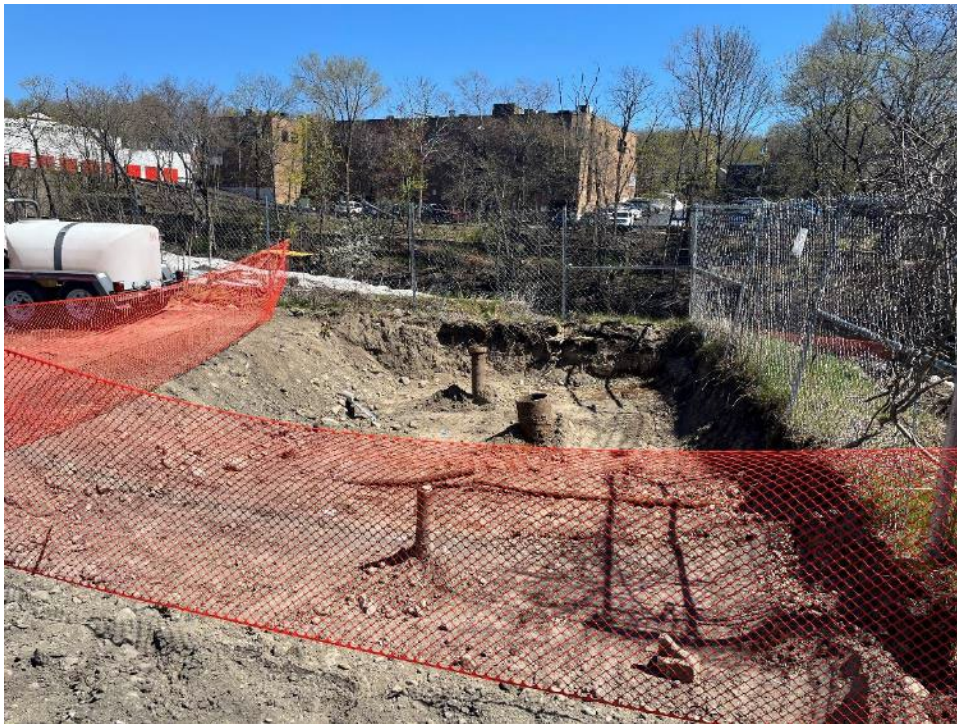
**SCENE:** View of vertical pipes located on the upland road after excavation to 3-4 feet below ground surface (bgs), near sample locations KP-020, KP-030, and KP-040. Photograph taken facing east.

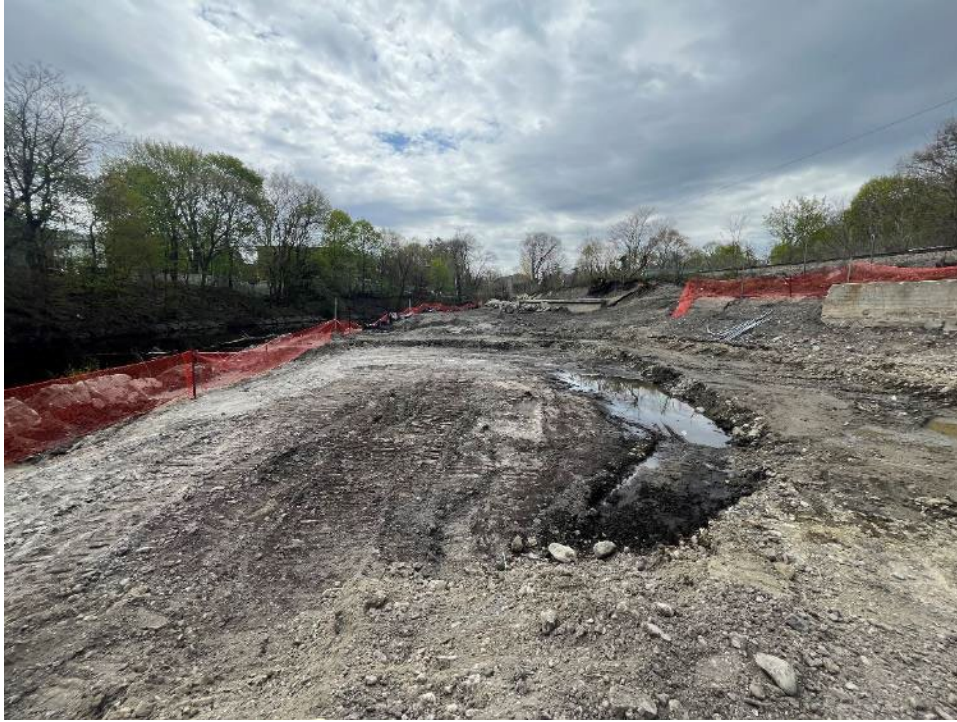
**SCENE:** View of the central area at the final post-excavation depth of 4-5 feet bgs. Photograph taken facing southwest.
