**REMOVAL PROGRAM  
AFTER ACTION REPORT  
FOR THE  
LEWIS CHEMICAL SITE  
HYDE PARK, SUFFOLK COUNTY, MASSACHUSETTS  
27 MARCH 2023 THROUGH 22 OCTOBER 2024**

U.S. Environmental Protection Agency  
Region I  
Emergency Planning and Response Branch  
5 Post Office Square, Suite 100  
Boston, Massachusetts 02109-3912

Weston Solutions, Inc.  
Region I  
Superfund Technical Assessment and Response Team  
101 Billerica Avenue, Building 5  
North Billerica, Massachusetts 01862

April 2025

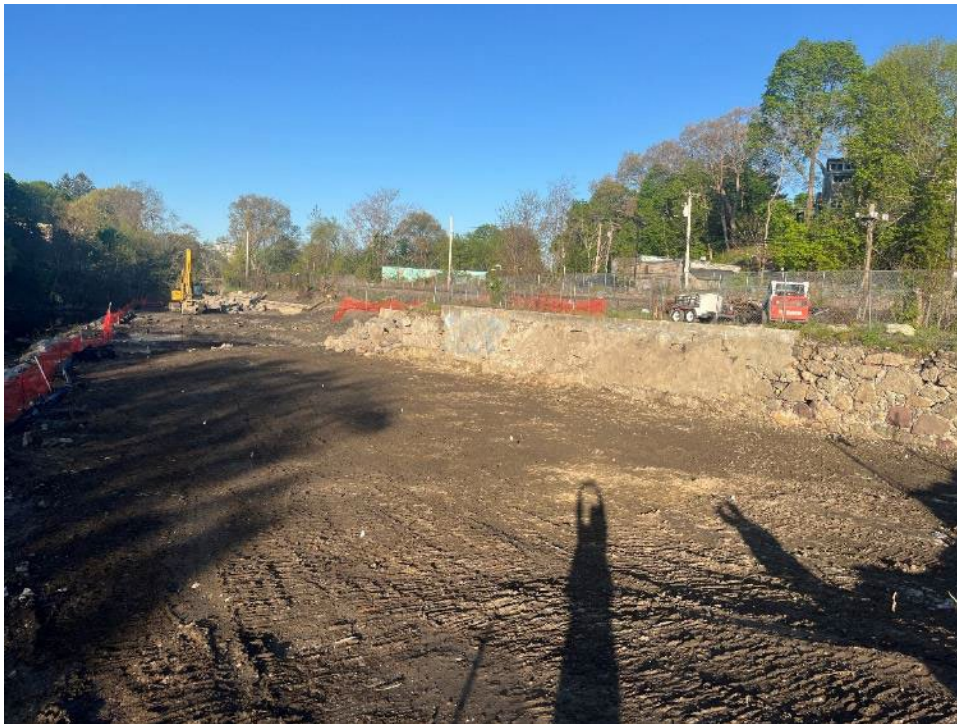
**SCENE:** View of post-excavation sampling locations SP-01 through SP-21, in the former stockpile area. Photograph taken facing southwest.

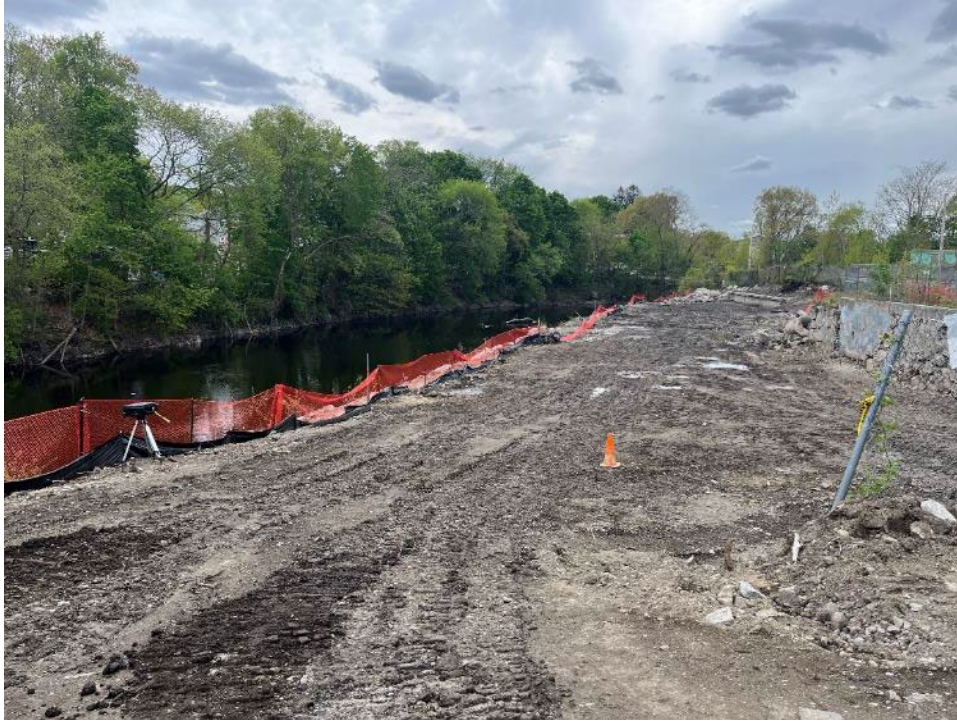
**SCENE:** View of the former stockpile area after excavation, loadout, and disposal of PCB-contaminated soil. Photograph taken facing southwest.

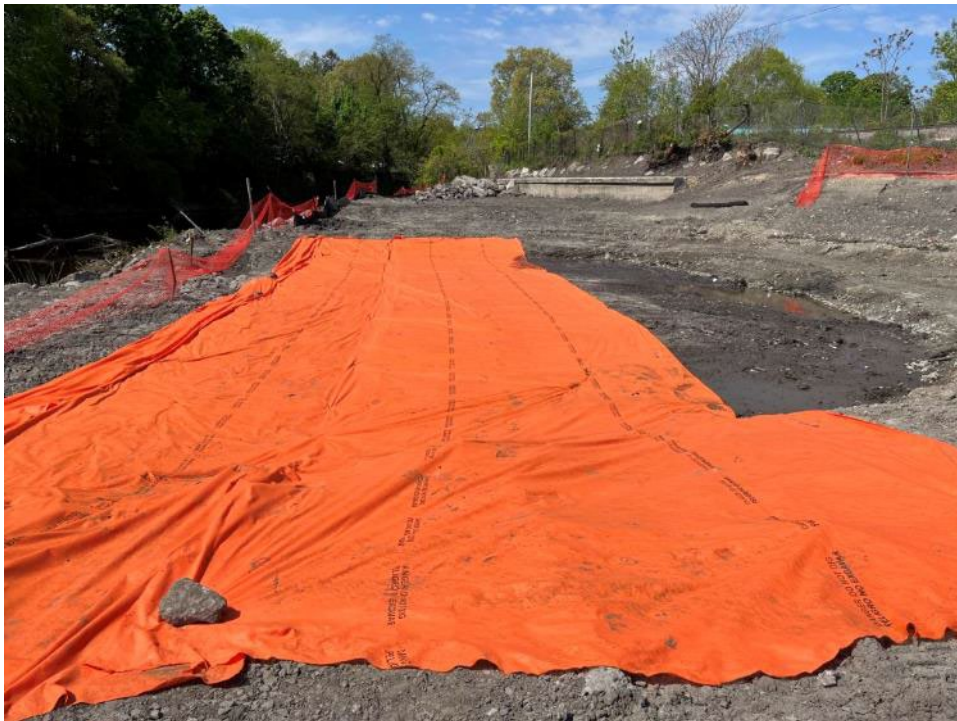
**SCENE:** View of the orange geotextile fabric placed on the excavated areas as a delineation marker prior to backfilling activities in the central area. Photograph taken facing south

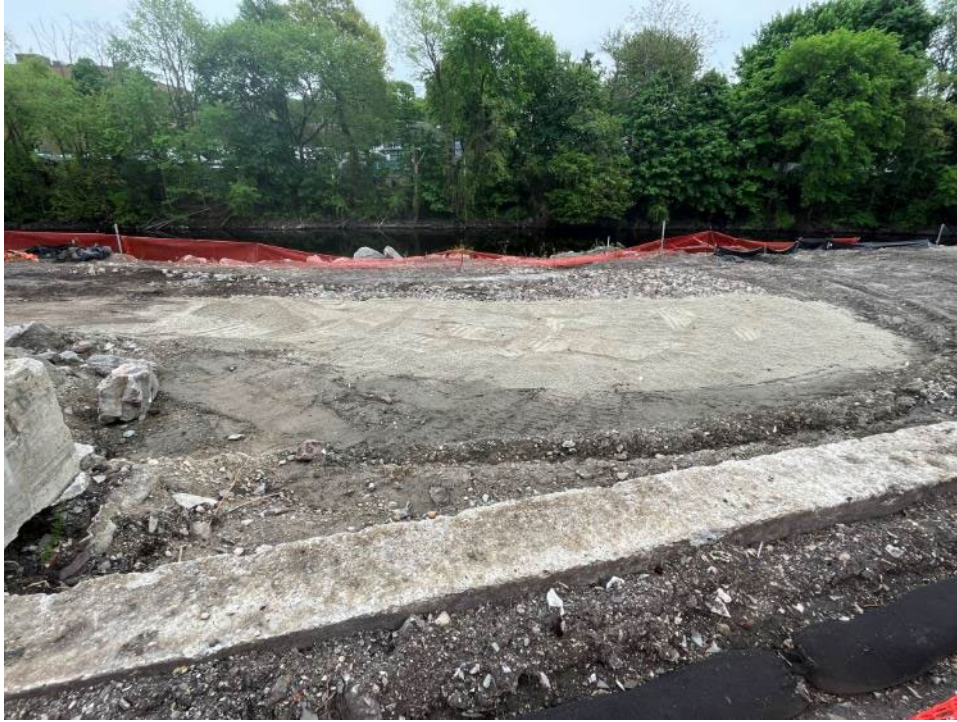
**SCENE:** View of backfilling activities in the central area. Backfill material was spread on top of orange geotextile fabric (not shown in photograph). Photograph taken facing east.

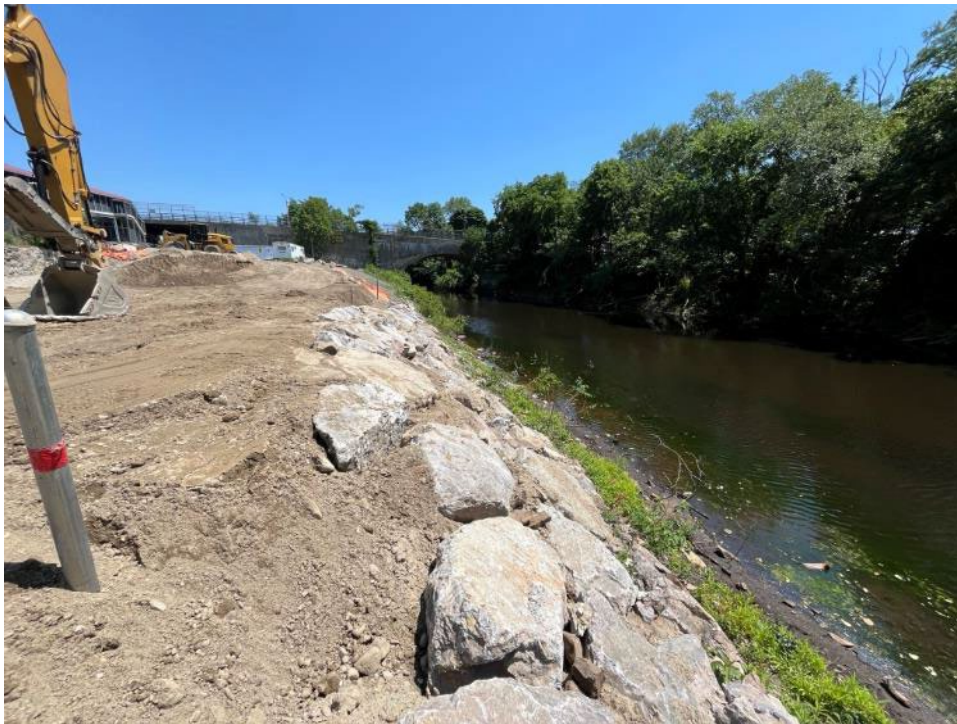
**SCENE:** View of the armor stones reinstalled along the riverbank at the completion of excavation and backfill activities. The red tape on the pole in the foreground indicates the height of the armor stones before excavation began. Photograph taken facing northeast.

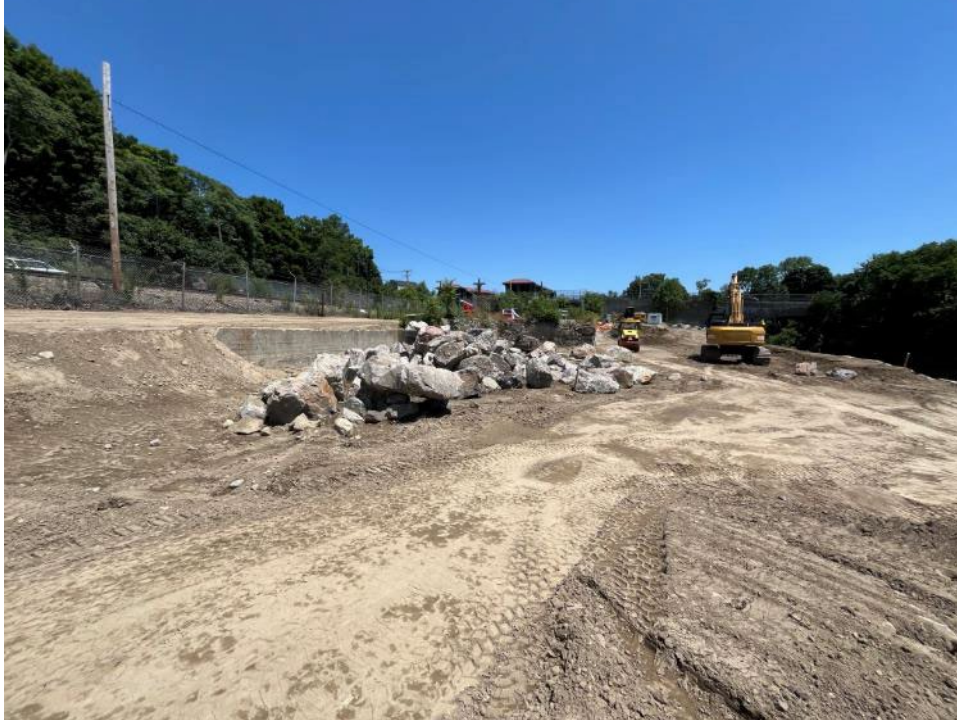
**SCENE:** View of the central area and the upland road at the completion of backfilling activities. Large stones are remaining armor stones to be placed back on the riverbank. Photograph taken facing north.

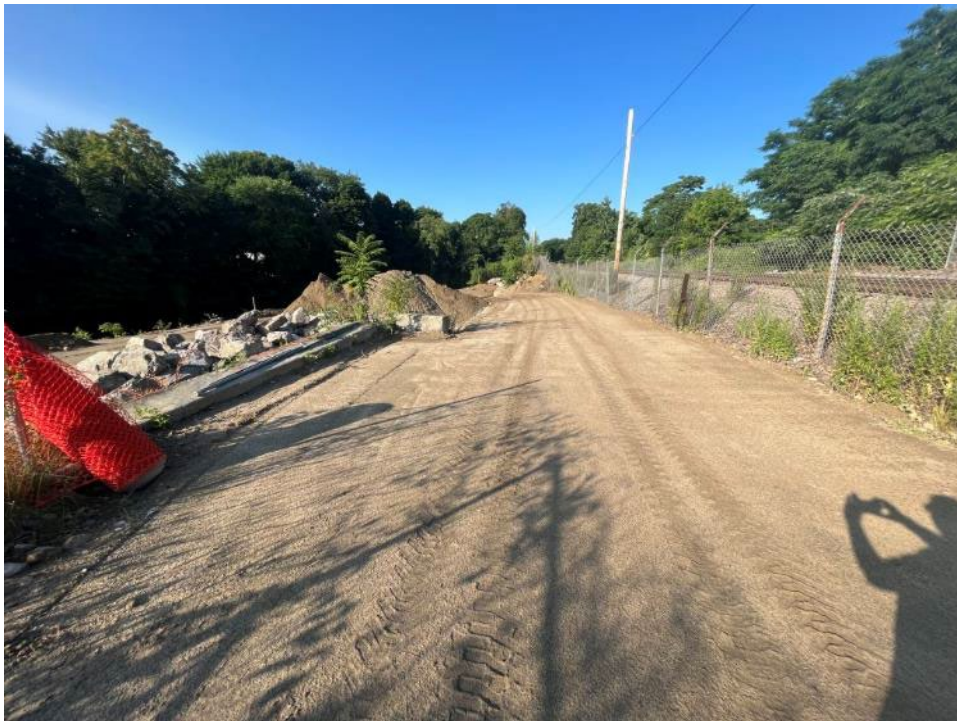
**SCENE:** View of the upland road at the completion of backfilling activities. Photograph taken facing southwest.

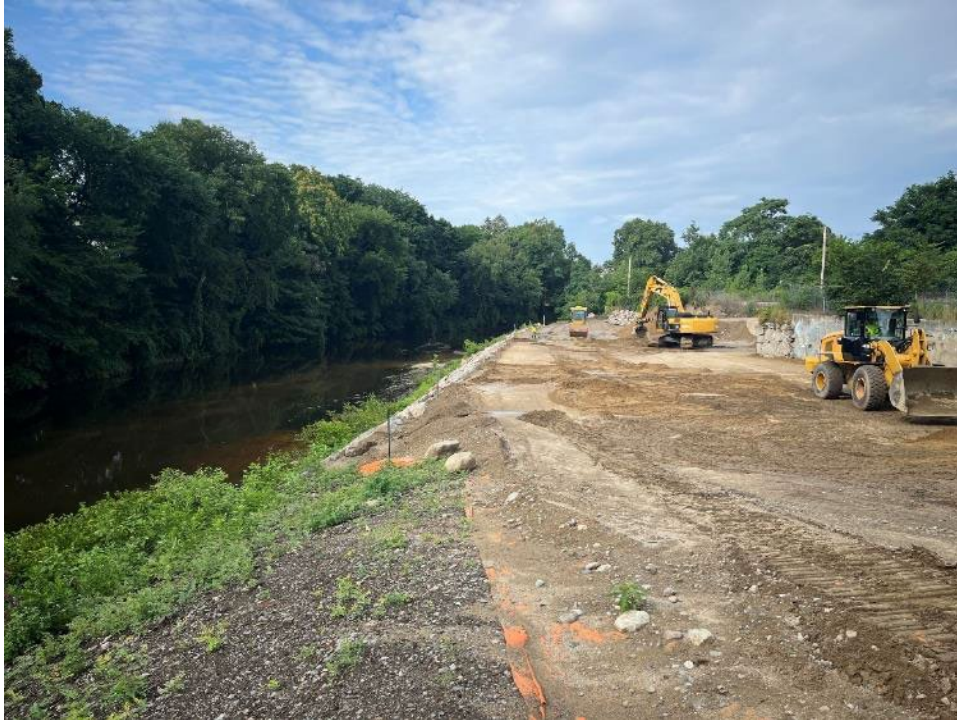
**SCENE:** View of Site restoration and backfilling activities. Photograph taken facing southwest.

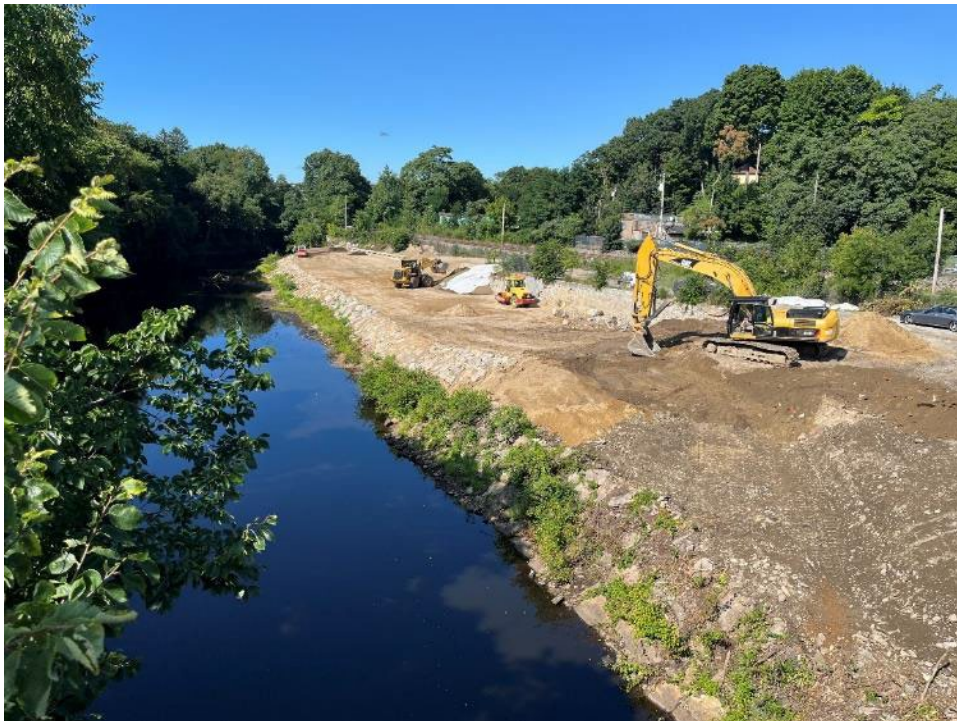
**SCENE:** View of the river access point for the Lower Neponset River (LNR) National Priorities List (NPL) Site and topsoil spreading activities on the Site. Photograph taken facing southwest.

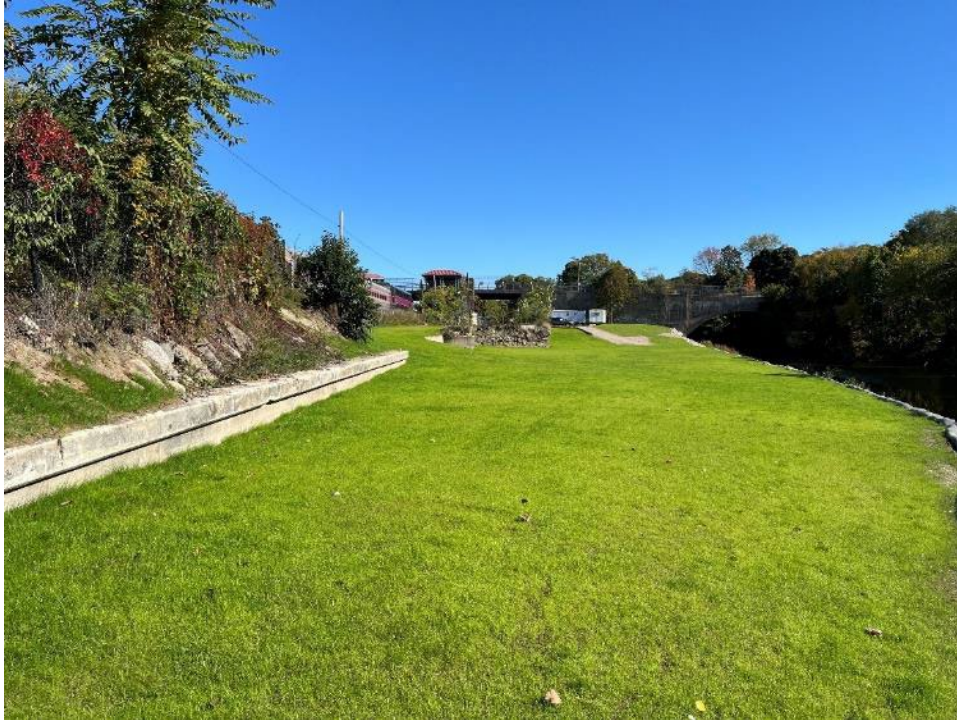
**SCENE:** View of the Site after backfilling, hydroseeding, and restoration was completed.

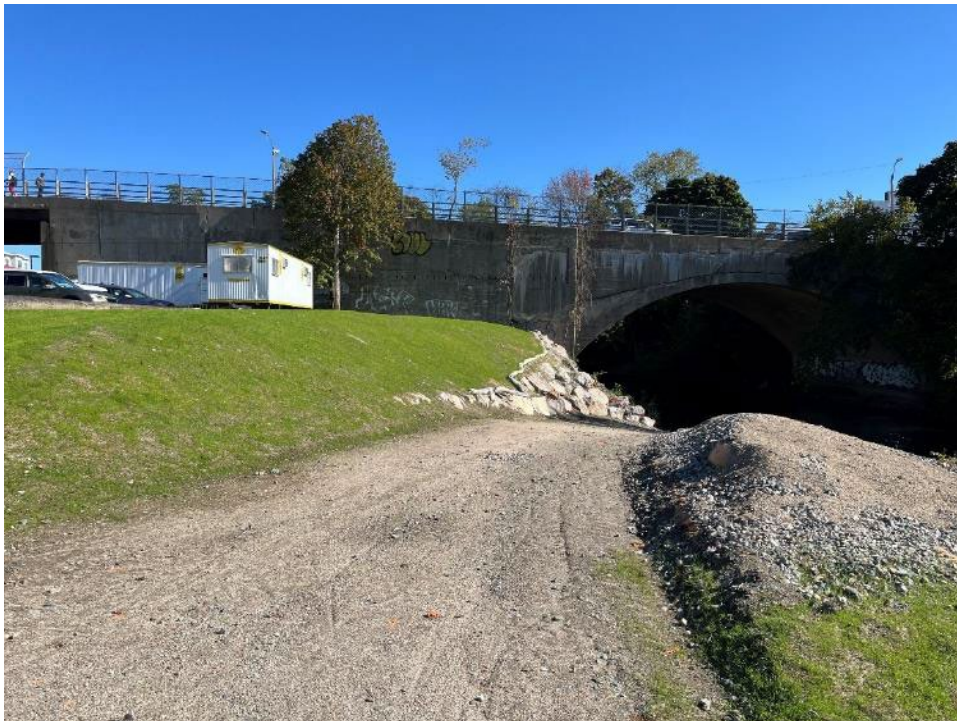
**SCENE:** View of the river access point to the Neponset River at the completion of grading and restoration. Photograph taken facing northeast.
