**ANALYTICAL RESULTS REPORT
SITE INSPECTION**

**GOLD HILL TAILINGS SITE
EPA ID# COD983801275**

**U.S. ENVIRONMENTAL PROTECTION AGENCY
REGION VIII**

October 14, 1994

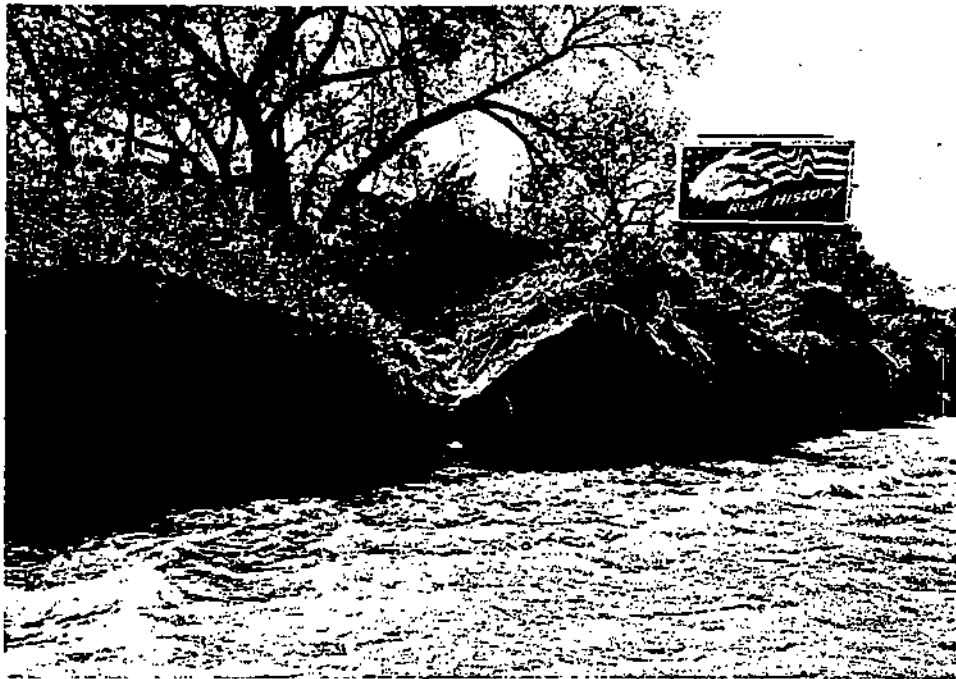
Sample GH-SE-3 was collected at the mouth of a drainage from the north central part of the tailings pile. The drainage mouth drops about 2 feet directly into Fountain Creek (see photo #5). Sample GH-SW-3 was collected directly beneath the mouth. Most of the area in this drainage has uncovered tailings present at the surface (see photos #6 through 8).
