Lisbon Valley Mining District Removal Site Update

Operations Period: 03 October 24-30, 2022

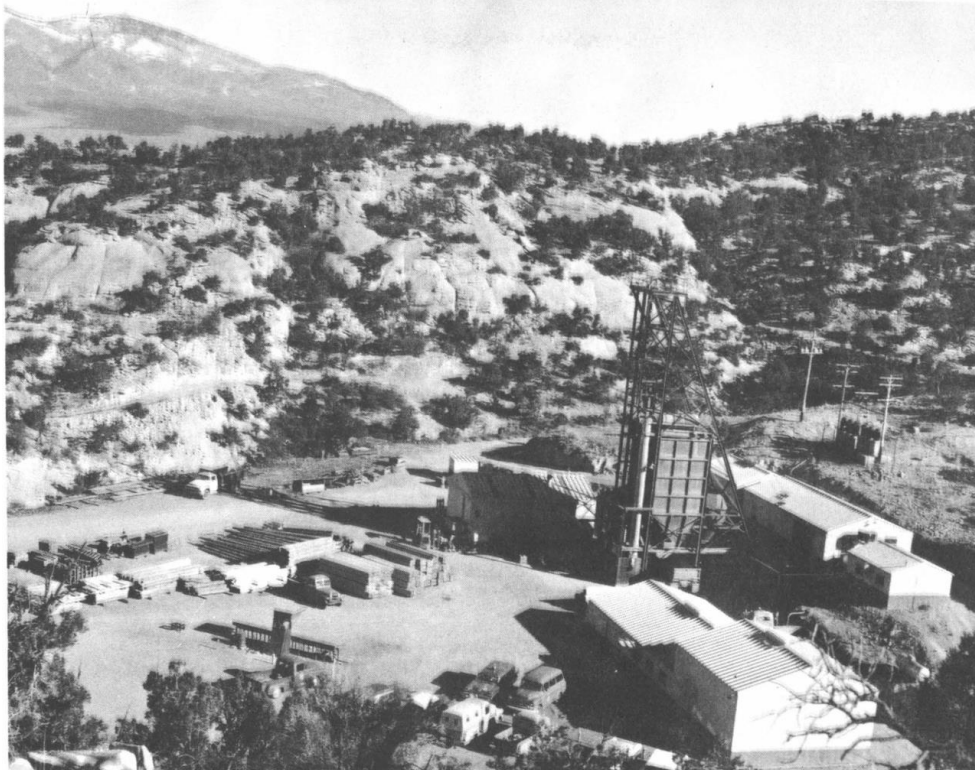
Radon Mine in approximately 1960. Image courtesy of Department of Interior Bureau of Mines.

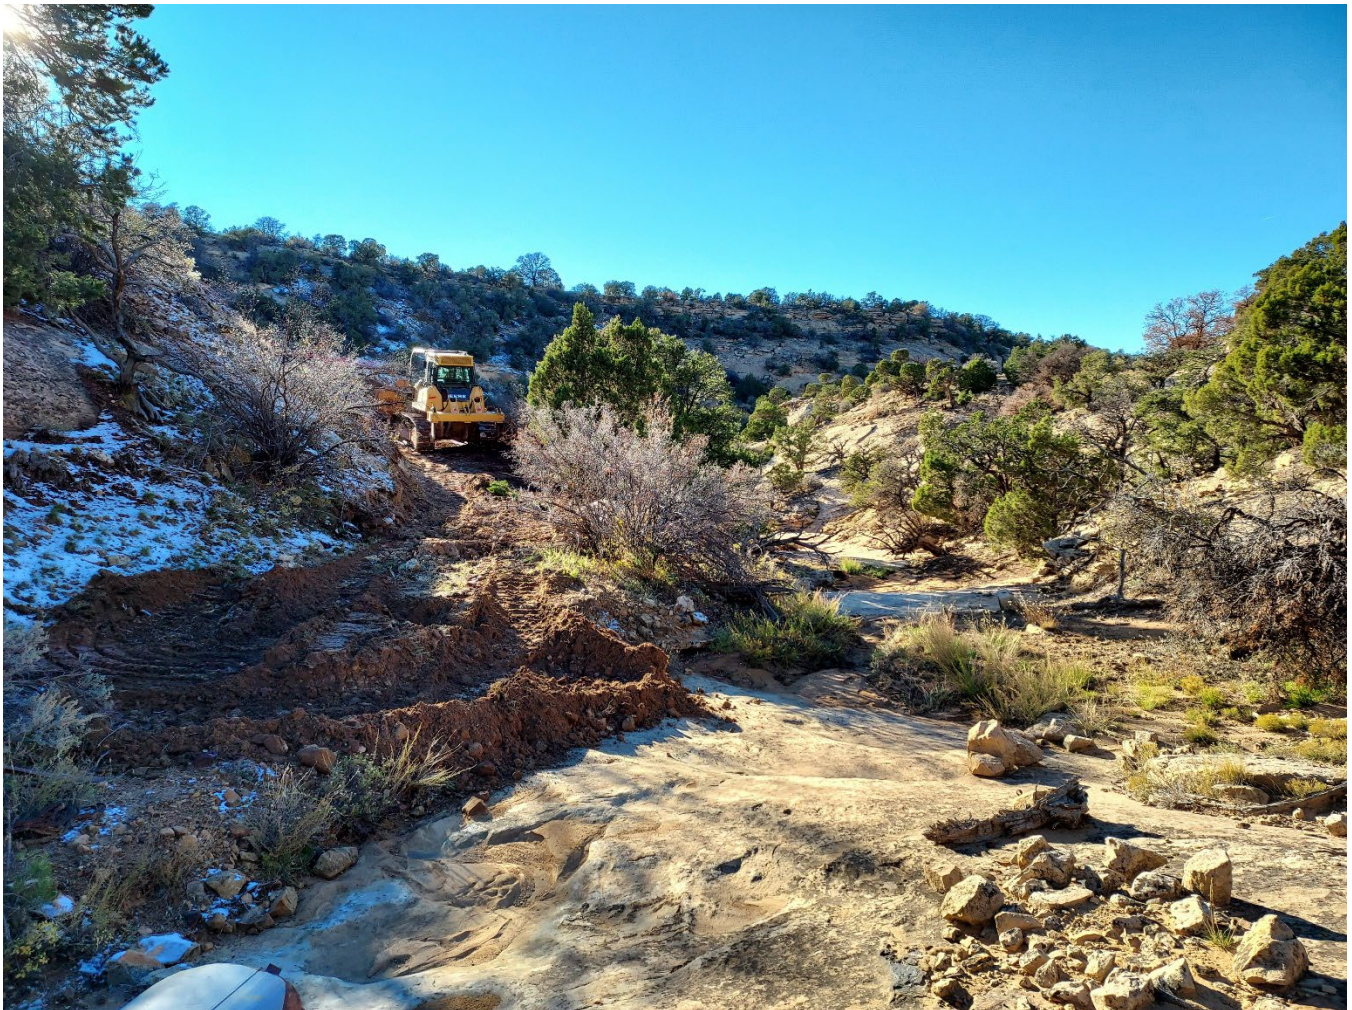
Beginning Construction of Ramp for Heavy Equipment to Access Bottom of Pile

The Team began construction of a ramp across the remaining face of the waste pile and down to the drainage which will allow heavy equipment to access the toe of the pile.

EPA's Response Team will complete construction of the access ramp down to the drainage and will begin pulling the toe of the pile back away from the drainage.

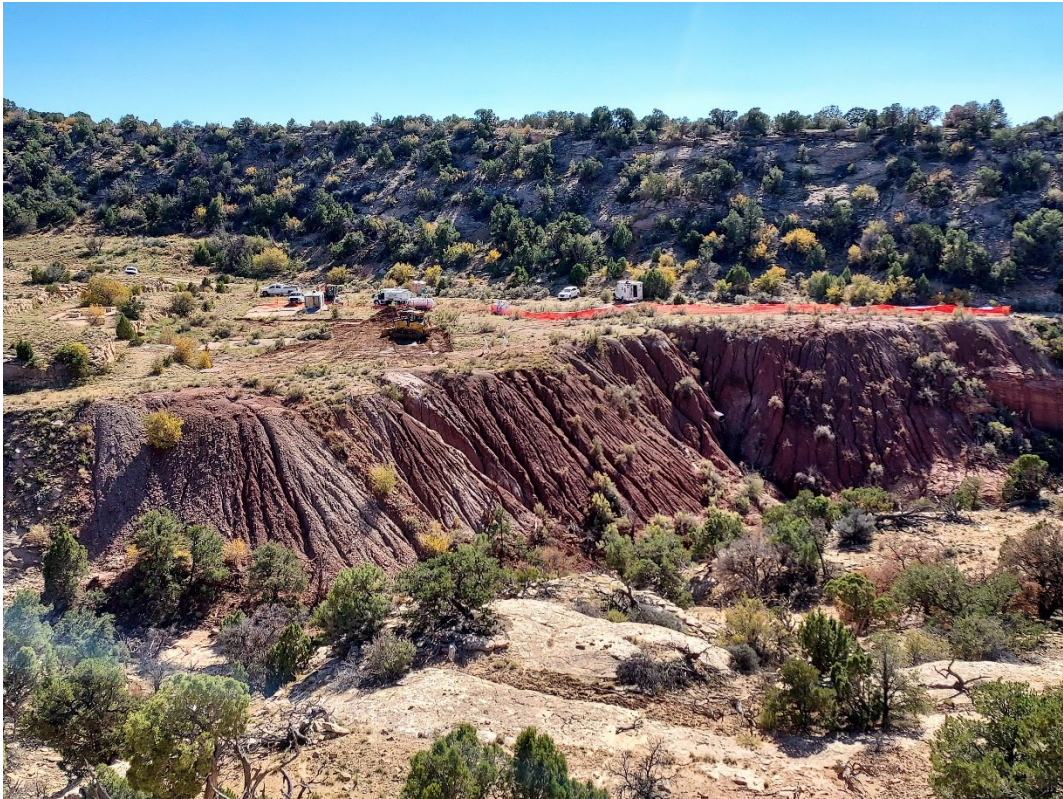
Radon Mine at the beginning of Work:

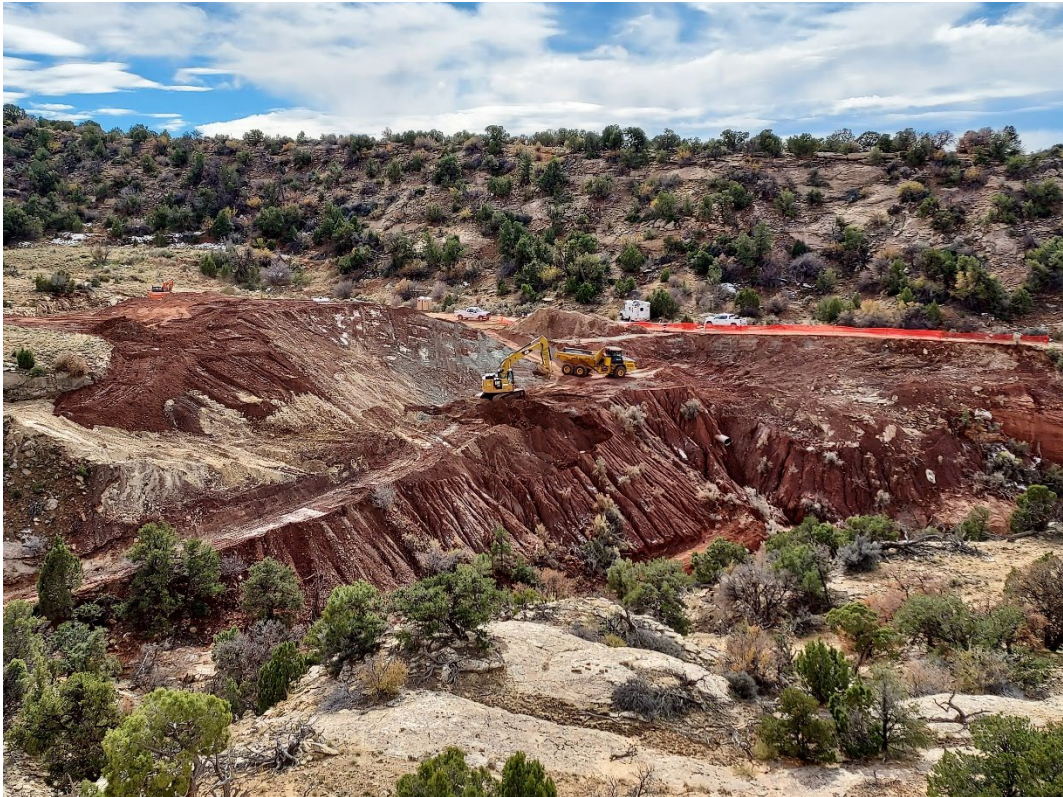
Radon Mine at the end of Operations Period:

EPA's Response Team removed a second lift or step from the crown of the Radon Mine waste pile. This second lift was again approximately 15' deep and 25' wide. The two lifts that were excavated will allow for easier access to the slope itself and to the toe of the pile.

The mine waste that was excavated was placed back away from the slope and used to continue establishing a more gentle gradient. The entire waste pile will eventually be regraded to better control erosion and keep the material from entering the drainage and migrating off-Site.
